Inspector: John Woodall

Residential Property Inspection Report

Property address: **10542 Thornview Dr**

Inspection date: **Saturday, July 25, 2020**

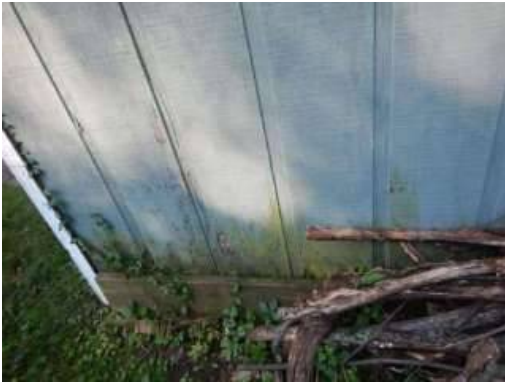
Photo 2-1

This property has a free standing shed. Shed was found with fungal rot, roof leak and earth on siding. If left unmaintained or repaired shed will decompose. Recommend repairs be made by a qualified professional.

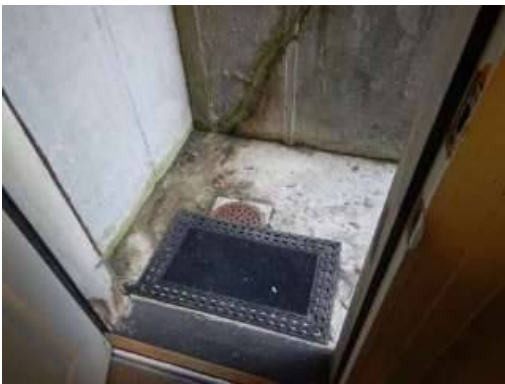
Photo 3-1

Recommend maintaining and monitoring stairwell drain in the future. If drain becomes clogged with leaves and silt water may enter the basement.

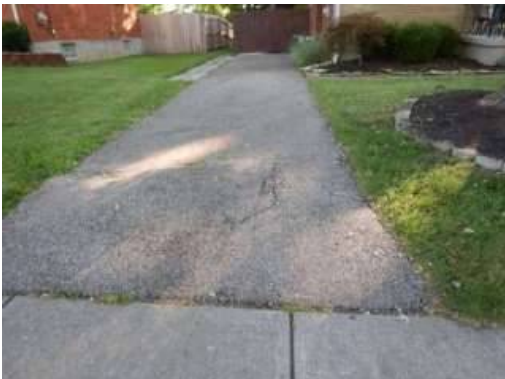
Photo 4-1

Minor cracks found in the asphalt driveway, but no trip hazards were found. Recommend monitoring and maintaining as necessary.

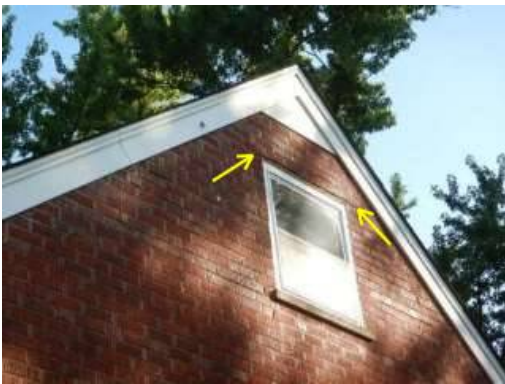
Photo 5-1

The masonry tuckpointing was damaged where the lintel over the window has rusted and expanded. Where cracks or openings are exposed, water can enter the wall structure causing further damage. Recommend that a qualified contractor repair as necessary. For example, by cleaning and painting the lintel(s) to inhibit rust and repointing as necessary.

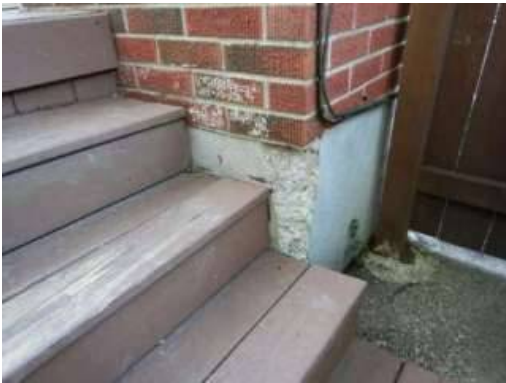
Minor cracks (1/8 inch or less) found in the foundation did not appear to be a structural concern, but recommend sealing them to prevent water infiltration and monitor them in the future. Numerous products exist to seal such cracks including hydraulic cement, non-shrinking grout, resilient caulks and epoxy sealants.

Photo 6-1 This corner is a cosmetic concern only

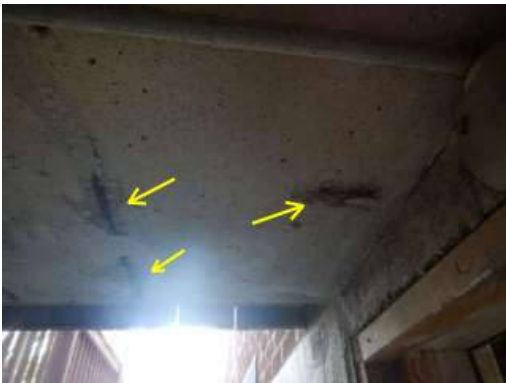
Photo 6-5 The ceiling over the basement stairwell has steel rebar rusting and needs to be sealed and maintained to prevent further damage.

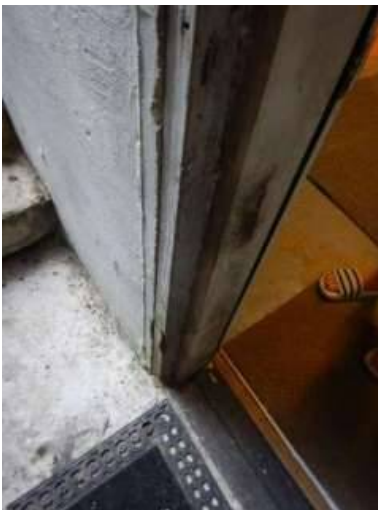
Photo 7-1

7) 🛠️💧 The paint or stain finish in some areas was failing (e.g. peeling, faded, worn, thinning). Siding and trim with a failing finish can be damaged by moisture. Recommend that a qualified contractor prep (e.g. clean, scrape, sand, prime, caulk) and repaint or restain where necessary and per standard building practices. Any repairs needed to the siding or trim should be made prior to this.

@ basement door jamb/brickmold

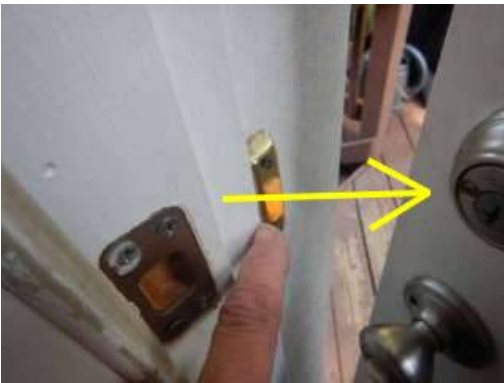
Photo 8-1

Exterior back door had double-cylinder deadbolt installed, where a key is required to open the door from both sides. This can be a safety hazard in the event of an emergency because egress can be obstructed or delayed. Recommend replacing double-cylinder deadbolts with single-cylinder deadbolts where a handle is installed on the interior side.

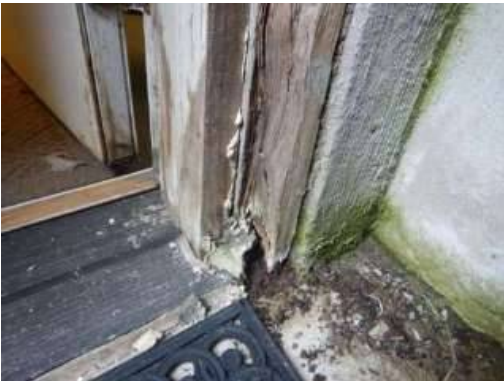
Photo 9-1

Fungal rot was found at basement exterior brick mold. Recommend that a qualified person repair as necessary.

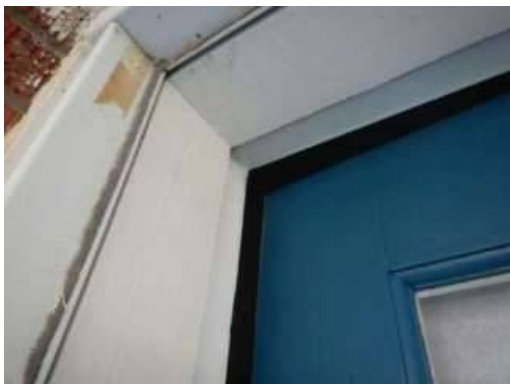
Photo 10-1

Exterior door at front binds in jamb. Recommend that a qualified person repair as necessary.

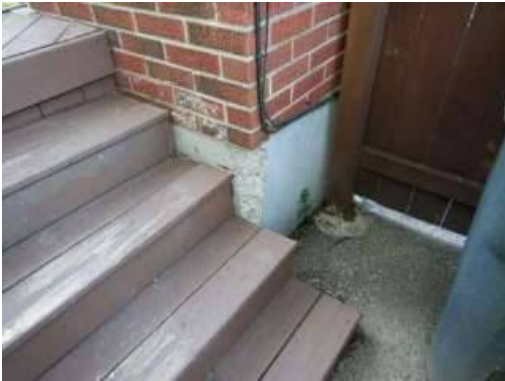
Photo 11-1

Wooden deck surfaces were overdue for normal maintenance. Recommend that a qualified person clean and preserve as necessary. Where decks have been coated with a finish such as opaque stains or paint, it may be too difficult to strip the finish and apply anything but paint or opaque stain. Where transparent stain or penetrating oil has been applied in the past, recommend that a penetrating oil be used. For more information, visit: <https://www.bestchoicehomeinspections.com/articles/deck-maintenance/>

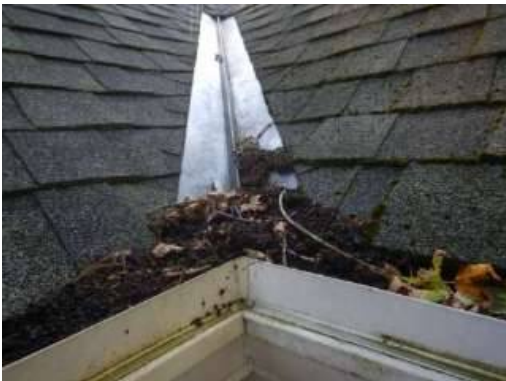
Photo 12-1

Debris has accumulated on the gutter guards. Gutters can overflow and cause water to come in contact with the building exterior, or water can accumulate around the foundation. This is a conducive condition for wood-destroying organisms. Recommend cleaning gutters and downspouts now and as necessary in the future. Recommend gutter guards be added to keep gutters free of debris and reduce maintenance.

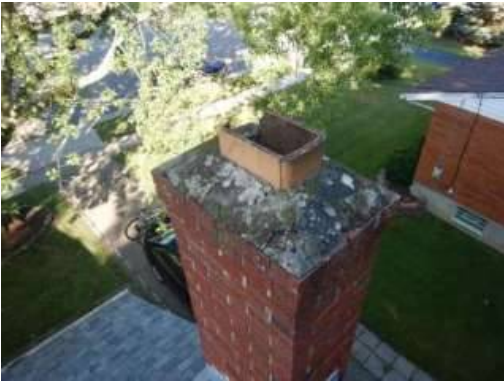
Photo 13-1

No rain cap was installed at chimney flue terminations. Rain caps prevent water from entering flues, mixing with combustion deposits and creating caustic chemicals which can corrode flues. They also prevent damage to masonry from freeze-thaw cycles and prevent metal components (e.g. dampers, metal firebox liners) from rusting. They also prevent wildlife (e.g. birds, rodents, raccoons) from entering flues. Recommend that a qualified person install rain caps per standard building practices where missing.

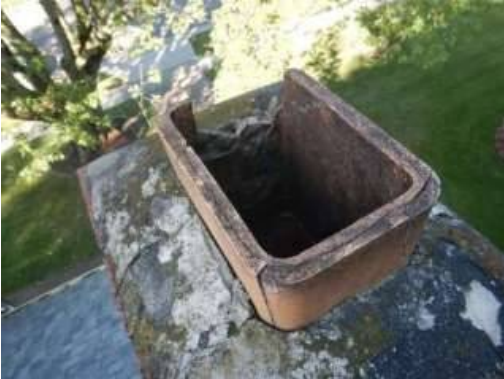
Photo 14-1

The masonry chimney crown is cracked. Crowns are meant to keep water off of the chimney structure and prevent damage from freeze-thaw cycles. Recommend that a qualified contractor repair or replace crowns as necessary, and per standard building practices.

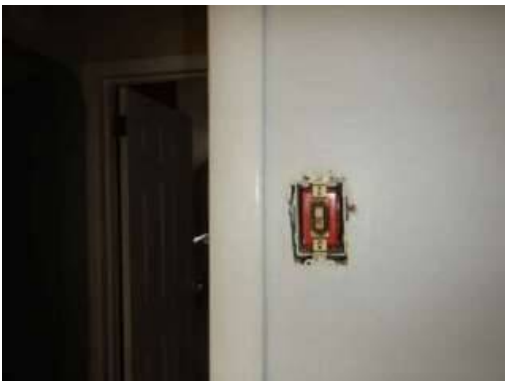
Photo 15-1

Cover plates for switches, receptacles (outlets) or junction boxes were missing or broken. These plates are intended to contain fire and prevent electric shock from occurring due to exposed wires. Recommend that a qualified person install cover plates where necessary.

@ attic

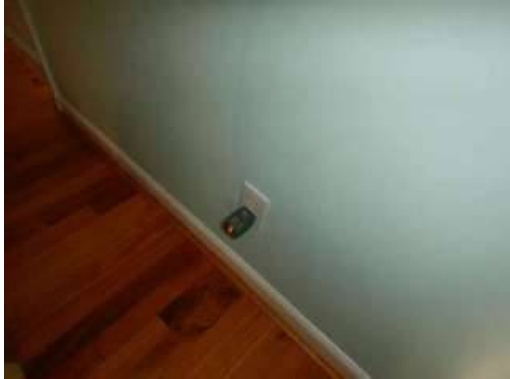
Photo 16-1

Modern, 3-slot electric receptacle (outlet) was found with an open ground. Three-slot receptacles should have a hot, a neutral and a ground wire connected. Homeowners often install new 3-slot receptacles on older, 2-wire circuits that only have hot and neutral wires. This is a shock hazard when appliances that require a ground are used with these receptacles. Examples of such appliances include computers and related hardware, refrigerators, freezers, portable air conditioners, clothes washers, aquarium pumps, and electrically operated gardening tools. Where the electric system was installed prior to when grounded circuits were required (1960's), it is permissible to replace 3-slot receptacles with 2-slot receptacles to prevent appliances that require a ground from being plugged into an ungrounded circuit. However, the client should be aware of this limitation when planning use for various rooms, such as an office. For newer electrical systems, circuits should be repaired so grounded, 3-wire cables provide power to 3-slot receptacles. Recommend

- dining room
- 2 in back bedroom
- 2 in front bedroom
- all but front plug in living room
- all in attic

that a qualified electrician repair per standard building practices.

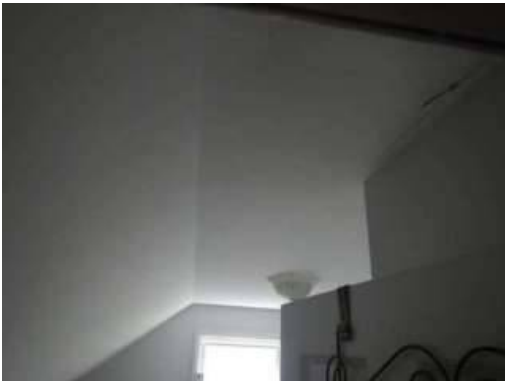
Photo 18-1

Some smoke/CO2 alarms were missing in areas where they should be. Smoke alarms should be installed in each bedroom, in hallways leading to bedrooms, on each level and in attached garages. They have a limited lifespan and should be replaced every 10 years. Batteries in smoke alarms should be changed when taking occupancy and annually in the future. Carbon monoxide alarms should be installed near sleeping areas and on each level in homes with a fuel-burning appliance or attached garage. For more information on smoke alarms see: <https://www.bestchoicehomeinspections.com/articles/smoke-alarms/>

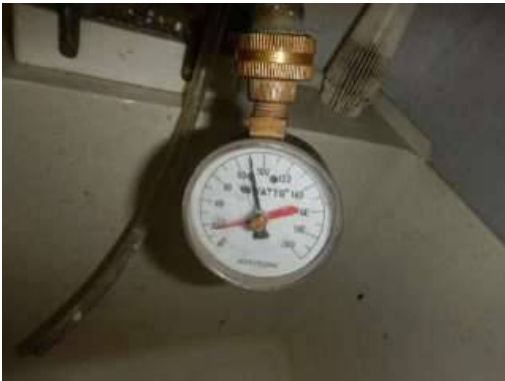
Photo 19-1

The water supply pressure was greater than 80 pounds per square inch (PSI). Pressures above 80 PSI may void warranties for some appliances such as water heaters or washing machines. Flexible supply lines to washing machines are likely to burst with higher pressures. 40-80 PSI is considered the normal range for water pressure in a home, and most plumbers recommend 50-60 PSI. Typically, the pressure cannot be regulated at the water meter. Recommend that a qualified plumber evaluate and make modifications to reduce the pressure to below 80 PSI. Installing a pressure reducing valve on the main service pipe is a common solution to this problem. If one exists, then it should be adjusted, repaired or replaced as necessary to maintain lower pressures. Note that installing a pressure reducing valve creates a "closed system," which may require installing an expansion tank at the water heater if one is not already installed.

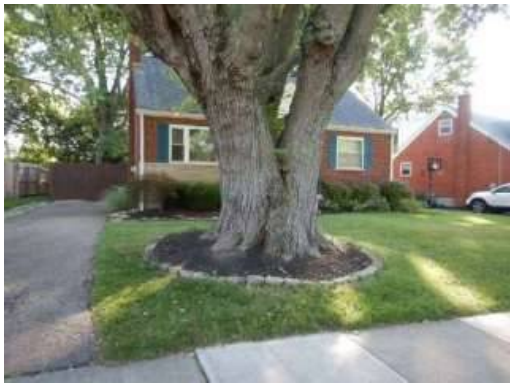
Photo 20-1

Based on the disclosures, the large old growth tree in front, and the slow basement bathtub drain, I believe it is important to have the main drainage line camera scoped to the street to be sure there are no future drainage issues. If the tree roots have penetrated the sewage line they will return and keep growing and you will always have drainage issues. If the sewage line has been penetrated it will have to be lined or replaced which can be costly. Recommend evaluation and repairs be done by a qualified professional.

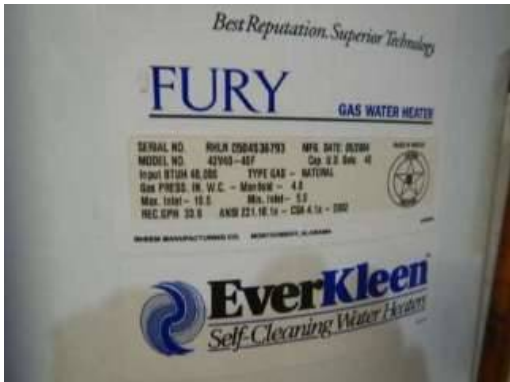
Photo 22-1

The estimated useful life for most water heaters is 8-12 years. This water heater appeared to be beyond this age. Recommend budgeting for repairs or replacement in the next few years.

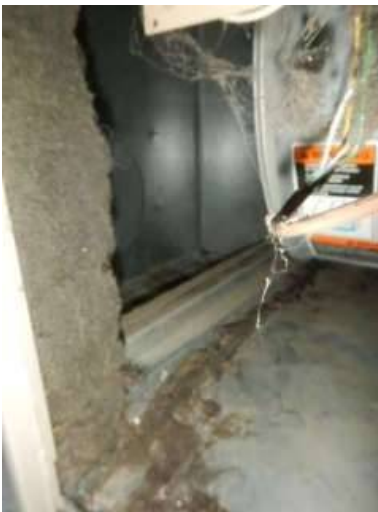
Photo 23-1

Air filter needs cleaning or replacement. Periodically (at least 4 times per year) check and replace, or wash, air filters and inspect your furnace for signs of unusual operation such as discoloration, soot, or disconnected vents. For more information see: <https://www.bestchoicehomeinspections.com/articles/hvac-filter/>

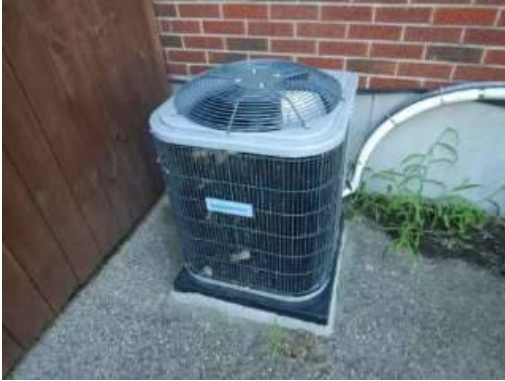
Photo 24-1

The last service date of the HVAC system appeared to be more than 2 years ago. Ask the property owner when it was last serviced. If unable to determine the last service date, or if this system was serviced more than 2 years ago, recommend that a qualified HVAC contractor service this system and

make repairs if necessary. Because this system has a compressor and refrigerant system, this servicing should be performed every few years in the future.

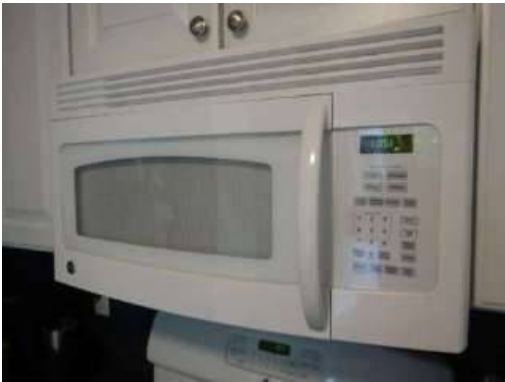
Photo 25-1

The microwave light was not working. Recommend evaluation, and replace bulb or repair fan as necessary.

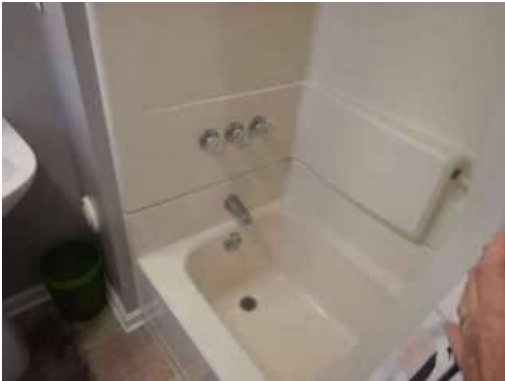
Photo 26-1

26) 🛠️ The bathtub drained slowly. Recommend clearing drain and/or that a qualified plumber repair if necessary.

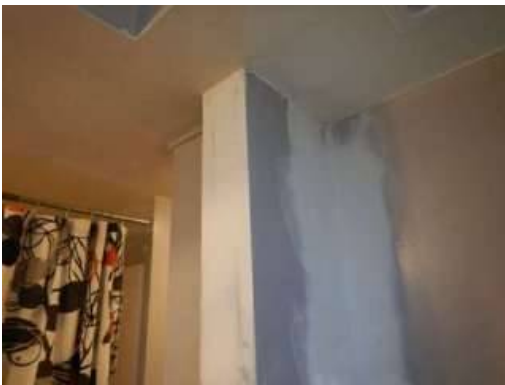
Photo 28-1

28) 🛠️ Interior walls and/or ceilings had incomplete or substandard repairs. Recommend that a qualified person evaluate and repair as necessary and per standard building practices.

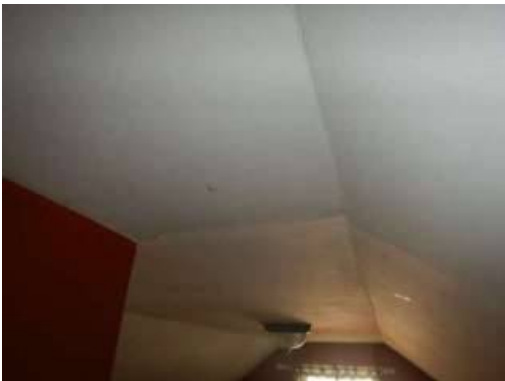
Photo 29-1

29) 🛠️ ⓘ Minor cracks, nail pops and/or blemishes were found in the walls and/or ceilings. Cracks and nail pops are common, are often caused by lumber shrinkage, seasonal expansion and contraction, or minor settlement, and can be more or less noticeable depending on changes in humidity. Blemishes may be caused by normal usage or substandard patching and painting. They did not appear to be a structural concern, but the client may wish to repair these for aesthetic reasons.

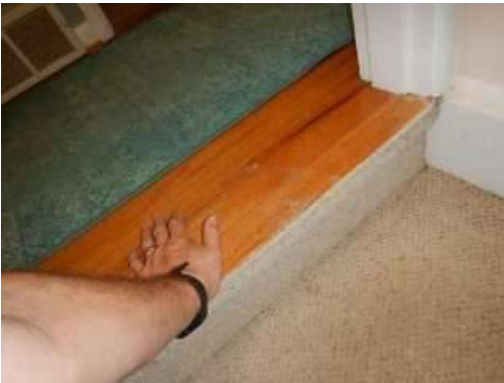
Photo 30-1

Stair nose/flooring was loose and subject to damage. This could also be a hazard. Recommend installing proper support for the stair nose as appropriate.

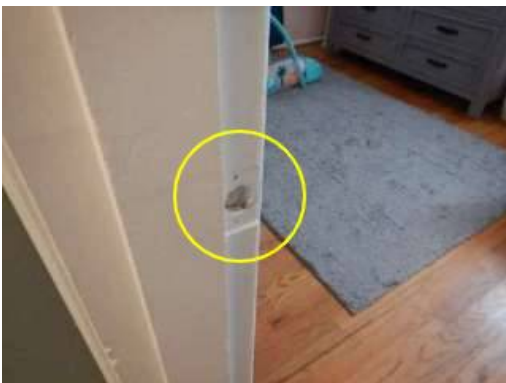
Photo 33-1

The back bedroom door strike plate was missing and the closet door latch was installed backwards. Recommend that a qualified person repair or replace as necessary.

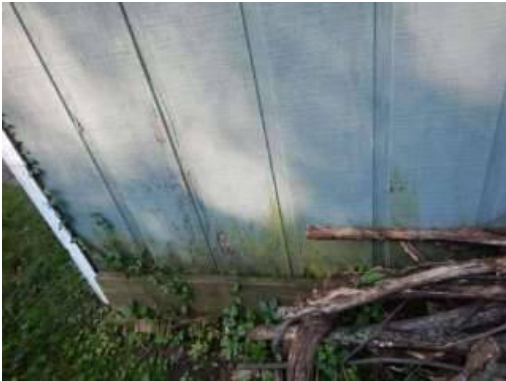
Photo 2-1

This property has a free standing shed. Shed was found with fungal rot, roof leak and earth on siding. If left unmaintained or repaired shed will decompose. Recommend repairs be made by a qualified professional.

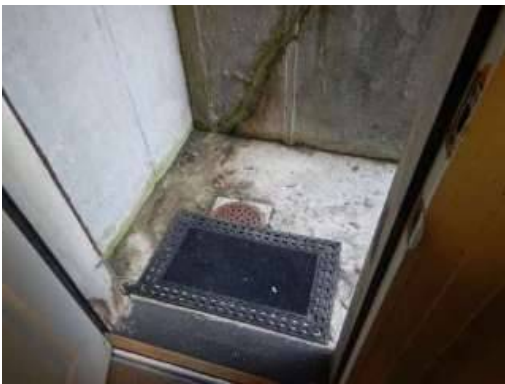
Photo 3-1

Recommend maintaining and monitoring stairwell drain in the future. If drain becomes clogged with leaves and silt water may enter the basement.

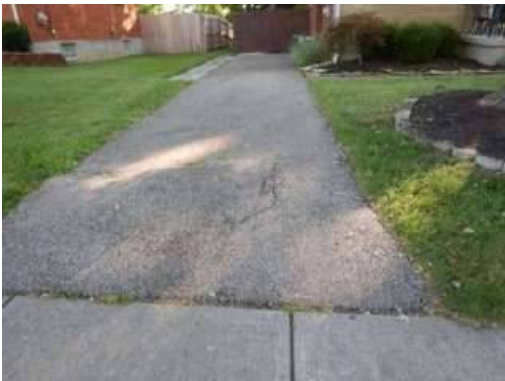
Photo 4-1

Minor cracks found in the asphalt driveway, but no trip hazards were found. Recommend monitoring and maintaining as necessary.

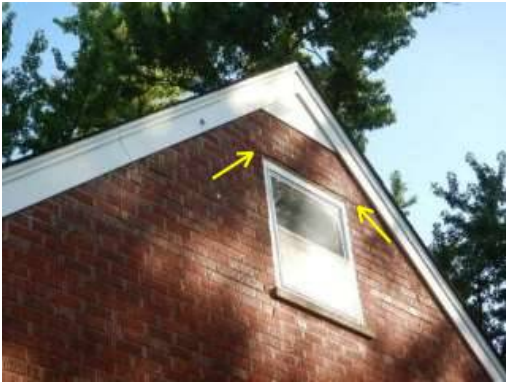
Photo 5-1

The masonry tuckpointing was damaged where the lintel over the window has rusted and expanded. Where cracks or openings are exposed, water can enter the wall structure causing further damage. Recommend that a qualified contractor repair as necessary. For example, by cleaning and painting the lintel(s) to inhibit rust and repointing as necessary.

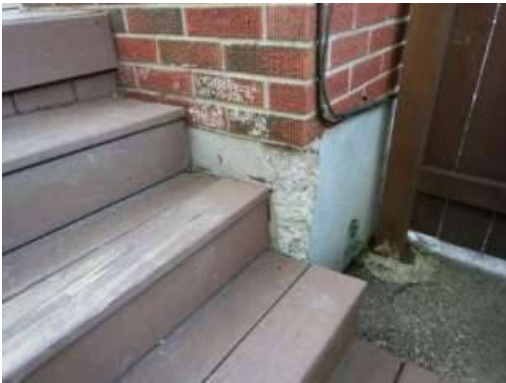
Minor cracks (1/8 inch or less) found in the foundation did not appear to be a structural concern, but recommend sealing them to prevent water infiltration and monitor them in the future. Numerous products exist to seal such cracks including hydraulic cement, non-shrinking grout, resilient caulks and epoxy sealants.

Photo 6-1 This corner is a cosmetic concern only

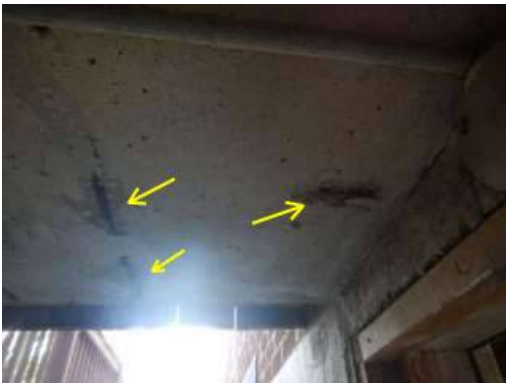
Photo 6-5 The ceiling over the basement stairwell has steel rebar rusting and needs to be sealed and maintained to prevent further damage.

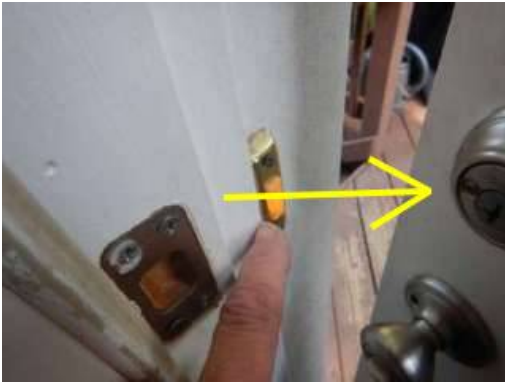
Photo 8-1

Exterior back door had double-cylinder deadbolt installed, where a key is required to open the door from both sides. This can be a safety hazard in the event of an emergency because egress can be obstructed or delayed. Recommend replacing double-cylinder deadbolts with single-cylinder deadbolts where a handle is installed on the interior side.

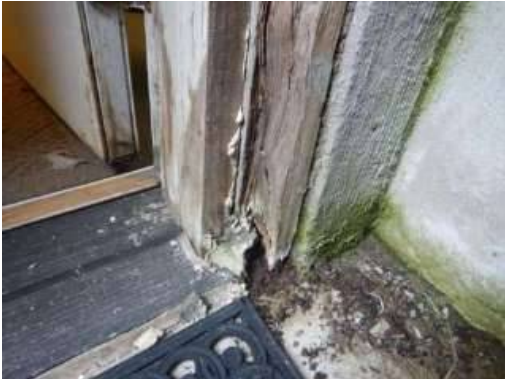
Photo 9-1

Fungal rot was found at basement exterior brick mold. Recommend that a qualified person repair as necessary.

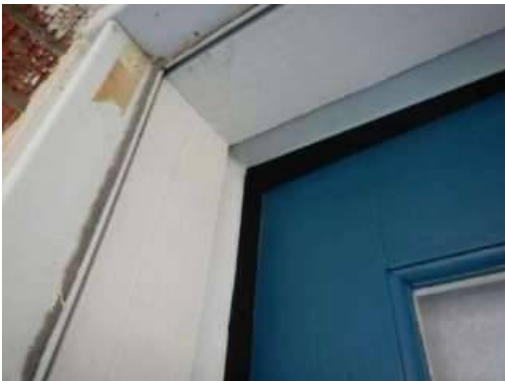
Photo 10-1

Exterior door at front binds in jamb. Recommend that a qualified person repair as necessary.

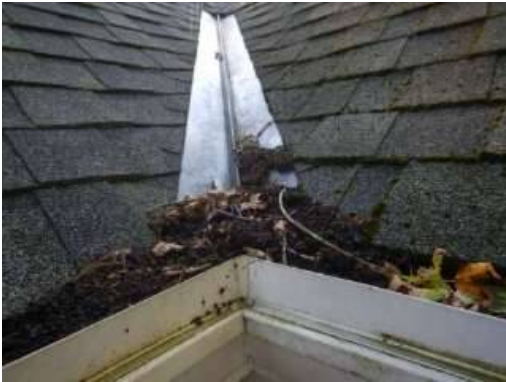
Photo 12-1

Debris has accumulated on the gutter guards. Gutters can overflow and cause water to come in contact with the building exterior, or water can accumulate around the foundation. This is a conducive condition for wood-destroying organisms. Recommend cleaning gutters and downspouts now and as necessary in the future. Recommend gutter guards be added to keep gutters free of debris and reduce maintenance.

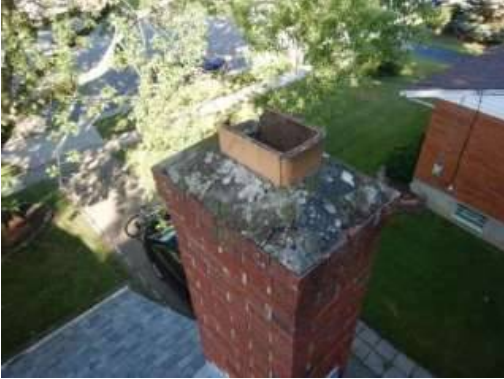
Photo 13-1

No rain cap was installed at chimney flue terminations. Rain caps prevent water from entering flues, mixing with combustion deposits and creating caustic chemicals which can corrode flues. They also prevent damage to masonry from freeze-thaw cycles and prevent metal components (e.g. dampers, metal firebox liners) from rusting. They also prevent wildlife (e.g. birds, rodents, raccoons) from entering flues. Recommend that a qualified person install rain caps per standard building practices where missing.

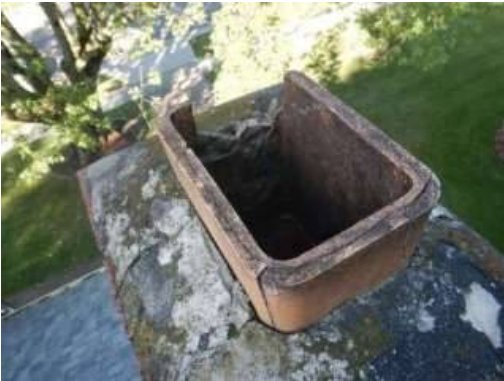
Photo 14-1

The masonry chimney crown is cracked. Crowns are meant to keep water off of the chimney structure and prevent damage from freeze-thaw cycles. Recommend that a qualified contractor repair or replace crowns as necessary, and per standard building practices.

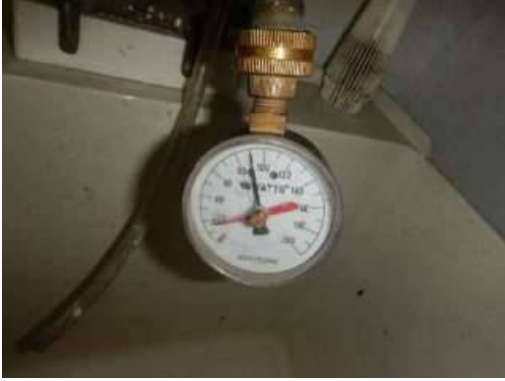
Photo 19-1

19) 🔍 The water supply pressure was greater than 80 pounds per square inch (PSI). Pressures above 80 PSI may void warranties for some appliances such as water heaters or washing machines. Flexible supply lines to washing machines are likely to burst with higher pressures. 40-80 PSI is considered the normal range for water pressure in a home, and most plumbers recommend 50-60 PSI . Typically, the pressure cannot be regulated at the water meter. Recommend that a qualified plumber evaluate and make modifications to reduce the pressure to below 80 PSI . Installing a pressure reducing valve on the main service pipe is a common solution to this problem. If one exists, then it should be adjusted, repaired or replaced as necessary to maintain lower pressures. Note that installing a pressure reducing valve creates a "closed system," which may require installing an expansion tank at the water heater if one is not already installed.

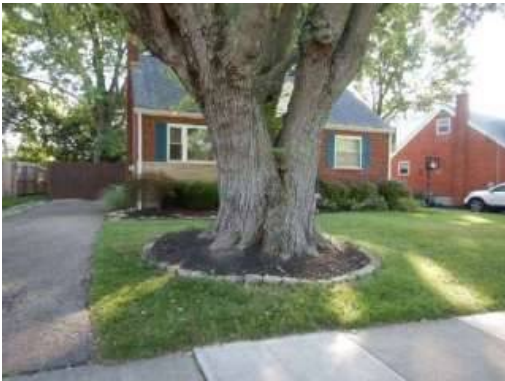
Photo 20-1

20) 🔍 Based on the disclosures, the large old growth tree in front, and the slow basement bathtub drain, I believe it is important to have the main drainage line camera scoped to the street to be sure there are no future drainage issues. If the tree roots have penetrated the sewage line they will return and keep growing and you will always have drainage issues. If the sewage line has been penetrated it will have to be lined or replaced which can be costly. Recommend evaluation and repairs be done by a qualified professional.

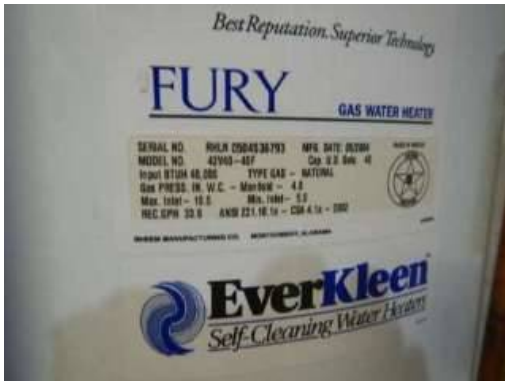
Photo 22-1

The estimated useful life for most water heaters is 8-12 years. This water heater appeared to be beyond this age. Recommend budgeting for repairs or replacement in the next few years.

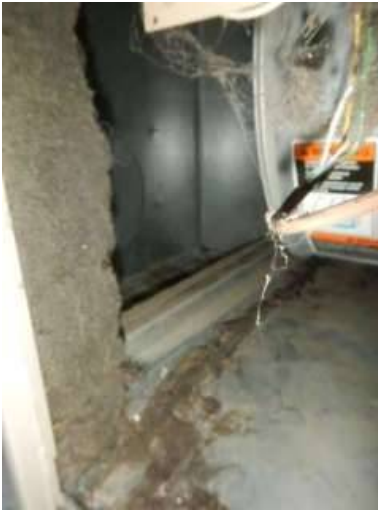
Photo 23-1

Air filter needs cleaning or replacement. Periodically (at least 4 times per year) check and replace, or wash, air filters and inspect your furnace for signs of unusual operation such as discoloration, soot, or disconnected vents. For more information see: <https://www.bestchoicehomeinspections.com/articles/hvac-filter/>

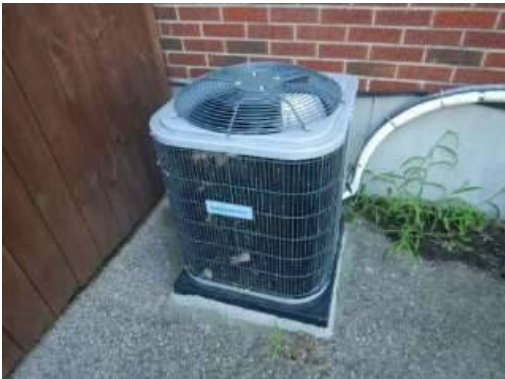
Photo 24-1

The last service date of the HVAC system appeared to be more than 2 years ago. Ask the property owner when it was last serviced. If unable to determine the last service date, or if this system was serviced more than 2 years ago, recommend that a qualified HVAC contractor service this system and make repairs if necessary. Because this system has a compressor and refrigerant system, this servicing should be performed every few years in the future.

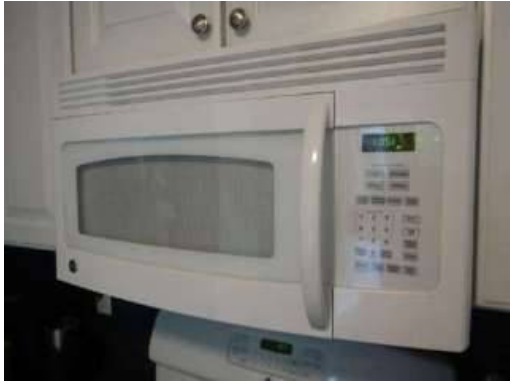
Photo 25-1

25) 🔧🔍 The microwave light was not working. Recommend evaluation, and replace bulb or repair fan as necessary.

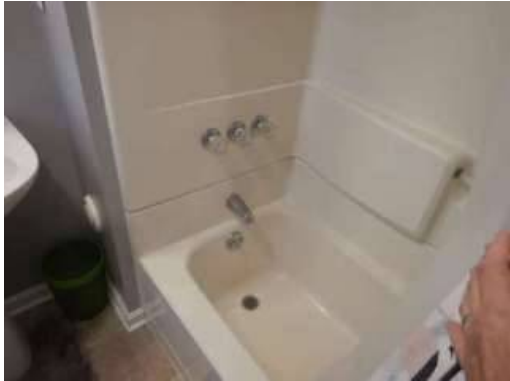
Photo 26-1

26) 🛠️ The bathtub drained slowly. Recommend clearing drain and/or that a qualified plumber repair if necessary.

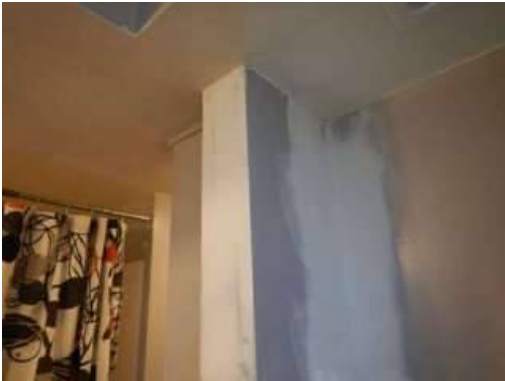
Photo 28-1

28) 🛠️ Interior walls and/or ceilings had incomplete or substandard repairs. Recommend that a qualified person evaluate and repair as necessary and per standard building practices.

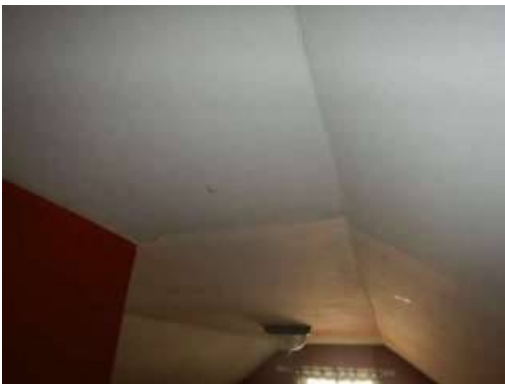
Photo 29-1

29) 🛠️ ⓘ Minor cracks, nail pops and/or blemishes were found in the walls and/or ceilings. Cracks and nail pops are common, are often caused by lumber shrinkage, seasonal expansion and contraction, or minor settlement, and can be more or less noticeable depending on changes in humidity. Blemishes may be caused by normal usage or substandard patching and painting. They did not appear to be a structural concern, but the client may wish to repair these for aesthetic reasons.

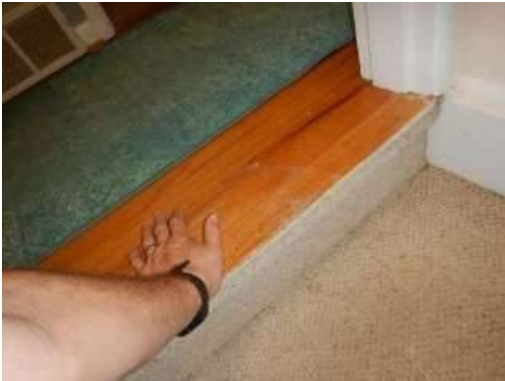
Photo 30-1

Stair nose/flooring was loose and subject to damage. This could also be a hazard. Recommend installing proper support for the stair nose as appropriate.
