## Residential Property Inspection Report

Client(s): Reid Butler

Property address: 41 Linden

Inspection date: Saturday, August 1, 2020

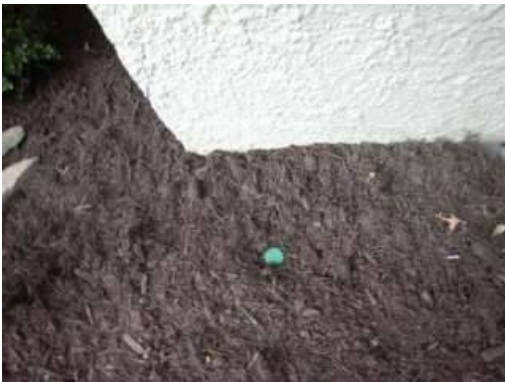
Photo 2-1

Bait traps found at perimeter. Recommend consult with property owner about history of treatment, infestation, prior or ongoing treatment plan and warranties.

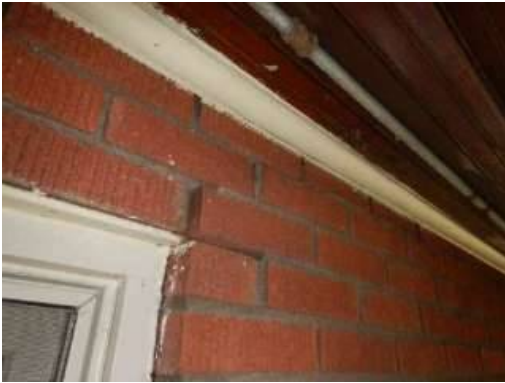
Photo 3-1

Minor cracks were found in the exterior masonry. These do not appear to be a structural concern. Where cracks or openings are exposed, water can enter causing further damage. Recommend that a qualified contractor seal cracks as necessary.

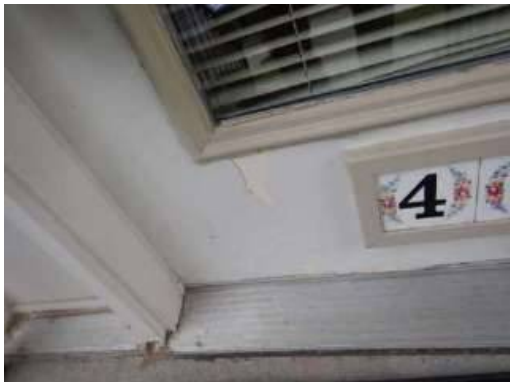
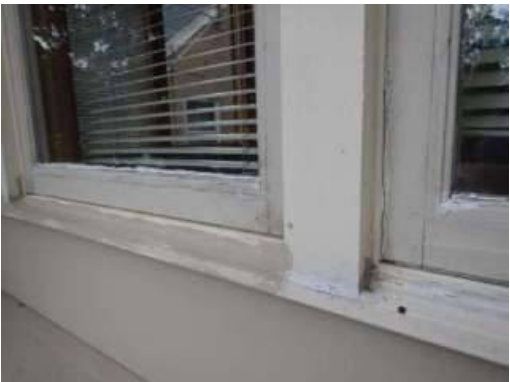
The paint or stain finish in some areas was failing (e.g. peeling, faded, worn, thinning). Siding and trim with a failing finish can be damaged by moisture. Recommend that a qualified contractor prep (e.g. clean, scrape, sand, prime, caulk) and repaint or restain where necessary and per standard building practices. Any repairs needed to the siding or trim should be made prior to this.

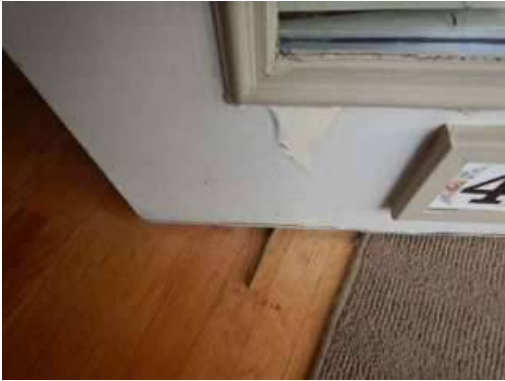
Photo 5-1

The front exterior door had damage and/or deterioration to the weatherstripping. Although serviceable, the client may wish to repair or replace to save on heating and cooling costs.

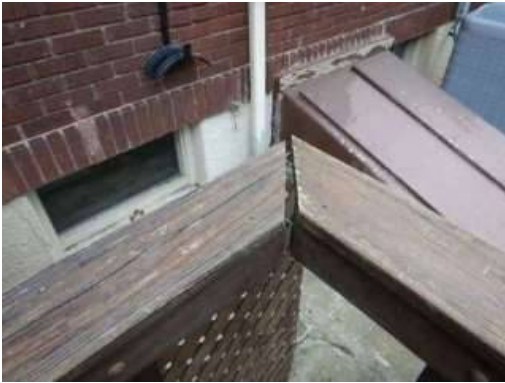
Photo 6-1

Guardrail on deck was loose at one corner. Recommend evaluate, repair or replace by a qualified professional.

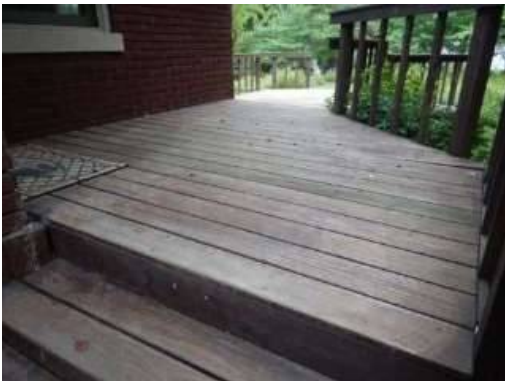
Photo 7-1

Wooden deck surfaces were overdue for normal maintenance. Recommend that a qualified person clean and preserve as necessary. Where decks have been coated with a finish such as opaque stains or paint, it may be too difficult to strip the finish and apply anything but paint or opaque stain. Where transparent stain or penetrating oil has been applied in the past, recommend that a penetrating oil be used. For more information, visit: <https://www.bestchoicehomeinspections.com/articles/deck-maintenance/>

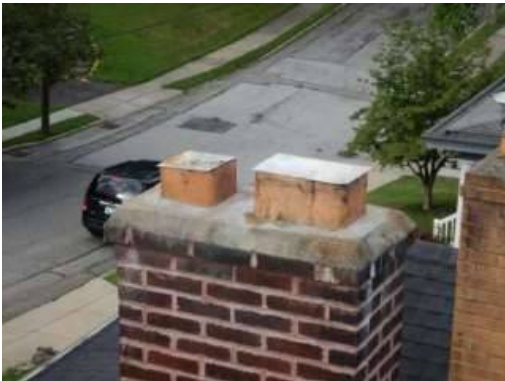
Photo 9-1

The chimney flue for the fireplace has been decommissioned. The flue appears to have been permanently blocked or capped. Therefore the fireplace has been taken out of service, is inoperable and ornamental only. Recommend consulting with a professional chimney/fireplace company if you wish to have fireplace made operable.

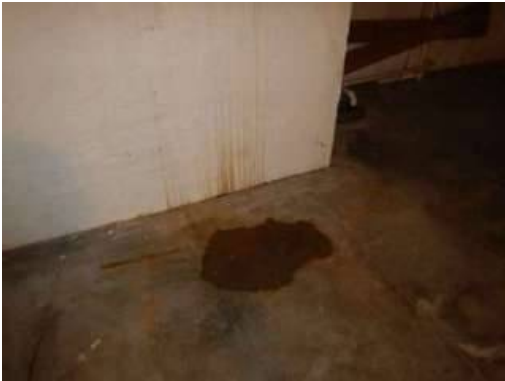
Photo 10-1

Water or signs of water were found in the basement. Source appears to be ground water penetration of the foundation. A qualified contractor who specializes in drainage issues should evaluate and repair as necessary. Typical repairs for preventing water from accumulating in basements include:

- Repairing, installing or improving rain run-off systems (gutters, downspouts, window wells and extensions or drain lines)
- Improving perimeter grading
- Repairing, installing or improving underground footing and/or curtain drains
- Epoxy injection foundation crack repairs

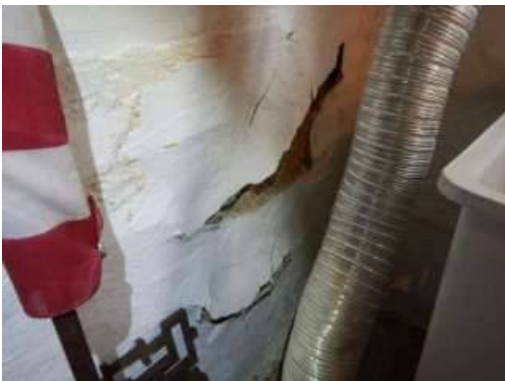
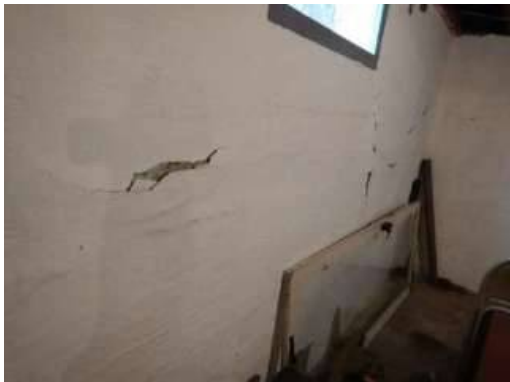
Efflorescence and/or spalling are visible on the brick and/or masonry. This can be a frustrating cosmetic issue, or it can be an indication of moisture problems including exterior wicking. Recommend evaluation and repairs be made by a qualified specialist. Recommend mitigating the moisture concerns prior to making any repairs.

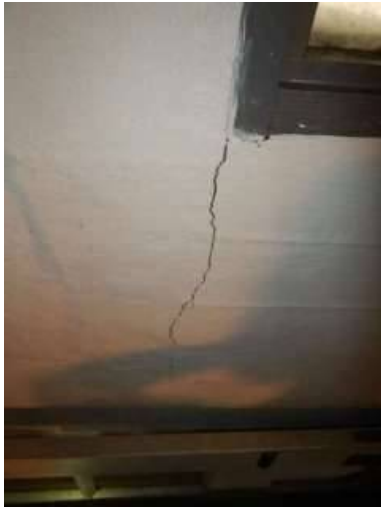
Photo 12-1

Minor cracks (1/8 inch or less) found in the foundation did not appear to be a structural concern, but recommend sealing them to prevent water infiltration and monitor them in the future. Numerous products exist to seal such cracks including hydraulic cement, non-shrinking grout, resilient caulks and epoxy sealants.

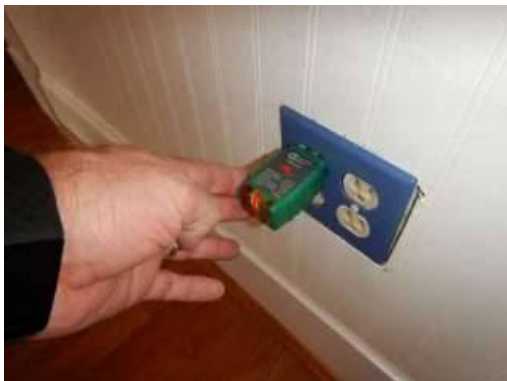
Photo 13-1

Receptacle (outlet) worn. Worn receptacles can work intermittently or when the plug is wiggled. They can overheat or arc and spark due to loose connections. This is a potential fire hazard. Recommend that a qualified electrician replace such receptacles as necessary.

@ kitchen wall, left side of double gang plug

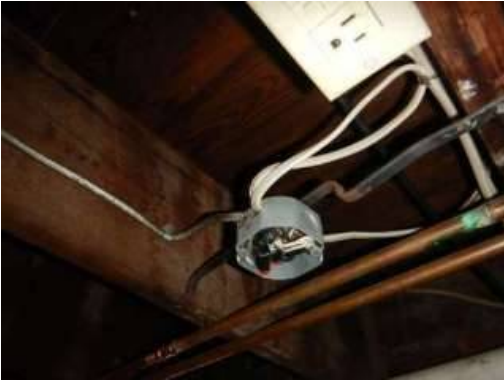
Photo 14-1

Cover plates for switches, receptacles (outlets) or junction boxes were missing or broken. These plates are intended to contain fire and prevent electric shock from occurring due to exposed wires. Recommend that a qualified person install cover plates where necessary.

@ basement ceiling

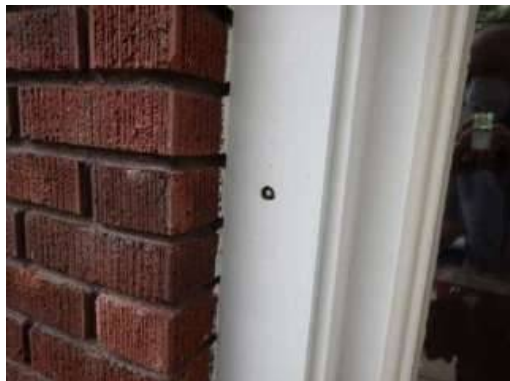
Photo 17-1

Doorbell not working. This may be inconvenient. Recommend repair or replace by a qualified professional.

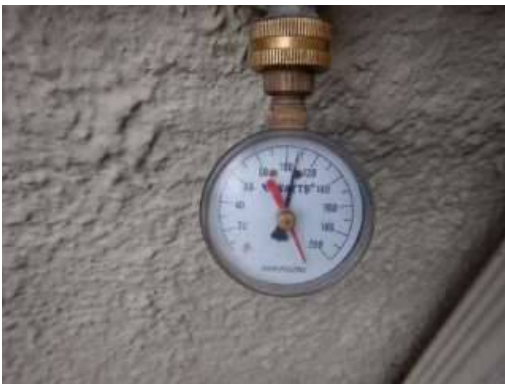
Photo 18-1

The water supply pressure was greater than 80 pounds per square inch (PSI). Pressures above 80 PSI may void warranties for some appliances such as water heaters or washing machines. Flexible supply lines to washing machines are likely to burst with higher pressures. 40-80 PSI is considered the normal range for water pressure in a home, and most plumbers recommend 50-60 PSI . Typically, the pressure cannot be regulated at the water meter. Recommend that a qualified plumber evaluate and make modifications to reduce the pressure to below 80 PSI . Installing a pressure reducing valve on the main service pipe is a common solution to this problem. If one exists, then it should be adjusted, repaired or replaced as necessary to maintain lower pressures. Note that installing a pressure reducing valve creates a "closed system," which may require installing an expansion tank at the water heater if one is not already installed.

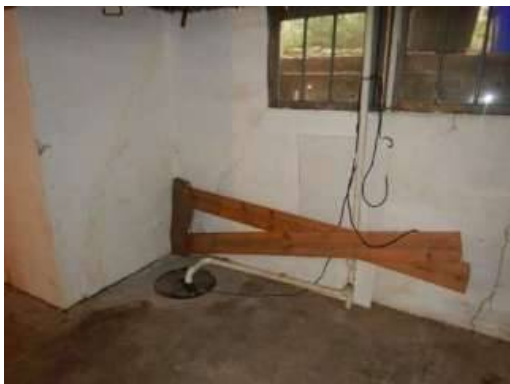
Photo 19-1

No battery backup system was found for the sump pump. If the power goes out during heavy rains, the sump pump won't be able to eliminate accumulated water. Consider installing a battery backup system for the sump pump, especially you travel frequently. For more information on sump pumps see:

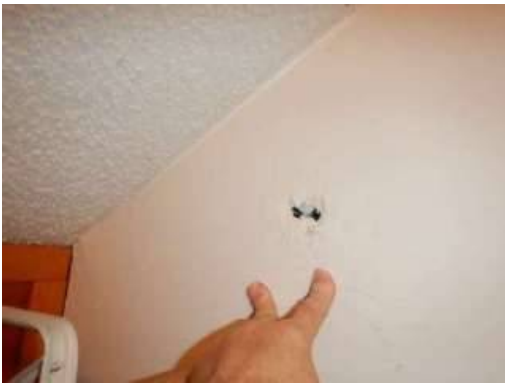
Photo 23-1

23) 🛠️ Interior walls were damaged. Recommend that a qualified person evaluate and repair as necessary and per standard building practices.

@ back right bedroom closet

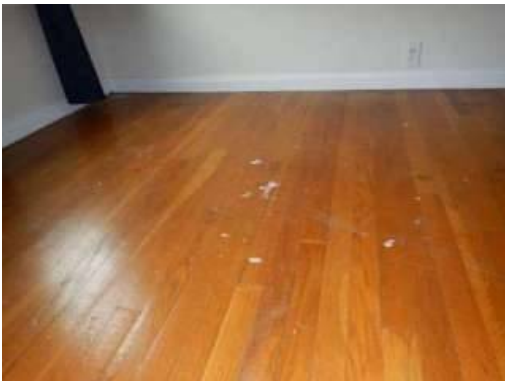
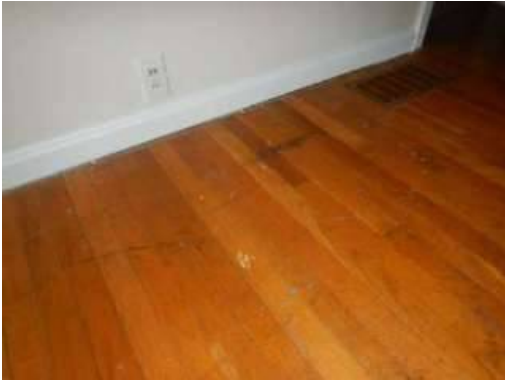
24) 🔍 Wood flooring was stained or substandard. Recommend that a qualified contractor evaluate, replace or refinish wood flooring as necessary.

@ attic

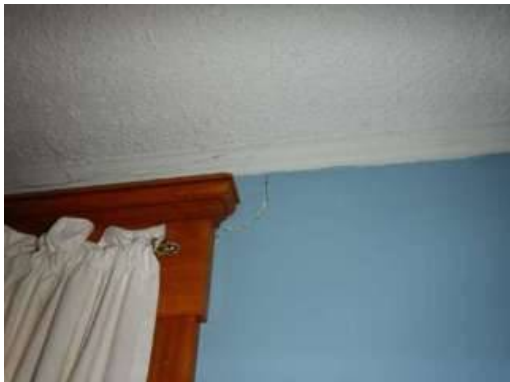
25) 🛠️ ⓘ Minor cracks, nail pops and/or blemishes were found in the walls and/or ceilings. Cracks and nail pops are common, are often caused by lumber shrinkage, seasonal expansion and contraction, or minor settlement, and can be more or less noticeable depending on changes in humidity. Blemishes may be caused by normal usage or substandard patching and painting. They did not appear to be a structural concern, but the client may wish to repair these for aesthetic reasons.

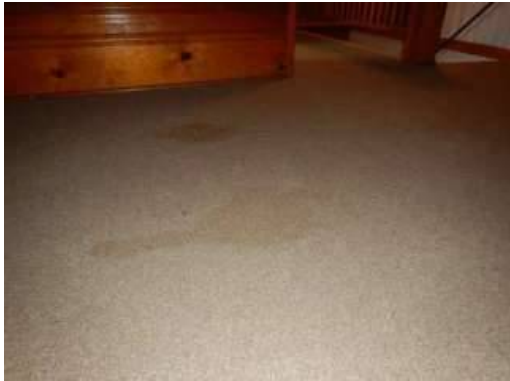
Photo 26-1

Carpet flooring was stained. Recommend having flooring evaluated and/or cleaned or replaced as necessary.

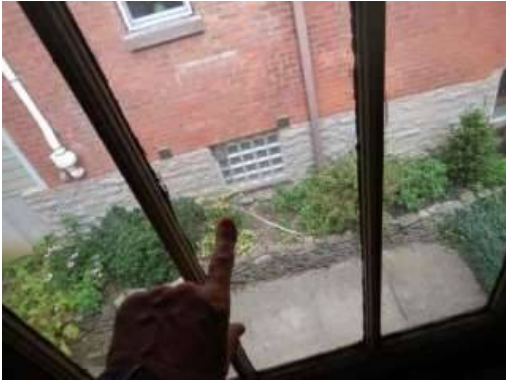
Photo 29-1

29) 🛠️🔍 Window damaged or out of adjustment and one panel is cracked. Recommend that a qualified person repair as necessary.

@ attic

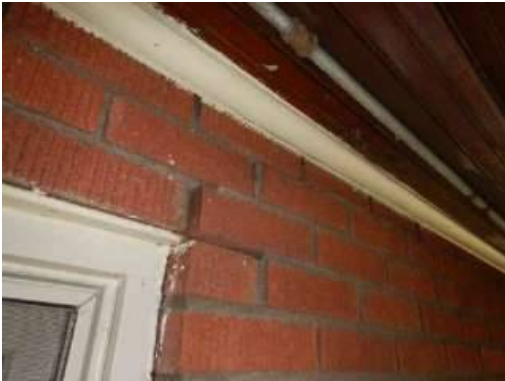
Photo 3-1

3) 🛠️ Minor cracks were found in the exterior masonry. These do not appear to be a structural concern. Where cracks or openings are exposed, water can enter causing further damage. Recommend that a qualified contractor seal cracks as necessary.

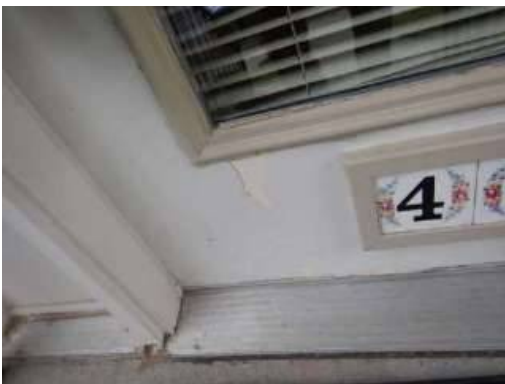
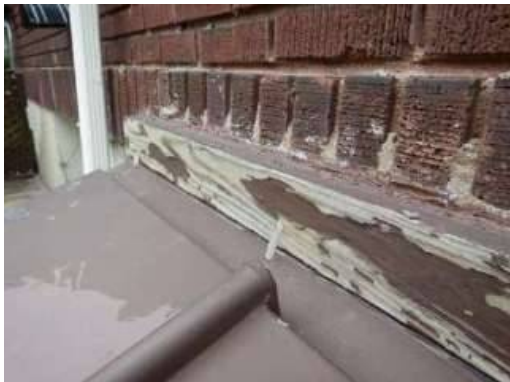
4) 🛠️💧 The paint or stain finish in some areas was failing (e.g. peeling, faded, worn, thinning). Siding and trim with a failing finish can be damaged by moisture. Recommend that a qualified contractor prep (e.g. clean, scrape, sand, prime, caulk) and repaint or restain where necessary and per standard building practices. Any repairs needed to the siding or trim should be made prior to this.

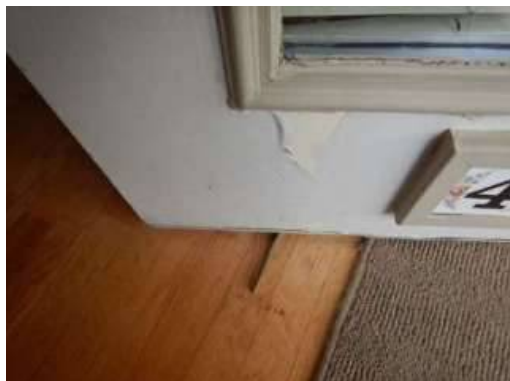
Photo 5-1

The front exterior door had damage and/or deterioration to the weatherstripping. Although serviceable, the client may wish to repair or replace to save on heating and cooling costs.

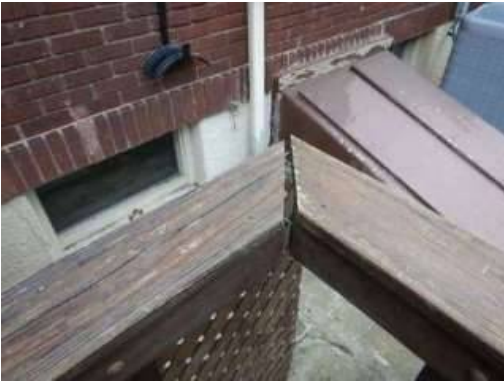
Photo 6-1

Guardrail on deck was loose at one corner. Recommend evaluate, repair or replace by a qualified professional.

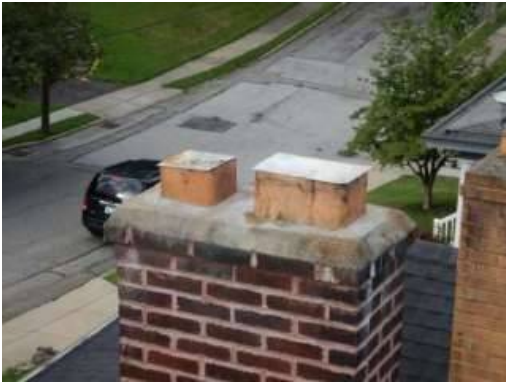
Photo 9-1

The chimney flue for the fireplace has been decommissioned. The flue appears to have been permanently blocked or capped. Therefore the fireplace has been taken out of service, is inoperable and ornamental only. Recommend consulting with a professional chimney/fireplace company if you wish to have fireplace made operable.

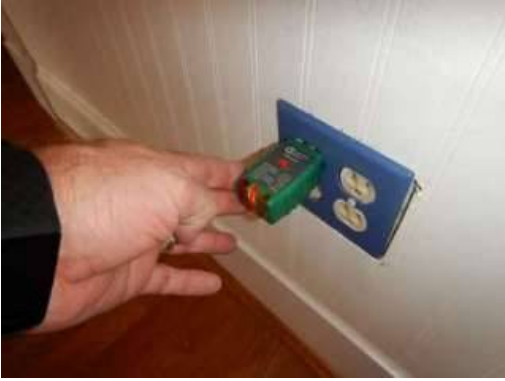
Photo 13-1

@ kitchen wall, left side of double gang plug

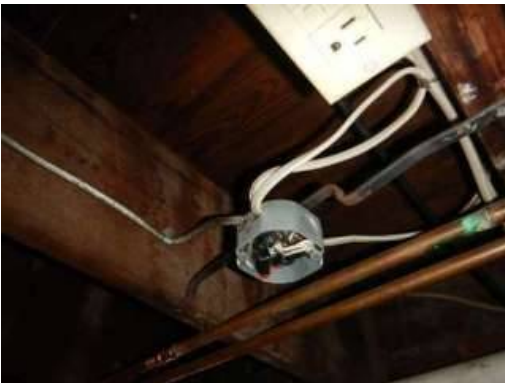
Photo 14-1

@ basement ceiling

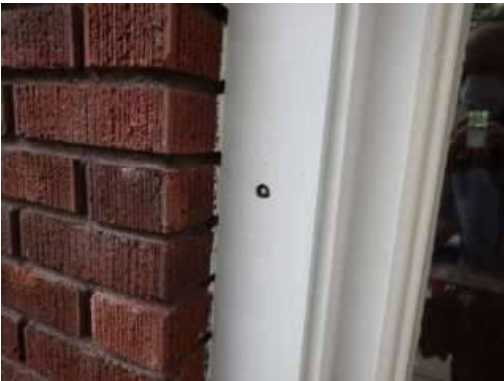
Photo 17-1

Doorbell not working. This may be inconvenient. Recommend repair or replace by a qualified professional.

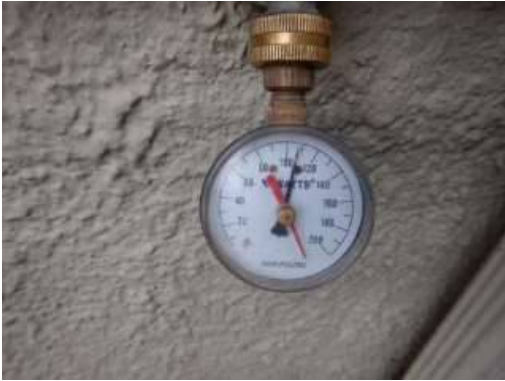
Photo 18-1

The water supply pressure was greater than 80 pounds per square inch (PSI). Pressures above 80 PSI may void warranties for some appliances such as water heaters or washing machines. Flexible supply lines to washing machines are likely to burst with higher pressures. 40-80 PSI is considered the normal range for water pressure in a home, and most plumbers recommend 50-60 PSI . Typically, the pressure cannot be regulated at the water meter. Recommend that a qualified plumber evaluate and make modifications to reduce the pressure to below 80 PSI . Installing a pressure reducing valve on the main service pipe is a common solution to this problem. If one exists, then it should be adjusted, repaired or replaced as necessary to maintain lower pressures. Note that installing a pressure reducing valve creates a "closed system," which may require installing an expansion tank at the water heater if one is not already installed.

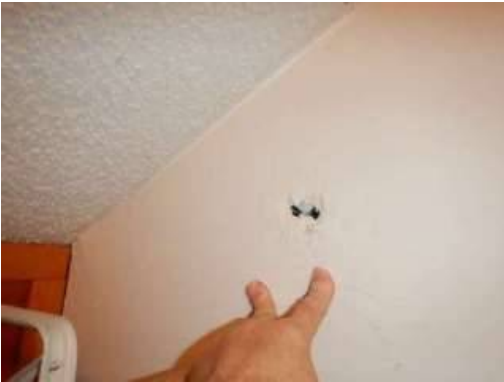
Photo 23-1

@ back right bedroom closet

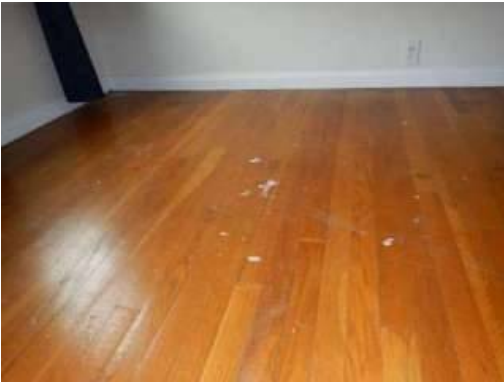
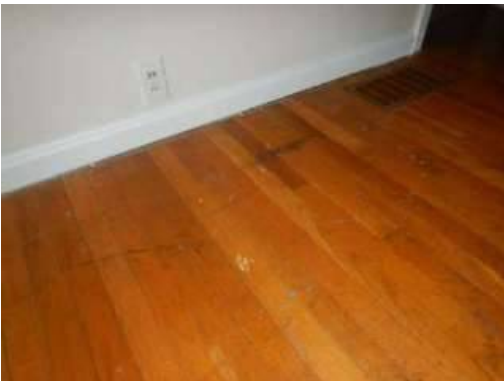
24) 🔍 Wood flooring was stained or substandard. Recommend that a qualified contractor evaluate, replace or refinish wood flooring as necessary.

@ attic

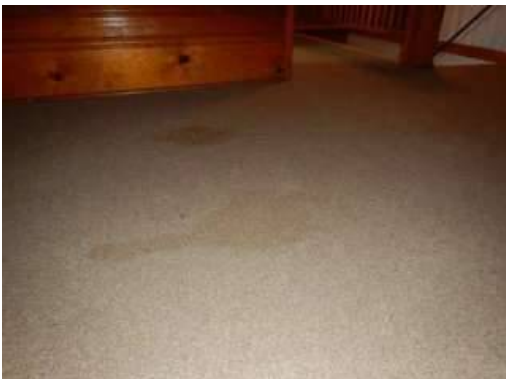
Photo 26-1

26) 🛠️ ⓘ Carpet flooring was stained. Recommend having flooring evaluated and/or cleaned or replaced as necessary.

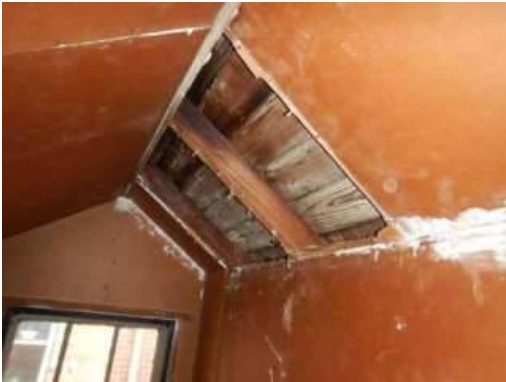
Photo 34-1

Some insulation in the attic was damaged or uneven. Heating and cooling costs may be higher due to reduced energy efficiency. Recommend that a qualified person repair, replace or install insulation as necessary and per standard building practices (typically R-38). For more information see: <https://www.bestchoicehomeinspections.com/articles/insulation/>
