Residential Property Inspection Report

Property address: 2273 Watch Hill Ct

Inspection date: Tuesday, August 18, 2020

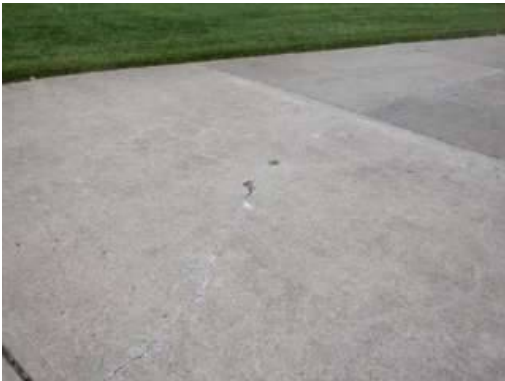
Photo 2-1

Minor cracks found in the concrete driveway, but no trip hazards were found. Recommend monitoring and maintaining as necessary.

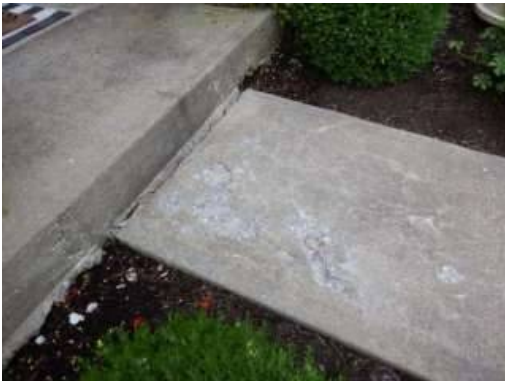
Photo 3-1

Minor cracks or scaling was found in the sidewalk, but no trip hazards were found. Recommend monitoring and maintaining as necessary.

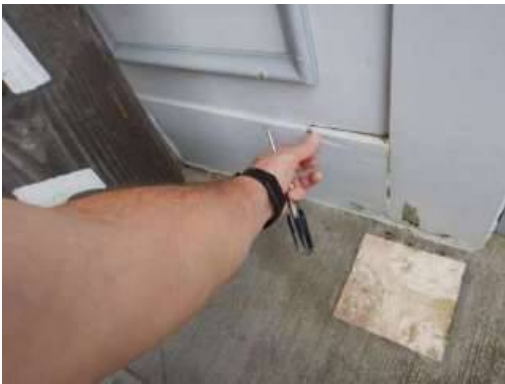
Photo 4-1

- 4) 🪛🔧💧 Fungal rot was found at sections of siding or trim. Conducive conditions for rot should be corrected. Recommend that a qualified person repair as necessary. Any rotten wood should be replaced.

Note: This is directly above where the termites were found in the basement.

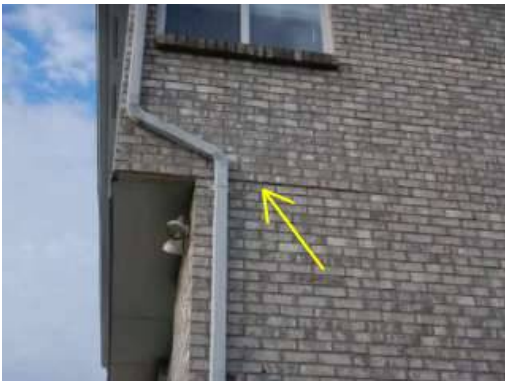
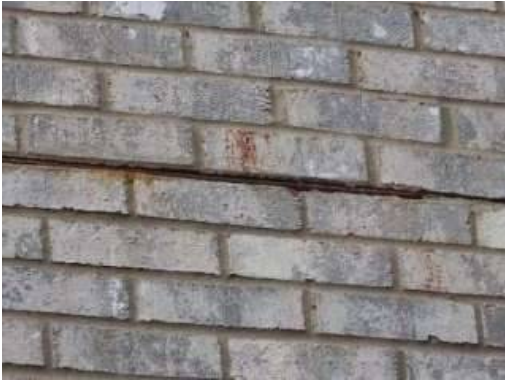
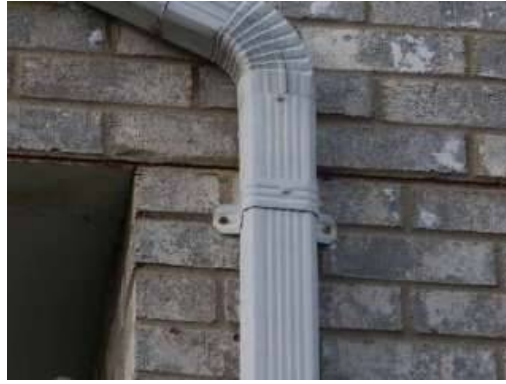
Photo 5-1

- 5) 🪛💧 The masonry tuckpointing was damaged where a lintel has rusted and expanded. Where cracks or openings are exposed, water can enter the wall structure causing further damage. Recommend that a qualified contractor repair as necessary. For example, by cleaning and painting the lintel(s) to inhibit rust and repointing as necessary.

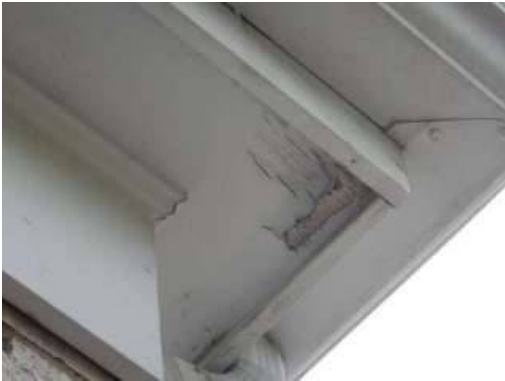
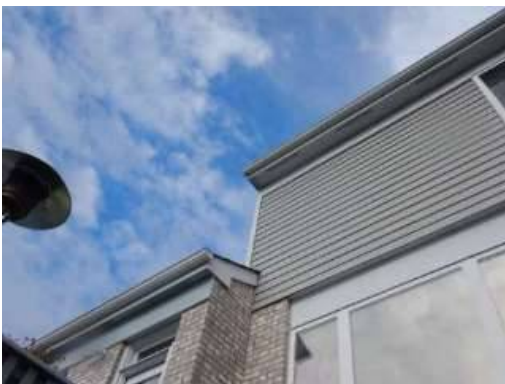
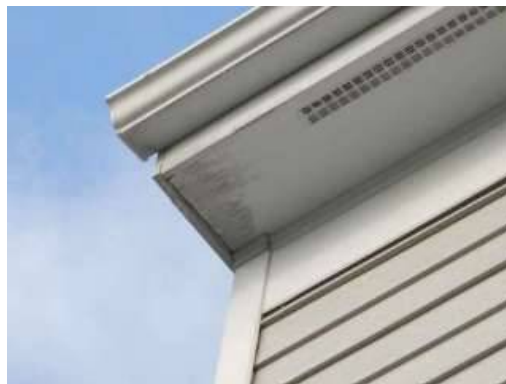
Photo 6-1

Paint failing or thinning on flashing and in need of maintenance, such as a rust inhibiting paint which will prolong the life of the metal flashing and help to prevent leaks from occurring. Recommend that a qualified person prep, prime and paint as necessary.

@ 2 locations on soffit
@ exterior window sill, back

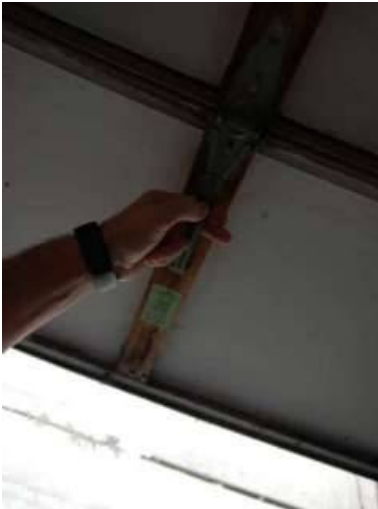
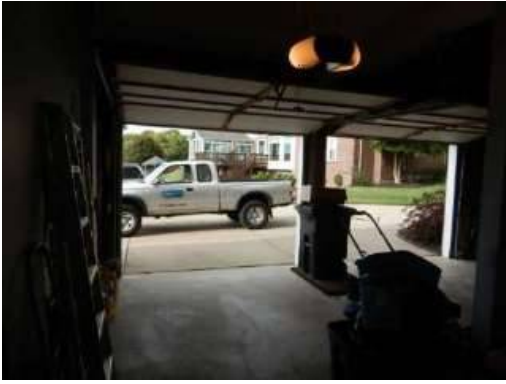
Photo 7-1

The auto-reverse mechanism on the automatic opener for the garage vehicle door required excessive force. This is a potential safety hazard. A qualified contractor should evaluate and repair as necessary. Note: Usually a clearly labeled adjustment screw can be found on the opener to correct this concern.

@ both doors

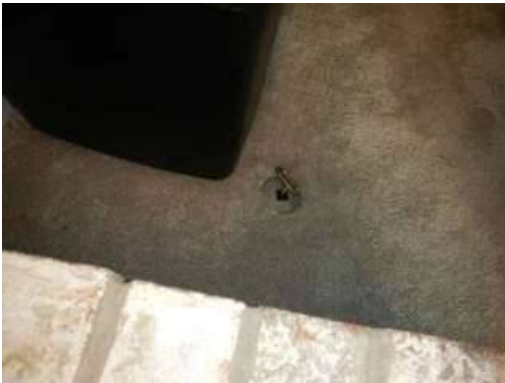
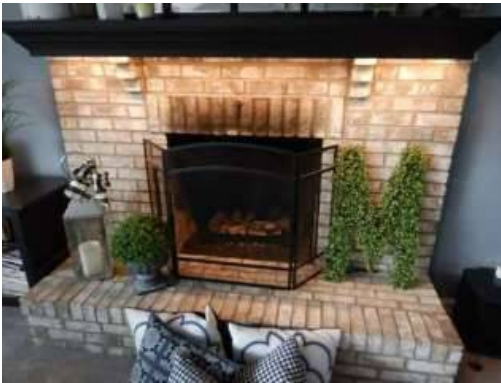
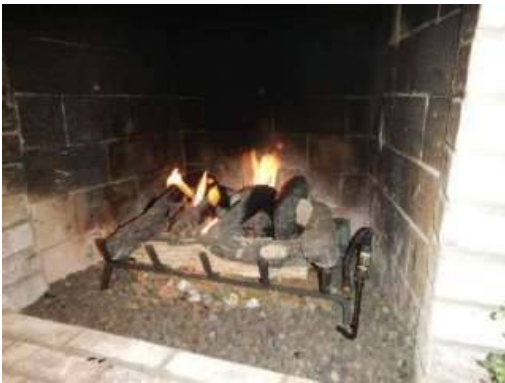
The gas fired fireplace was tested and appears to be functioning properly. Recommend that the client review all available documentation for the gas-fired fireplace. Depending on how they are operated (for routine heating versus ambiance), such appliances may need servicing annually or every few years. Consult with the property owner and/or a qualified specialist to determine if service is needed now.

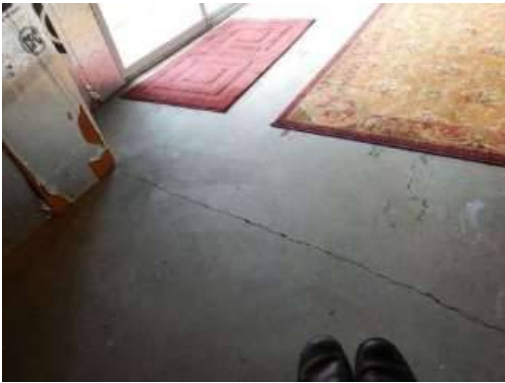
Photo 10-1

Minor cracks (1/8 inch or less) found in the concrete floor or pad are superficial and did not appear to be a structural concern nor was there any sign of water intrusion. Cracks are probably due to concrete curing or minor settling. Recommend monitoring and maintaining as necessary.

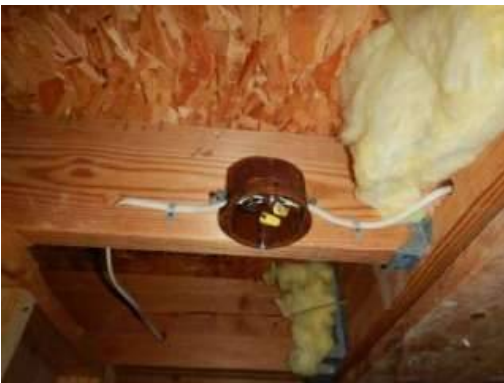
Photo 11-1

Cover plates for switches, receptacles (outlets) or junction boxes were missing or broken. These plates are intended to contain fire and prevent electric shock from occurring due to exposed wires. Recommend that a qualified person install cover plates where necessary.

- 2 on basement ceiling

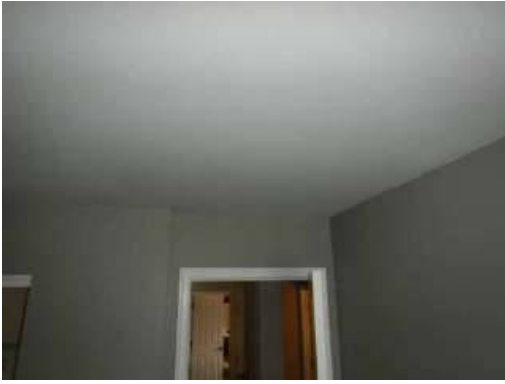
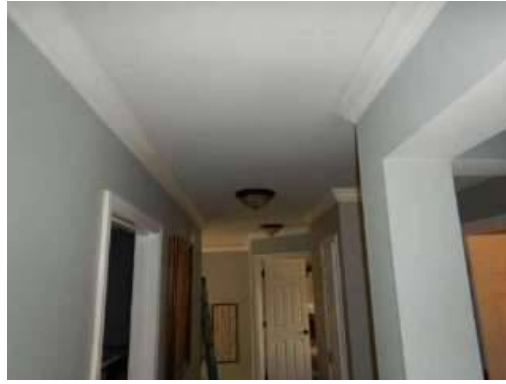
Photo 12-1

Some smoke/CO2 alarms were missing in areas where they should be. Smoke alarms should be installed in each bedroom, in hallways leading to bedrooms, on each level and in attached garages. They have a limited lifespan and should be replaced every 10 years. Batteries in smoke alarms should be changed when taking occupancy and annually in the future. Carbon monoxide alarms should be installed near sleeping areas and on each level in homes with a fuel-burning appliance or attached garage. For more information on smoke alarms see: <https://www.bestchoicehomeinspections.com/articles/smoke-alarms/>

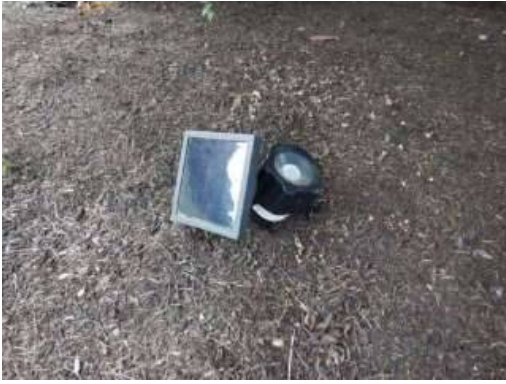
Photo 13-1

Photovoltaic solar energy lighting was installed. Evaluating these systems is beyond the scope of a home inspection. Its condition is unknown, and it is excluded from this inspection. Recommend that a qualified electrician review this system and make repairs if necessary.

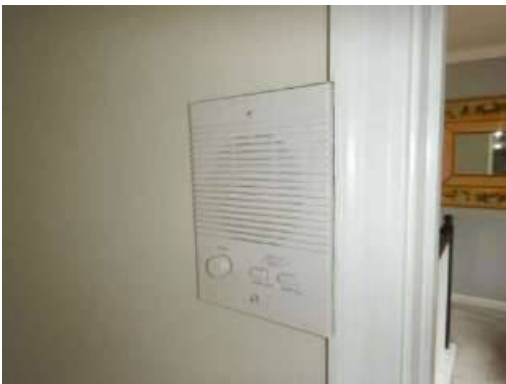
Photo 14-1

An intercom or secured entry was installed. Evaluating these systems is beyond the scope of a home inspection. Its condition is unknown, and it is excluded from this inspection. Recommend consult with the homeowner and that a qualified electrician review this system and make repairs if necessary.

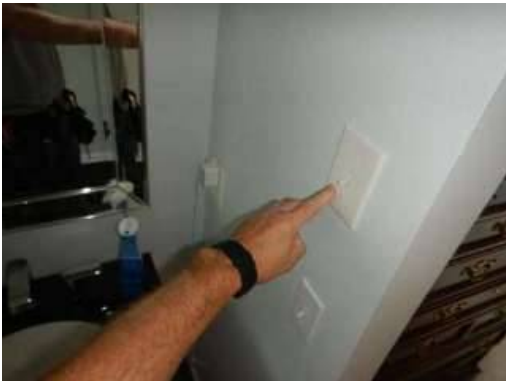
Photo 15-1

Switch appeared to operate nothing or inspector could not determine what the switch was for. Consult with current occupant or owner if possible to determine switch functionality. If undetermined then recommend that a qualified electrician evaluate and repair if necessary.

- in master bathroom, upper switch

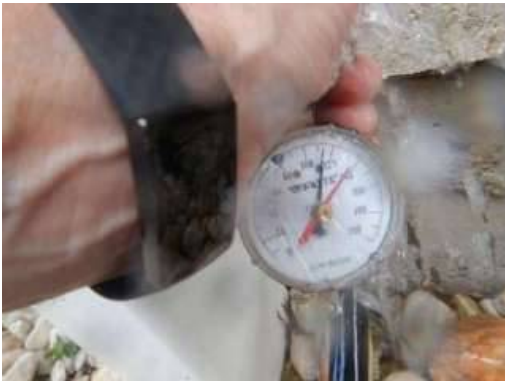
Photo 16-1

The water supply pressure was greater than 80 pounds per square inch (PSI). Pressures above 80 PSI may void warranties for some appliances such as water heaters or washing machines. Flexible supply lines to washing machines are likely to burst with higher pressures. 40-80 PSI is considered the normal range for water pressure in a home, and most plumbers recommend 50-60 PSI . Typically, the pressure cannot be regulated at the water meter. Recommend that a qualified plumber evaluate and make modifications to reduce the pressure to below 80 PSI . Installing a pressure reducing valve on the main service pipe is a common solution to this problem. If one exists, then it should be adjusted, repaired or replaced as necessary to maintain lower pressures. Note that installing a pressure reducing valve creates a "closed system," which may require installing an expansion tank at the water heater if one is not already installed.

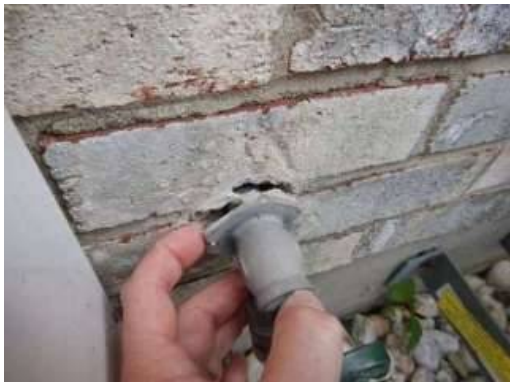
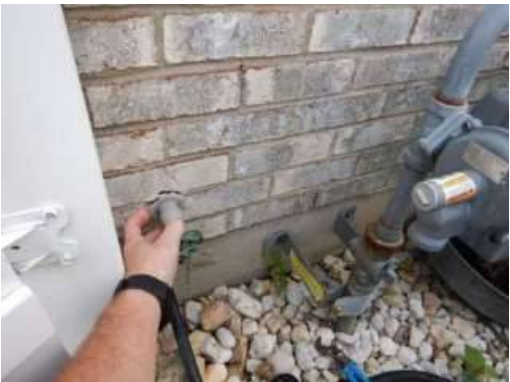
Photo 17-1

Hose bibb (outside faucet) was loose. Recommend that a qualified person repair or replace as necessary.

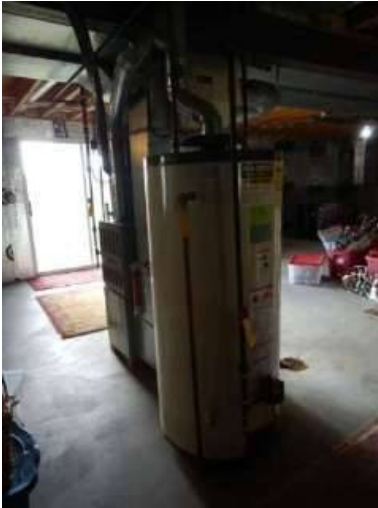
Photo 19-1

The estimated useful life for most water heaters is 8-12 years. This water heater appeared to be beyond this age. Recommend budgeting for repairs or replacement in the next few years.

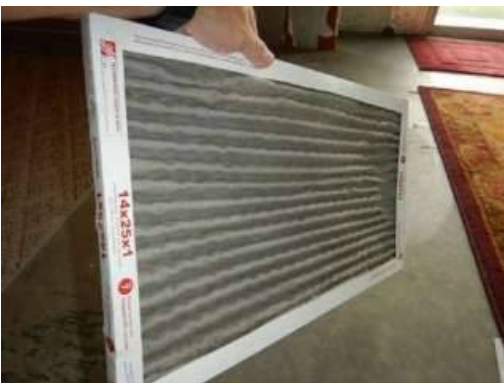
Photo 20-1

Air filter needs cleaning or replacement. Periodically (at least 4 times per year) check and replace, or wash, air filters and inspect your furnace for signs of unusual operation such as discoloration, soot, or disconnected vents. For more information see: <https://www.bestchoicehomeinspections.com/articles/hvac-filter/>

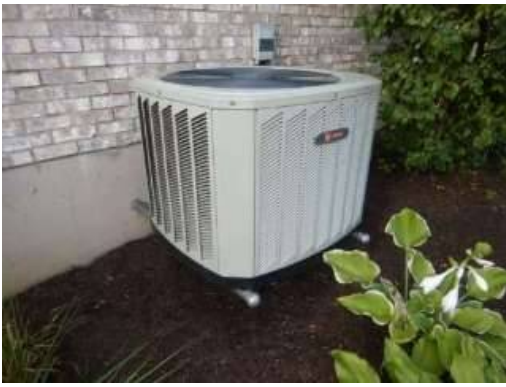
Photo 21-1

The last service date of the HVAC system appeared to be more than 2 years ago. Ask the property owner when it was last serviced. If unable to determine the last service date, or if this system was serviced more than 2 years ago, recommend that a qualified HVAC contractor service this system and make repairs if necessary. Because this system has a compressor and refrigerant system, this servicing should be performed every few years in the future.

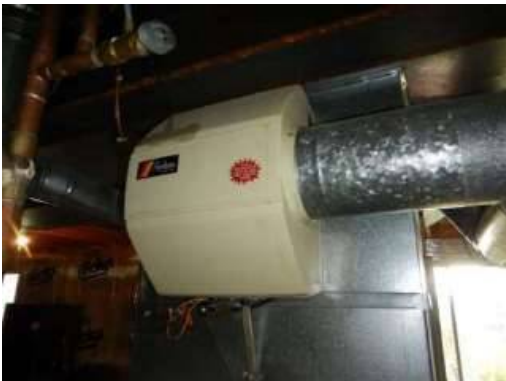
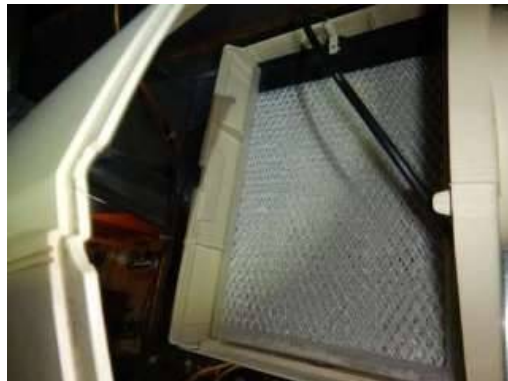
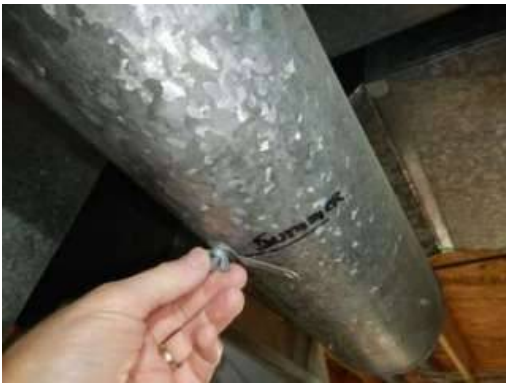
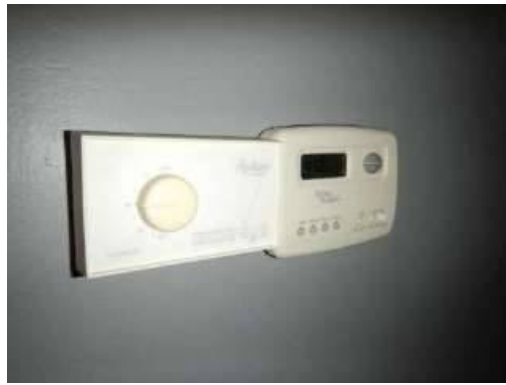
Humidifier appears to be working. These are seasonal systems that require some instruction and regular maintenance. Recommend that the client review all available documentation for the humidifier. Recommend the humidifier be serviced when the HVAC system is serviced.

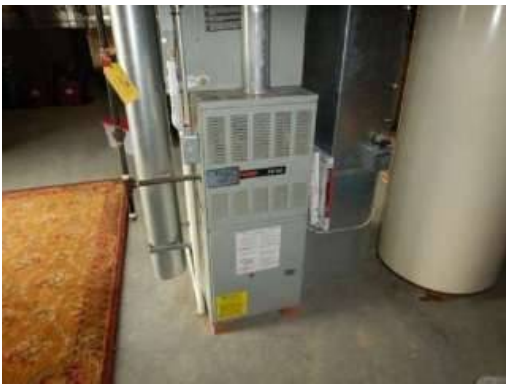
Photo 23-1

23) **i** The estimated useful life for most forced air furnaces is about 25 years. This furnace appeared to be at this age. Recommend budgeting for repairs or replacement in the next few years.

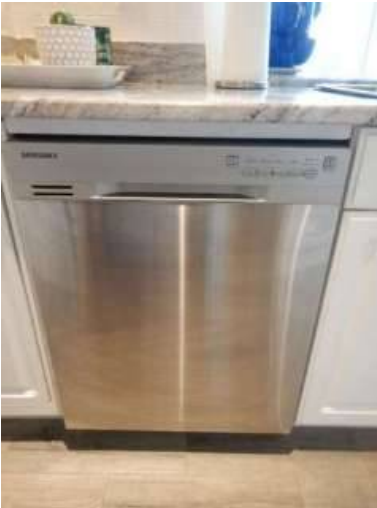
Photo 24-1

The dishwasher door spring appeared to be damaged allowing the door to fall open. This could be a safety hazard. Recommend that a qualified person evaluate and repair as necessary.

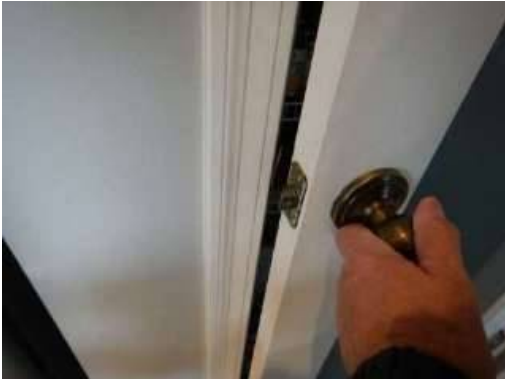
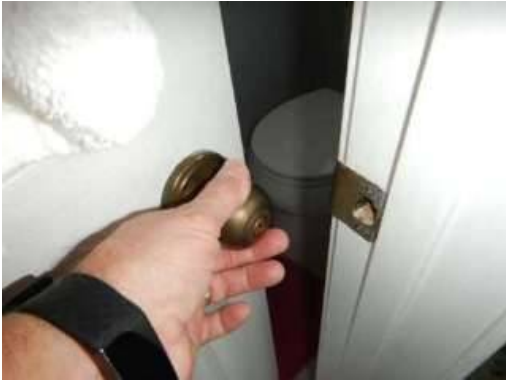
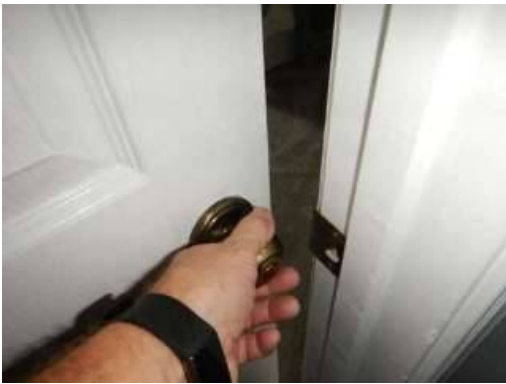
Photo 25-1

Interior door wouldn't latch or was difficult to latch. Recommend that a qualified person repair as necessary. For example, by adjusting latch plates or lock set.

- @ basement, bottom of stairs
- @ kitchen pantry
- @ master bath, toilet room
- @ bedroom, front, left
- @ bedroom, front, right

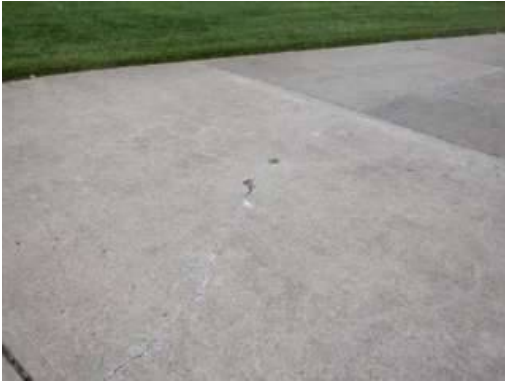
Photo 2-1

Minor cracks found in the concrete driveway, but no trip hazards were found. Recommend monitoring and maintaining as necessary.

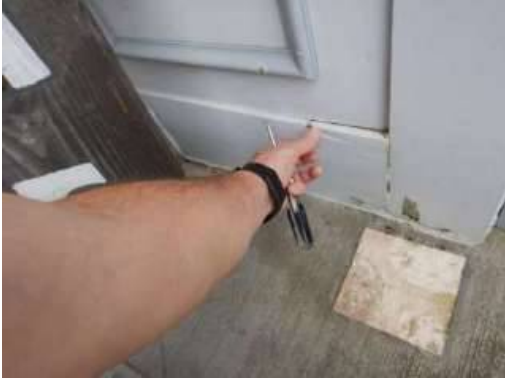
Photo 4-1

Fungal rot was found at sections of siding or trim. Conductive conditions for rot should be corrected. Recommend that a qualified person repair as necessary. Any rotten wood should be replaced.

Note: This is directly above where the termites were found in the basement.

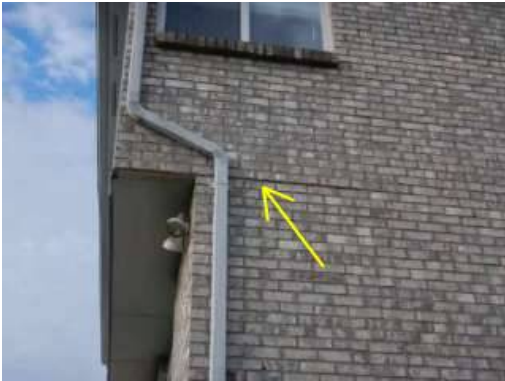
Photo 5-1

The masonry tuckpointing was damaged where a lintel has rusted and expanded. Where cracks or openings are exposed, water can enter the wall structure causing further damage. Recommend that a qualified contractor repair as necessary. For example, by cleaning and painting the lintel(s) to inhibit rust and repointing as necessary.

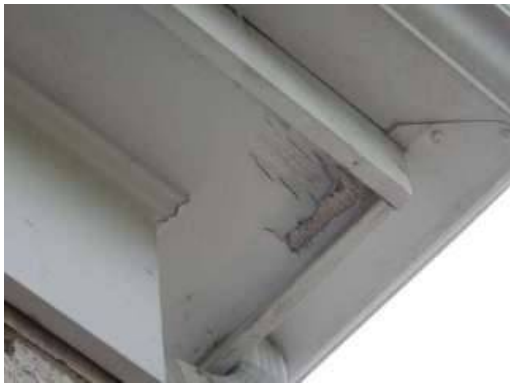
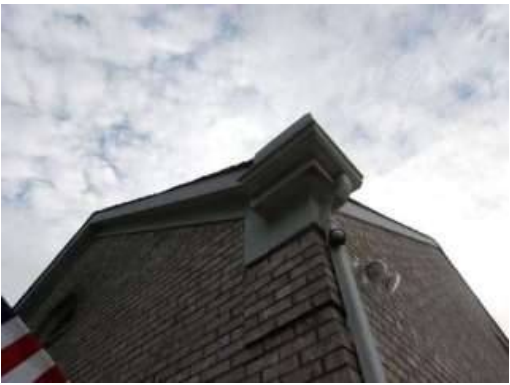
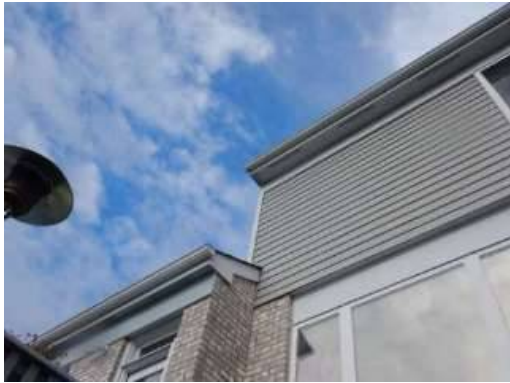
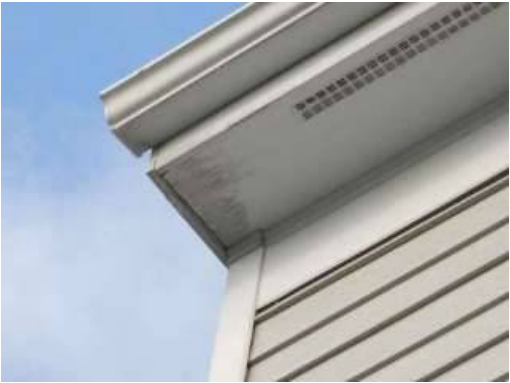
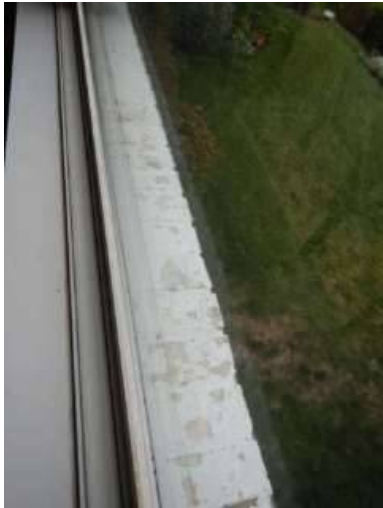
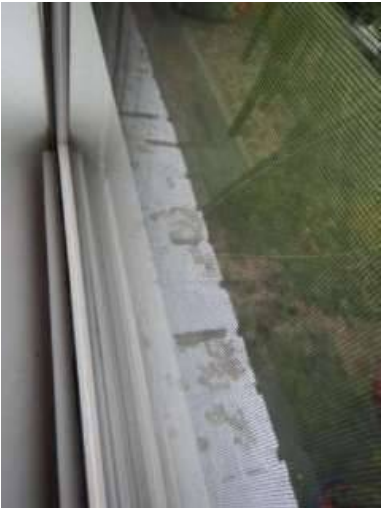
Paint failing or thinning on flashing and in need of maintenance, such as a rust inhibiting paint which will prolong the life of the metal flashing and help to prevent leaks from occurring. Recommend that a qualified person prep, prime and paint as necessary.

@ 2 locations on soffit
 @ exterior window sill, back

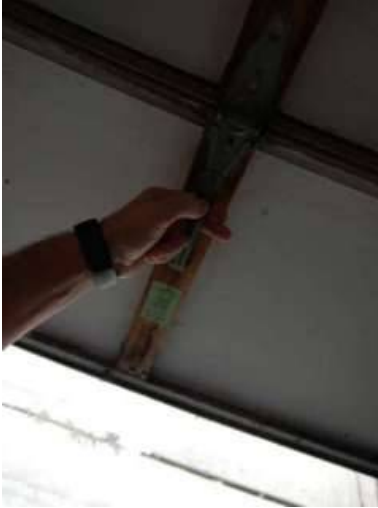
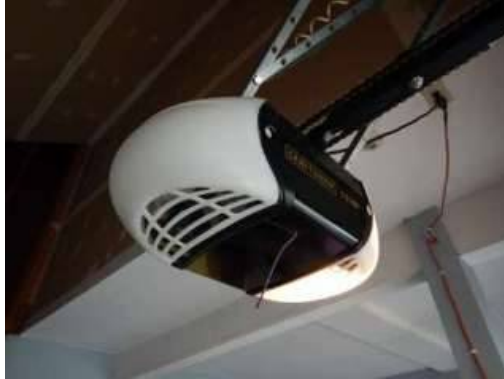
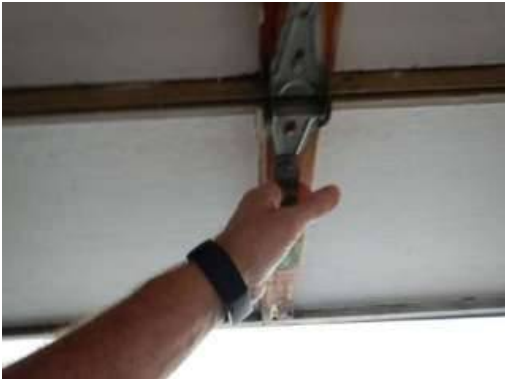
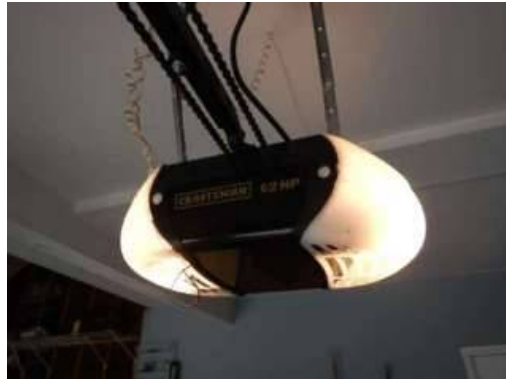
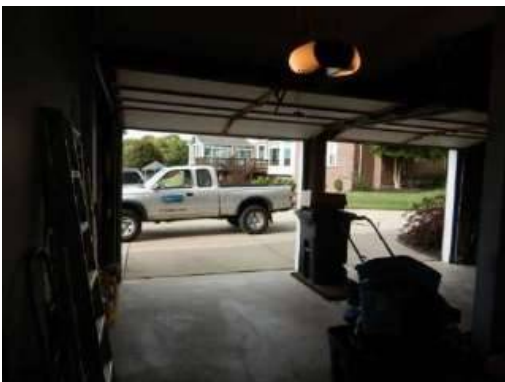
The auto-reverse mechanism on the automatic opener for the garage vehicle door required excessive force. This is a potential safety hazard. A qualified contractor should evaluate and repair as necessary. Note: Usually a clearly labeled adjustment screw can be found on the opener to correct this concern.

@ both doors

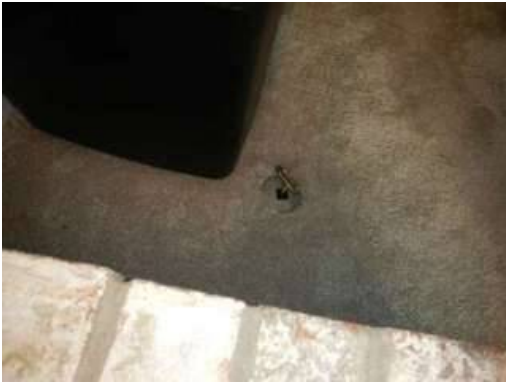
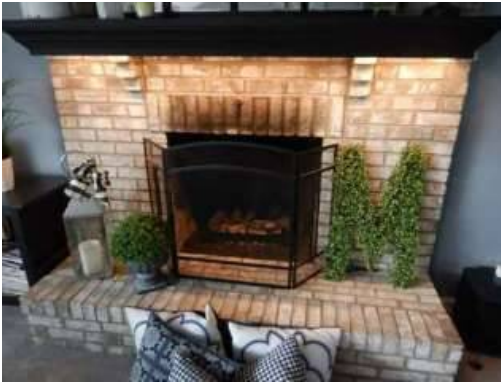
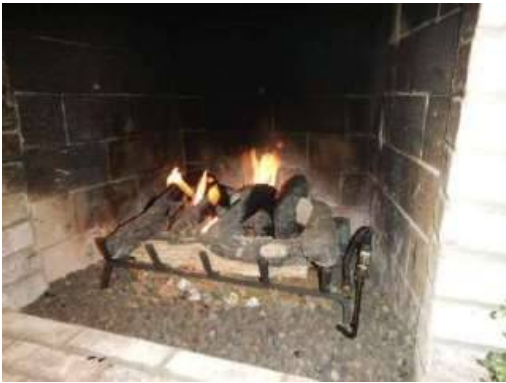
The gas fired fireplace was tested and appears to be functioning properly. Recommend that the client review all available documentation for the gas-fired fireplace. Depending on how they are operated (for routine heating versus ambiance), such appliances may need servicing annually or every few years. Consult with the property owner and/or a qualified specialist to determine if service is needed now.

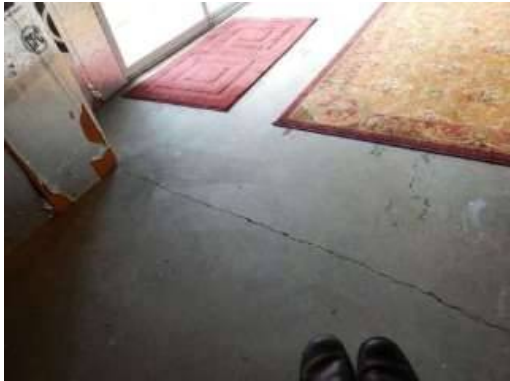
Photo 10-1

Minor cracks (1/8 inch or less) found in the concrete floor or pad are superficial and did not appear to be a structural concern nor was there any sign of water intrusion. Cracks are probably due to concrete curing or minor settling. Recommend monitoring and maintaining as necessary.

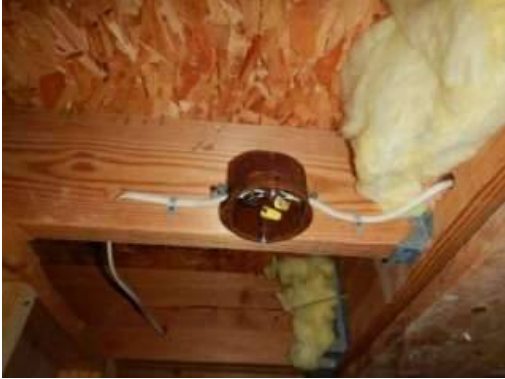
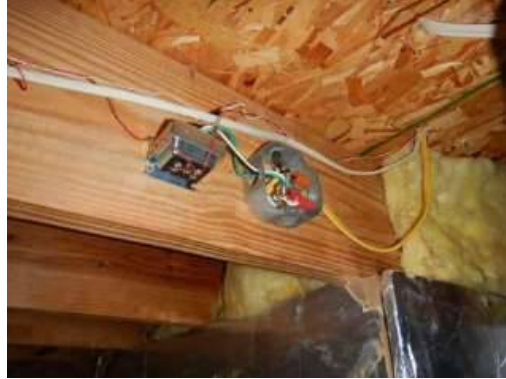
Cover plates for switches, receptacles (outlets) or junction boxes were missing or broken. These plates are intended to contain fire and prevent electric shock from occurring due to exposed wires. Recommend that a qualified person install cover plates where necessary.

- 2 on basement ceiling

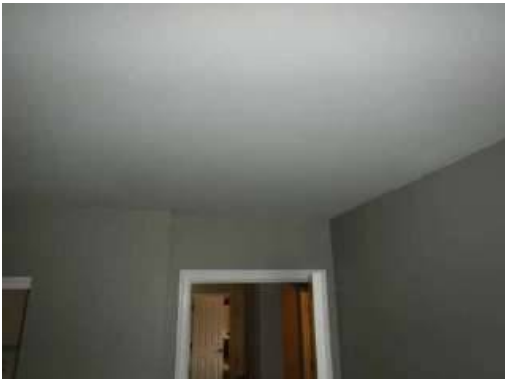
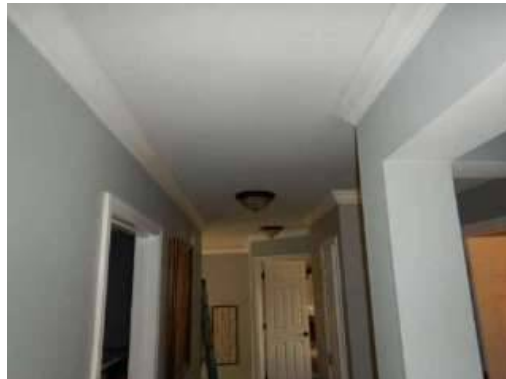
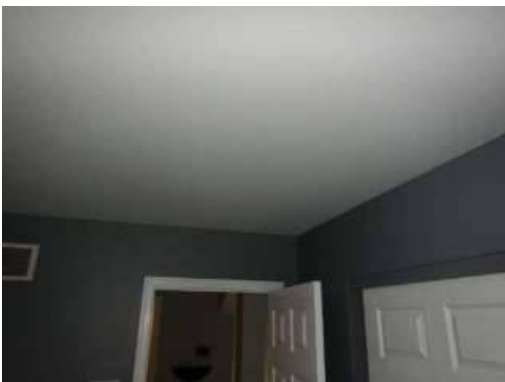
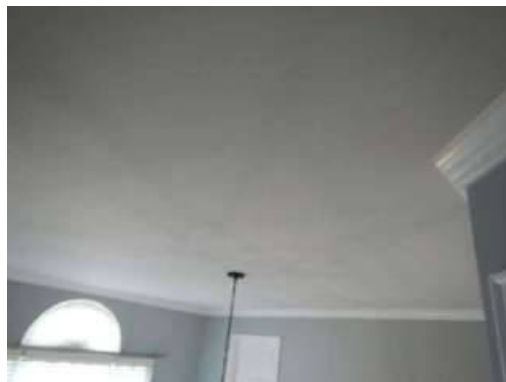
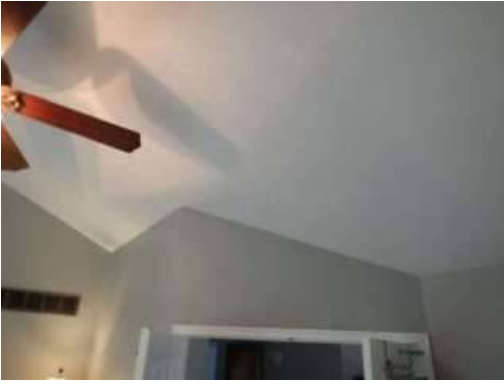
Some smoke/CO2 alarms were missing in areas where they should be. Smoke alarms should be installed in each bedroom, in hallways leading to bedrooms, on each level and in attached garages. They have a limited lifespan and should be replaced every 10 years. Batteries in smoke alarms should be changed when taking occupancy and annually in the future. Carbon monoxide alarms should be installed near sleeping areas and on each level in homes with a fuel-burning appliance or attached garage. For more information on smoke alarms see: <https://www.bestchoicehomeinspections.com/articles/smoke-alarms/>

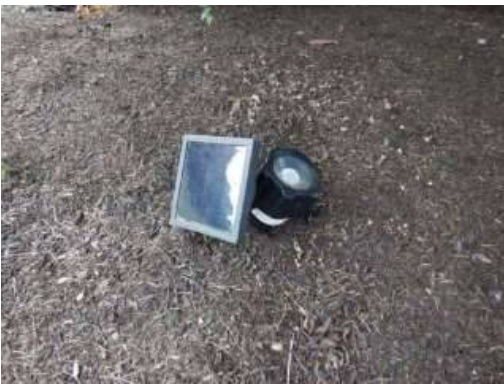
Photo 13-1

Photovoltaic solar energy lighting was installed. Evaluating these systems is beyond the scope of a home inspection. Its condition is unknown, and it is excluded from this inspection. Recommend that a qualified electrician review this system and make repairs if necessary.

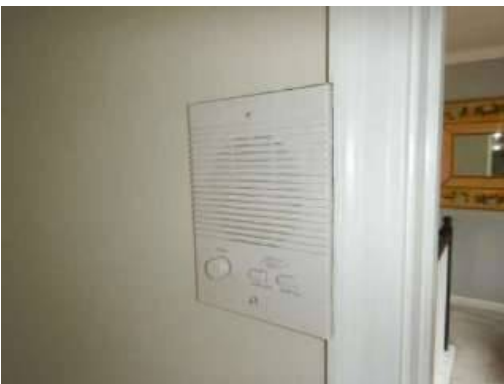
Photo 14-1

An intercom or secured entry was installed. Evaluating these systems is beyond the scope of a home inspection. Its condition is unknown, and it is excluded from this inspection. Recommend consult with the homeowner and that a qualified electrician review this system and make repairs if necessary.

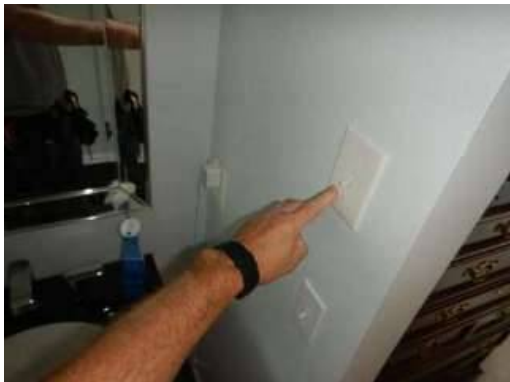
Photo 15-1

Switch appeared to operate nothing or inspector could not determine what the switch was for. Consult with current occupant or owner if possible to determine switch functionality. If undetermined then recommend that a qualified electrician evaluate and repair if necessary.

- in master bathroom, upper switch

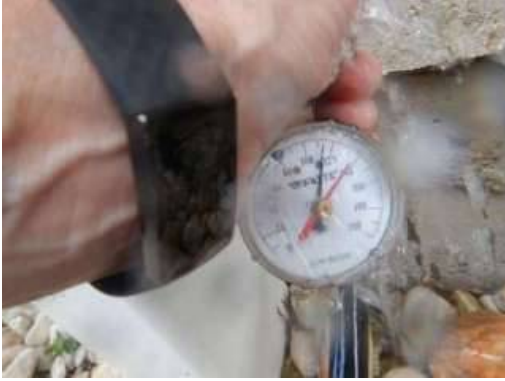
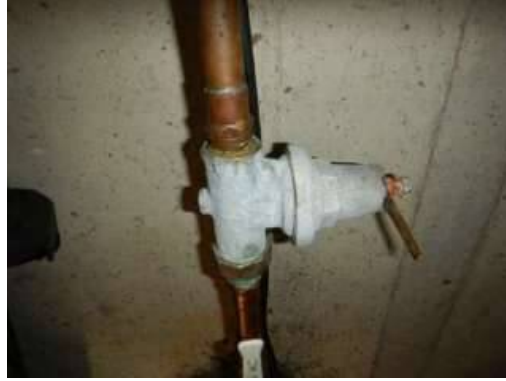
The water supply pressure was greater than 80 pounds per square inch (PSI). Pressures above 80 PSI may void warranties for some appliances such as water heaters or washing machines. Flexible supply lines to washing machines are likely to burst with higher pressures. 40-80 PSI is considered the normal range for water pressure in a home, and most plumbers recommend 50-60 PSI . Typically, the pressure cannot be regulated at the water meter. Recommend that a qualified plumber evaluate and make modifications to reduce the pressure to below 80 PSI . Installing a pressure reducing valve on the main service pipe is a common solution to this problem. If one exists, then it should be adjusted, repaired or replaced as necessary to maintain lower pressures. Note that installing a pressure reducing valve creates a "closed system," which may require installing an expansion tank at the water heater if one is not already installed.

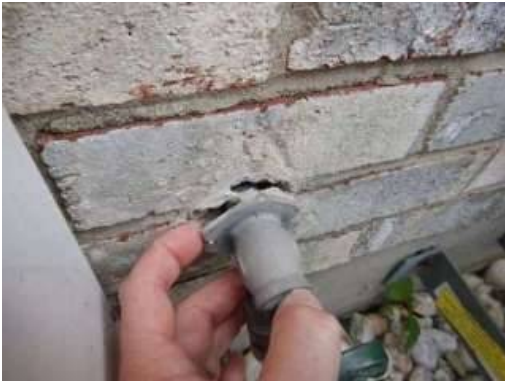
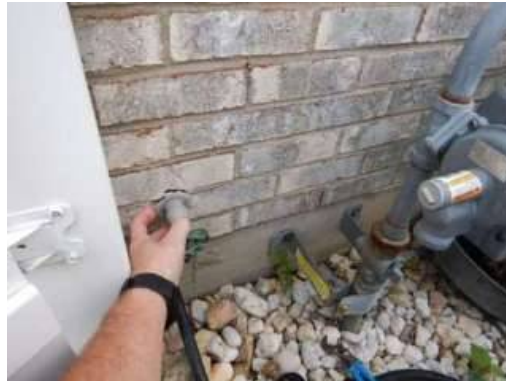
Hose bibb (outside faucet) was loose. Recommend that a qualified person repair or replace as necessary.

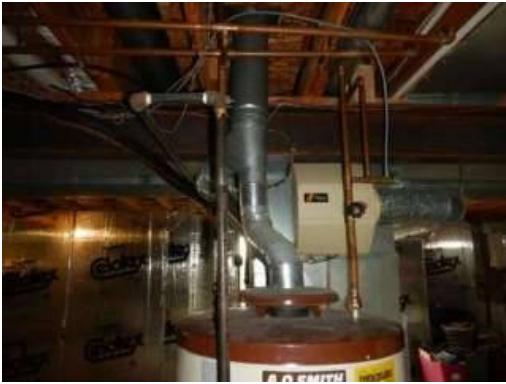
Photo 18-1

No expansion tank was installed for the water supply system. Expansion tanks are recommended when a property is on a public water supply system and the property's water system is "closed" via a pressure reducing valve (PRV), check valve, or backflow preventer. No room for expansion of water exists in this type of system. Thermal expansion occurs when water is heated during non-use periods. In a closed system with no provision for expansion, its effects can include:

- Backflow into the water main
- Damage to water heater connections, gas water heater flue tubes and pumps serving washers and dishwashers
- Leaking faucets
- "Weeping" of water through the water heater temperature-pressure relief (TPR) valve
- Noisy water hammer in the pipes

Expansion tanks can eliminate these problems by giving water a place to go when thermal expansion occurs. When a water heating cycle ends, or when any fixture is opened within the system, the impact of thermal expansion is reduced, and water drains out of the expansion tank back into the system. Recommend that a qualified plumber install an expansion tank per standard building practices.

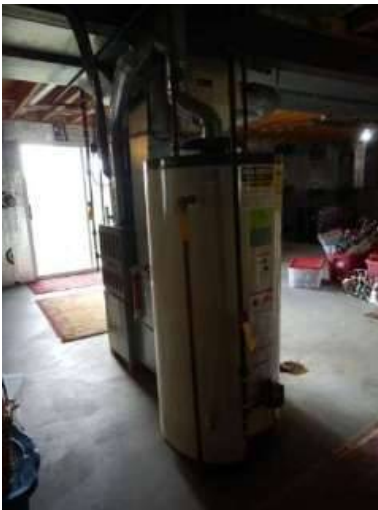
Photo 19-1

The estimated useful life for most water heaters is 8-12 years. This water heater appeared to be beyond this age. Recommend budgeting for repairs or replacement in the next few years.

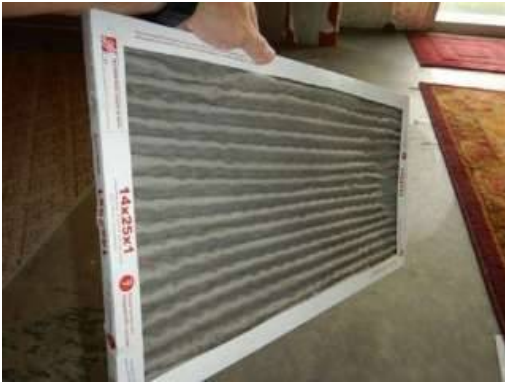
Photo 20-1

Air filter needs cleaning or replacement. Periodically (at least 4 times per year) check and replace, or wash, air filters and inspect your furnace for signs of unusual operation such as discoloration, soot, or disconnected vents. For more information see: <https://www.bestchoicehomeinspections.com/articles/hvac-filter/>

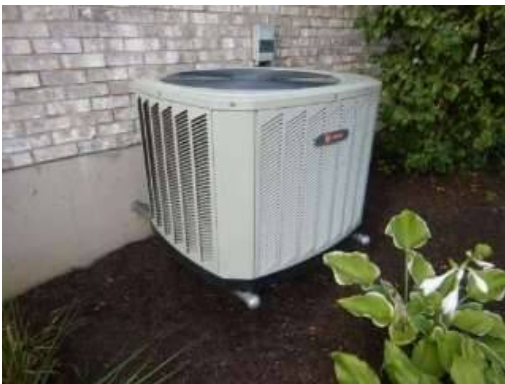
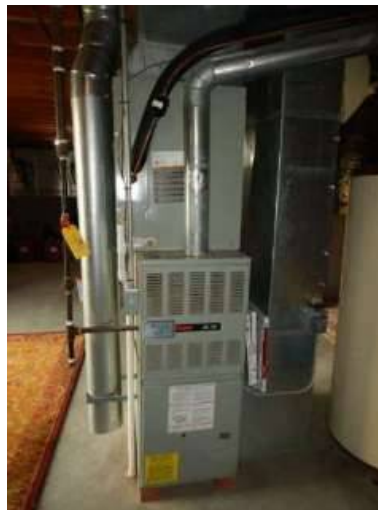
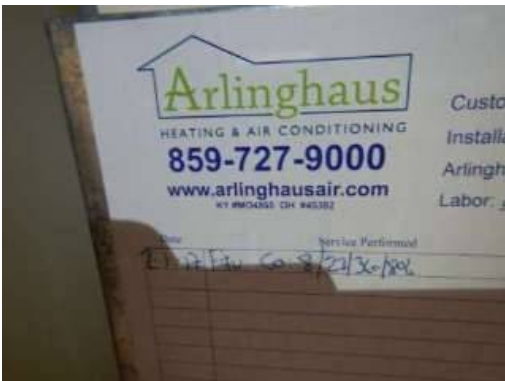
The last service date of the HVAC system appeared to be more than 2 years ago. Ask the property owner when it was last serviced. If unable to determine the last service date, or if this system was serviced more than 2 years ago, recommend that a qualified HVAC contractor service this system and make repairs if necessary. Because this system has a compressor and refrigerant system, this servicing should be performed every few years in the future.

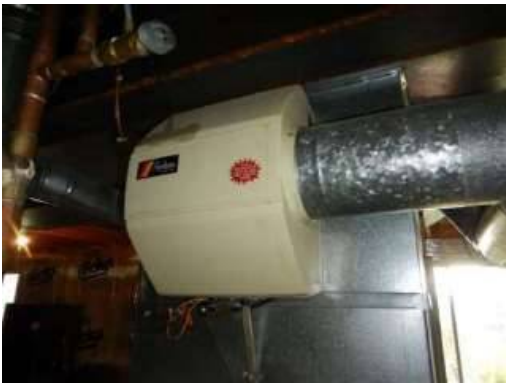
Photo 22-1

Humidifier appears to be working. These are seasonal systems that require some instruction and regular maintenance. Recommend that the client review all available documentation for the humidifier. Recommend the humidifier be serviced when the HVAC system is serviced.

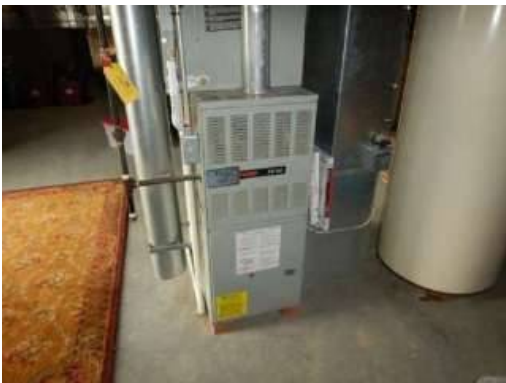
Photo 23-1

23) **i** The estimated useful life for most forced air furnaces is about 25 years. This furnace appeared to be at this age. Recommend budgeting for repairs or replacement in the next few years.

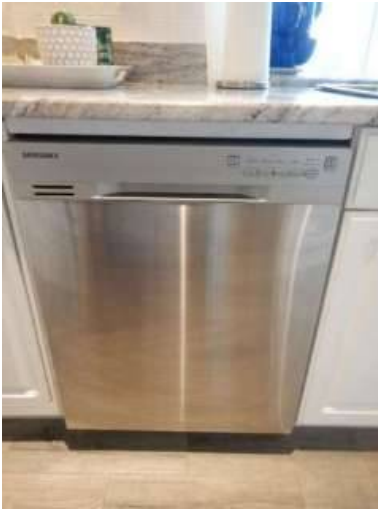
Photo 24-1

The dishwasher door spring appeared to be damaged allowing the door to fall open. This could be a safety hazard. Recommend that a qualified person evaluate and repair as necessary.

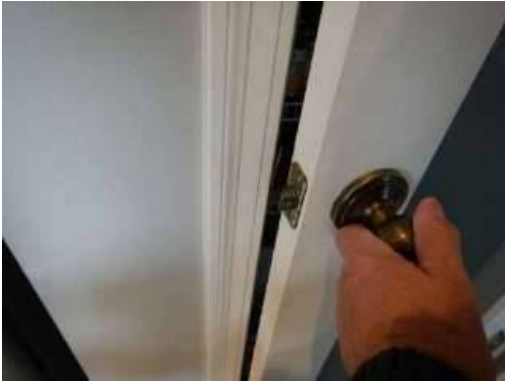
Photo 25-1

25) 🛠 Interior door wouldn't latch or was difficult to latch. Recommend that a qualified person repair as necessary. For example, by adjusting latch plates or lock set.

- @ basement, bottom of stairs
- @ kitchen pantry
- @ master bath, toilet room
- @ bedroom, front, left
- @ bedroom, front, right
