Residential Property Inspection Report

Property address: **1539 Ambrose Ave**

Inspection date: **Thursday, August 20, 2020**

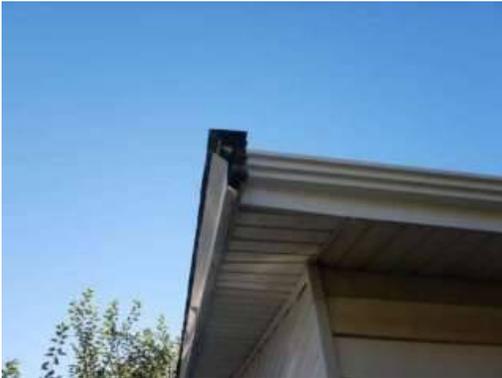
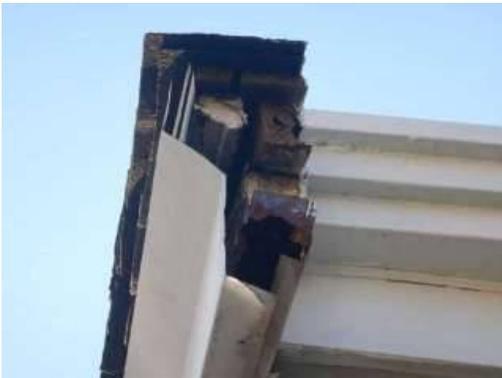
Section of trim found damaged. Vermin, insects or water may enter the structure. Recommend that a qualified person evaluate, repair, or replace as necessary.

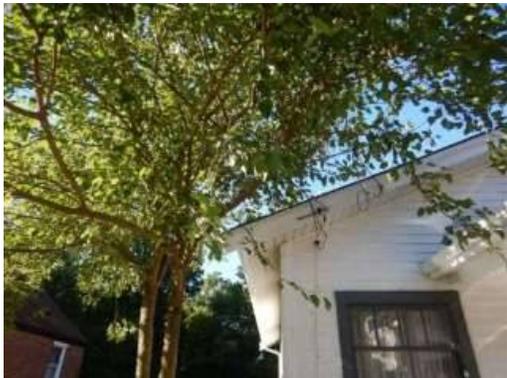
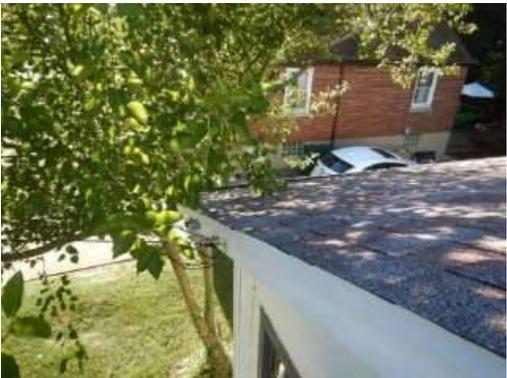
Trees were in contact with or were close to the building. Damage to the building can occur, especially during high winds. Tree roots can cause significant structural damage to foundations, or may have already caused damage. Recommend that a qualified tree service or certified arborist evaluate, prune or remove as necessary to prevent damage to the building exterior.

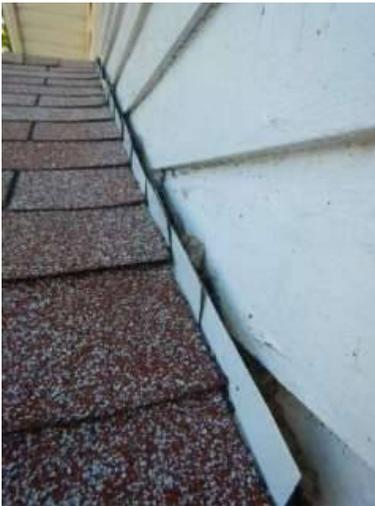
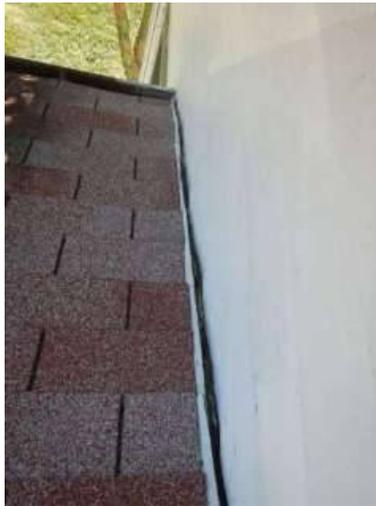
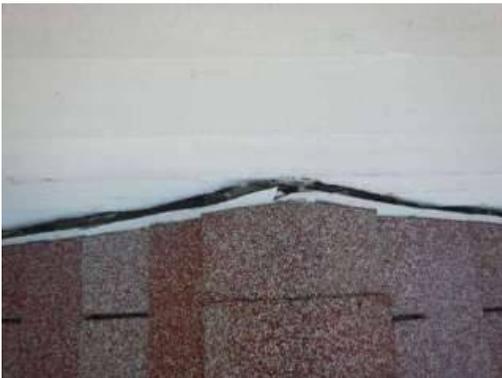
Roof flashing was substandard. Leaks can occur as a result. This is a conducive condition for wood-destroying organisms. Recommend that a qualified person repair as necessary.

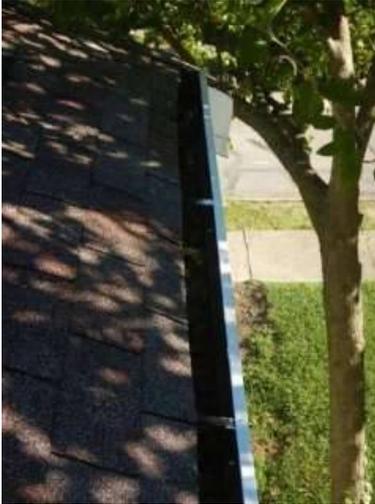
Photo 5-1

Debris has accumulated in gutters and downspouts. Gutters can overflow and cause water to come in contact with the building exterior, or water can accumulate around the foundation. This is a conducive condition for wood-destroying organisms. Recommend cleaning gutters and downspouts now and as necessary in the future. Recommend gutter guards be added to keep gutters free of debris and reduce maintenance.

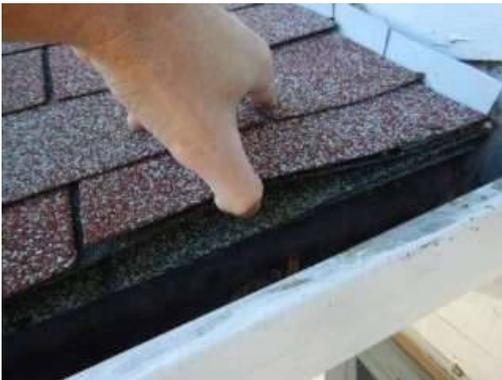
Photo 6-1

6) **i** This asphalt composition roof surface appeared to have two or more layers of shingles. Additional layers of composition shingles typically last only 80% of their rated life, and the shingle manufacturer's warranty may be voided. The client should be aware that all layers of roofing will need to be removed when this roof surface needs replacing in the future. This will add to the cost.

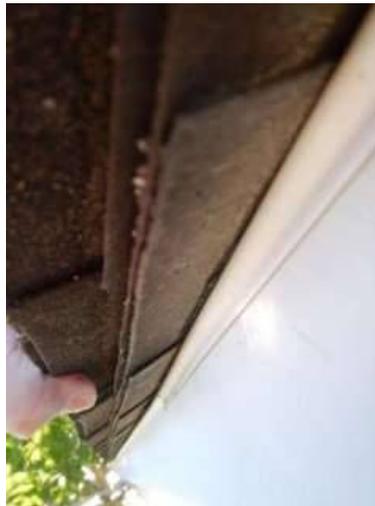
Photo 6-2

- 6) **i** This asphalt composition roof surface appeared to have two or more layers of shingles. Additional layers of composition shingles typically last only 80% of their rated life, and the shingle manufacturer's warranty may be voided. The client should be aware that all layers of roofing will need to be removed when this roof surface needs replacing in the future. This will add to the cost.

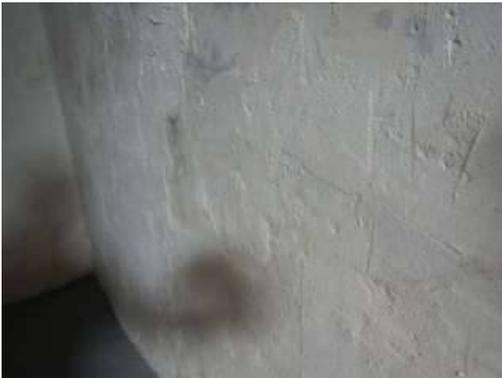
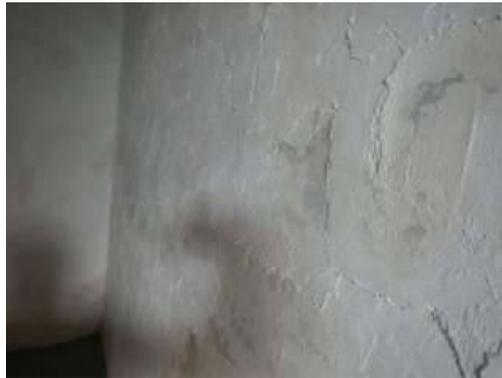
Minor moisture or leaching visible on masonry. This does not appear to be significant enough to allow water into basement. However, recommend sealing and dehumidifying space to prevent microbial growth.

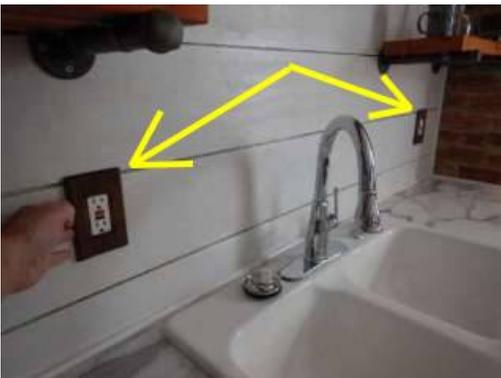
Photo 8-1

GFCI's appeared to be incorrectly wired where two GFCI plugs are on one line in tandem. This will make resetting difficult. Recommend that a qualified electrician repair as necessary. For more information see: <https://www.bestchoicelhomeinspections.com/articles/gfci-guide/>

@ kitchen sink

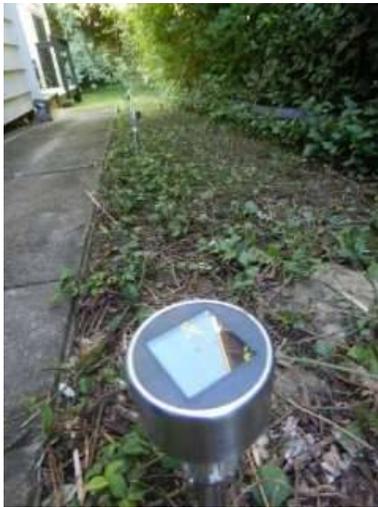
Photo 9-1

Photovoltaic solar energy lighting was installed. Evaluating these systems is beyond the scope of a home inspection. Its condition is unknown, and it is excluded from this inspection. Recommend that a qualified electrician review this system and make repairs if necessary.

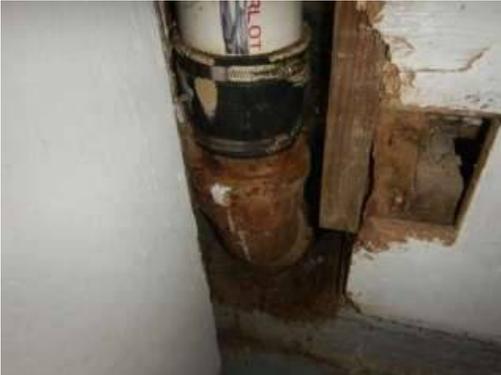
Photo 10-1

Based on a slow drain or back-up at the lowest point in the structure the main waste lines may have obstructions. Significant repairs may be needed. If on a public sewer system, the property owners are usually responsible for repairs to the property side of the sewer and publicly owned lateral lines. Recommend that a qualified plumber inspect the waste lines using a camera scope device to determine if they need repair or replacement.

NOTE: If repairs are needed they are often expensive due to the need for excavation.

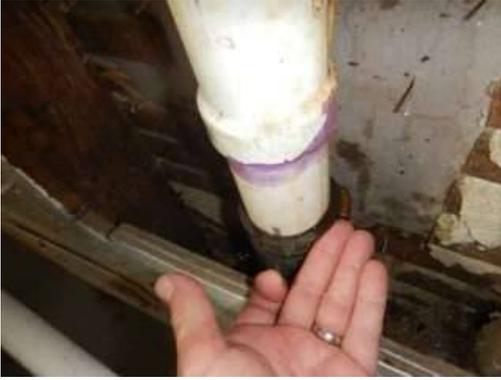
**Photo 11-1**

Leaks were found in the drain pipes or fittings. A qualified plumber should evaluate and repair as necessary.

- behind kitchen sink in utility room

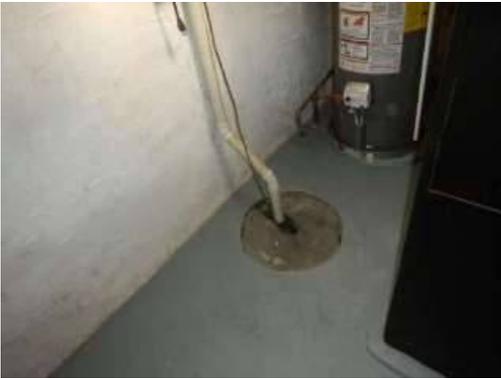
**Photo 12-1**

The sump pump appeared to be inoperable. Water may accumulate in the building substructure during periods of heavy rain. Recommend that a qualified contractor evaluate and repair or replace the sump pump as necessary. For more information on sump pumps see:

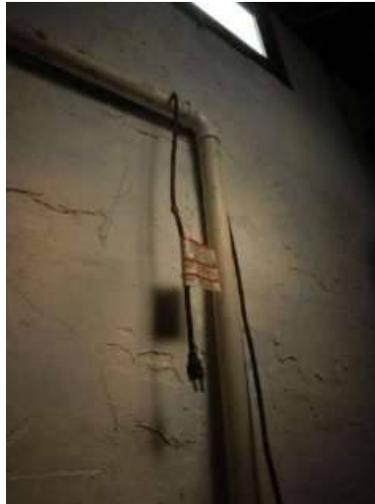
**Photo 12-2**

12) 🛠️🔍💧 The sump pump appeared to be inoperable. Water may accumulate in the building substructure during periods of heavy rain. Recommend that a qualified contractor evaluate and repair or replace the sump pump as necessary. For more information on sump pumps see:

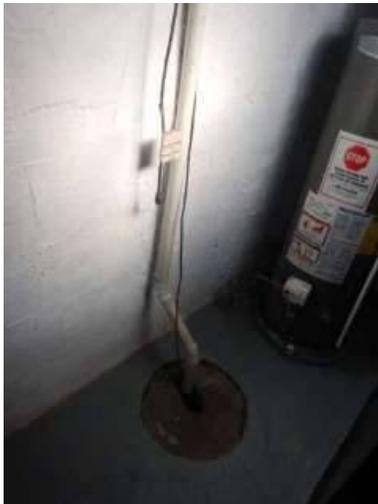
Photo 13-1

No battery backup system was found for the sump pump. If the power goes out during heavy rains, the sump pump won't be able to eliminate accumulated water. Consider installing a battery backup system for the sump pump, especially you travel frequently. For more information on sump pumps see:

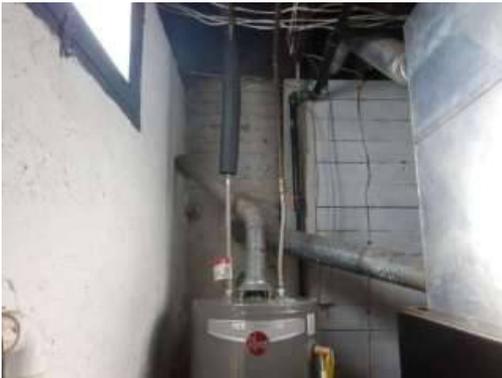
Photo 14-1

No expansion tank was installed for the water supply system. Expansion tanks are recommended when a property is on a public water supply system and the property's water system is "closed" via a pressure reducing valve (PRV), check valve, or backflow preventer. No room for expansion of water exists in this type of system. Thermal expansion occurs when water is heated during non-use periods. In a closed system with no provision for expansion, its effects can include:

- Backflow into the water main
- Damage to water heater connections, gas water heater flue tubes and pumps serving washers and dishwashers
- Leaking faucets
- "Weeping" of water through the water heater temperature-pressure relief (TPR) valve
- Noisy water hammer in the pipes

Expansion tanks can eliminate these problems by giving water a place to go when thermal expansion occurs. When a water heating cycle ends, or when any fixture is opened within the system, the impact of thermal expansion is reduced, and water drains out of the expansion tank back into the system. Recommend that a qualified plumber install an expansion tank per standard building practices.

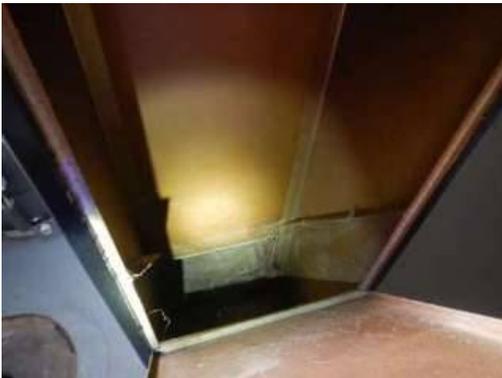
Photo 15-1

Air filter needs replacement. Periodically (at least 4 times per year) check and replace, or wash, air filters and inspect your furnace for signs of unusual operation such as discoloration, soot, or disconnected vents. For more information see: <https://www.bestchoicehomeinspections.com/articles/hvac-filter/>

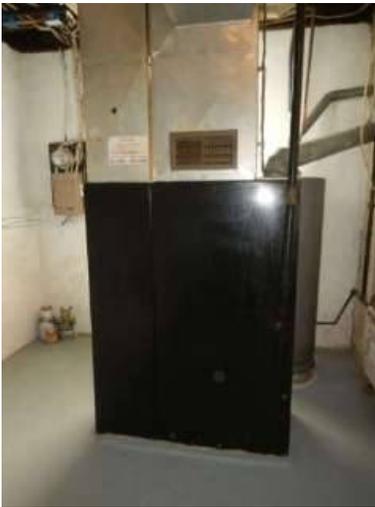
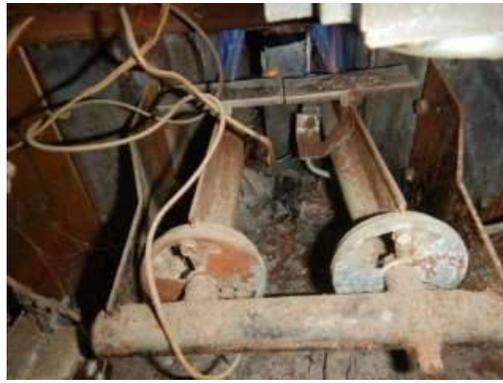
The last service date of the gas forced air furnace appeared to be more than 1 year ago, or the inspector was unable to determine the last service date. Ask the property owner when it was last serviced. If unable to determine the last service date, or if this system was serviced more than 1 year ago, recommend that a qualified HVAC contractor inspect, clean, and service this system, and make repairs if necessary. For safety reasons, and because this system is fueled by gas, this servicing should be performed every few years in the future. Any needed repairs noted in this report should be brought to the attention of the HVAC contractor when it's serviced.

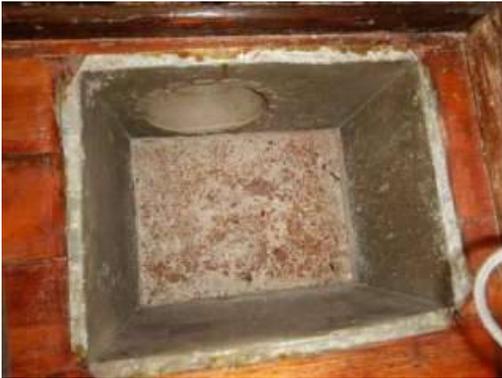
Photo 17-1

Dirt and debris found in register box and/or duct work. This could circulate dirt and dust into the air, aggravate allergies, and reduce energy efficiency. Recommend cleaning and maintaining.

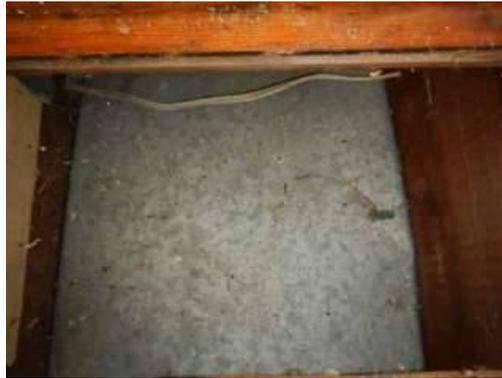
Photo 17-2

17) 🗝️🔧🔍 Dirt and debris found in register box and/or duct work. This could circulate dirt and dust into the air, aggravate allergies, and reduce energy efficiency. Recommend cleaning and maintaining.

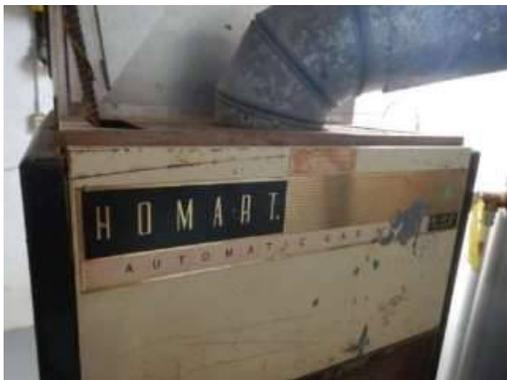
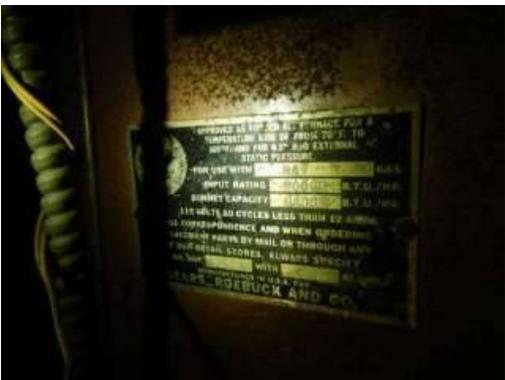
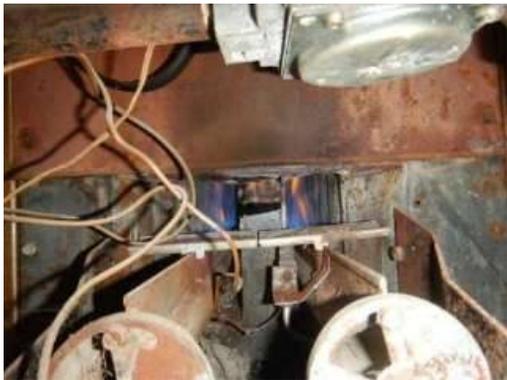
The estimated useful life for most forced air furnaces is about 25 years. This furnace appeared to be beyond this age. Recommend budgeting for repairs or replacement in the next few years.

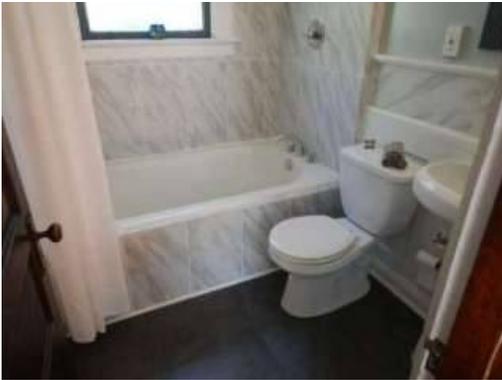
Photo 19-1

The bathroom with a shower or bathtub didn't have an exhaust fan installed. Moisture can accumulate and result in peeling paint, mold, bacteria or fungal growth. Even if the bathroom has a window that opens, it may not provide adequate ventilation, especially during cold weather when windows are closed or when wind blows air into the bathroom. Recommend that a qualified contractor install exhaust fans per standard building practices where missing in bathrooms with showers or bathtubs.

Note: In older homes adding and properly venting a fan may not be practical.

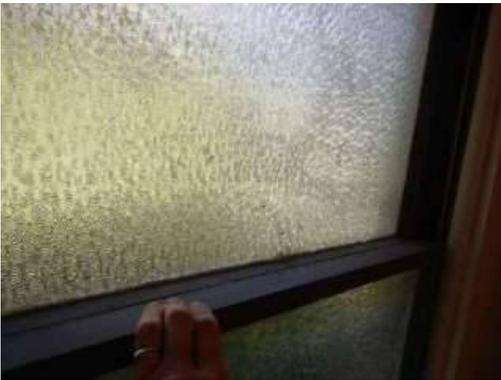
Photo 21-1

21) 🛠️ Locks on window missing in bathroom. Recommend that a qualified person repair as necessary.

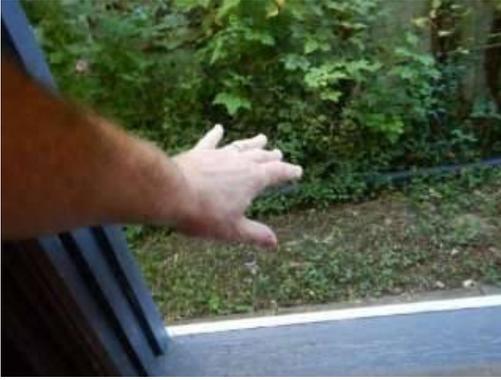
Photo 22-1

22) 🛠️ Screens were missing at all windows. Windows may not provide ventilation during months when insects are active. Recommend replacing window screens as necessary.

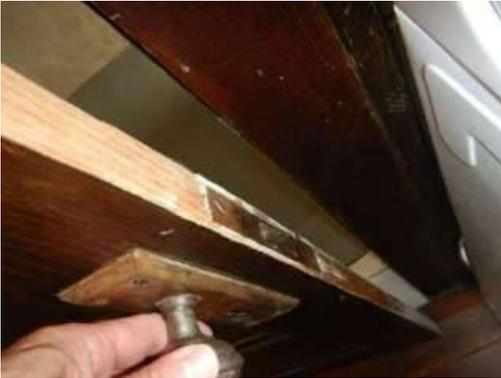
Photo 23-1

Interior door wouldn't latch or was difficult to latch. Recommend that a qualified person repair as necessary. For example, by adjusting latch plates or lock set.

- from kitchen to utility room

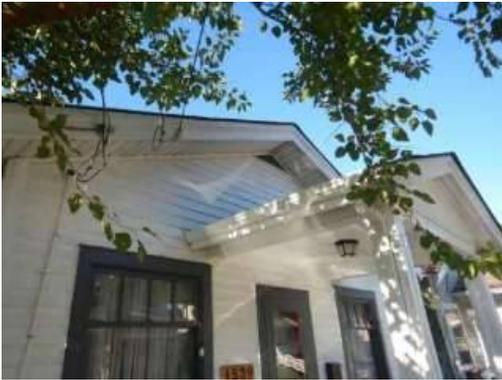
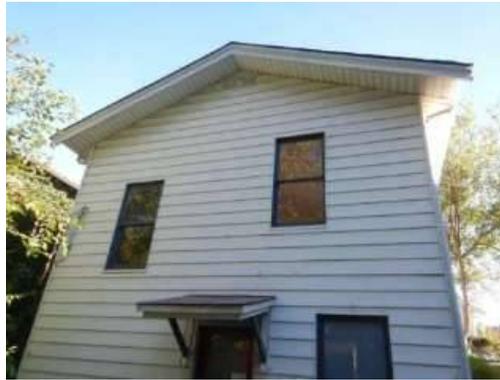
24) ⓘ No access or accessible attic spaces were found or inspected at this property. Recommend access panel be installed as necessary so that a proper attic inspection can done.

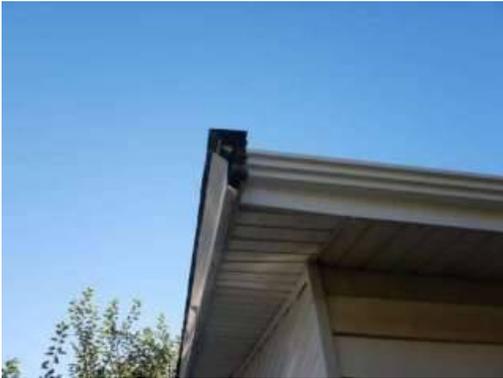
Photo 2-1

Section of trim found damaged. Vermin, insects or water may enter the structure. Recommend that a qualified person evaluate, repair, or replace as necessary.

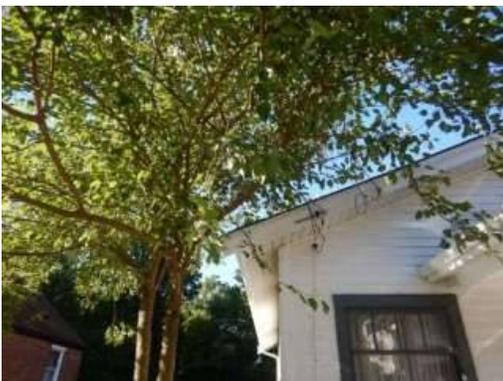
Photo 3-1

Trees were in contact with or were close to the building. Damage to the building can occur, especially during high winds. Tree roots can cause significant structural damage to foundations, or may have already caused damage. Recommend that a qualified tree service or certified arborist evaluate, prune or remove as necessary to prevent damage to the building exterior.

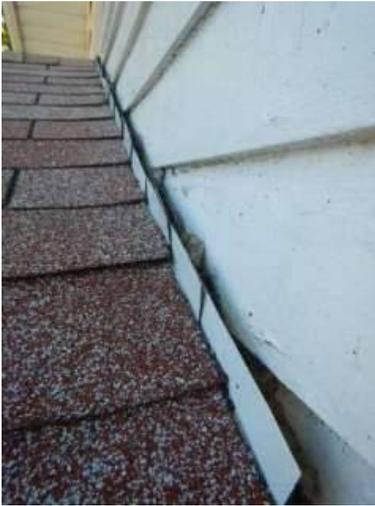
Photo 4-1

Roof flashing was substandard. Leaks can occur as a result. This is a conducive condition for wood-destroying organisms. Recommend that a qualified person repair as necessary.

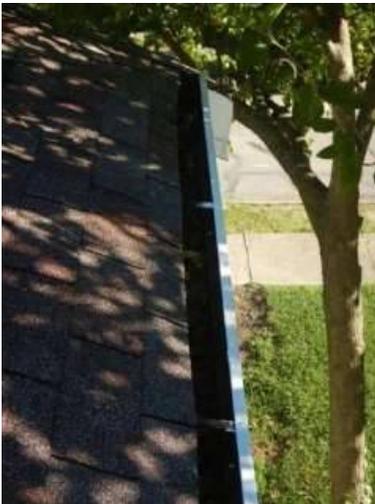
Photo 5-1

Debris has accumulated in gutters and downspouts. Gutters can overflow and cause water to come in contact with the building exterior, or water can accumulate around the foundation. This is a conducive condition for wood-destroying organisms. Recommend cleaning gutters and downspouts now and as necessary in the future. Recommend gutter guards be added to keep gutters free of debris and reduce maintenance.

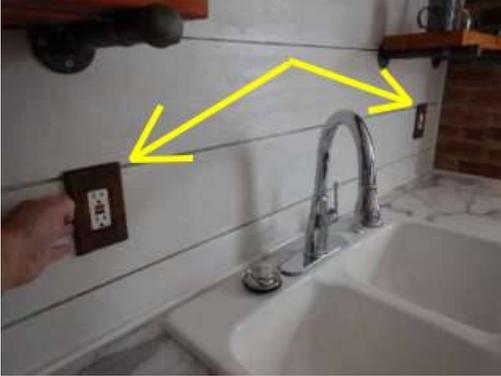
Photo 8-1

GFCI's appeared to be incorrectly wired where two GFCI plugs are on one line in tandem. This will make resetting difficult. Recommend that a qualified electrician repair as necessary. For more information see: <https://www.bestchoicehomeinspections.com/articles/gfci-guide/>

@ kitchen sink

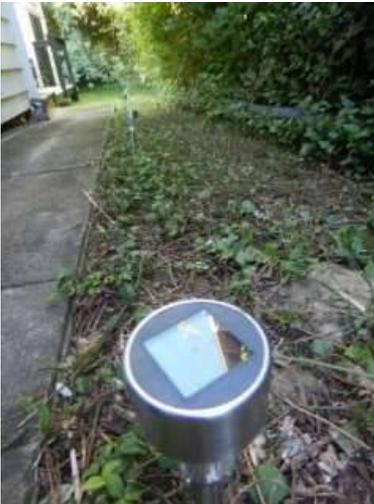
Photo 9-1

Photovoltaic solar energy lighting was installed. Evaluating these systems is beyond the scope of a home inspection. Its condition is unknown, and it is excluded from this inspection. Recommend that a qualified electrician review this system and make repairs if necessary.

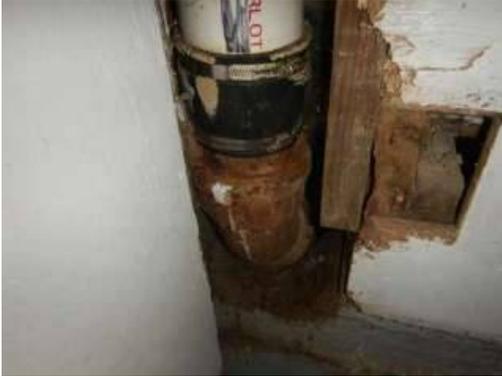
Photo 10-1

10) 🛠️🔍 Based on a slow drain or back-up at the lowest point in the structure the main waste lines may have obstructions. Significant repairs may be needed. If on a public sewer system, the property owners are usually responsible for repairs to the property side of the sewer and publicly owned lateral lines. Recommend that a qualified plumber inspect the waste lines using a camera scope device to determine if they need repair or replacement.

NOTE: If repairs are needed they are often expensive due to the need for excavation.

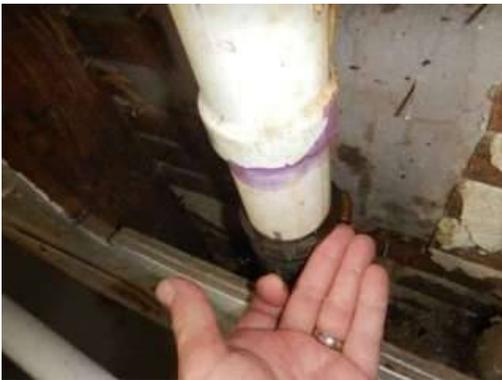
Photo 11-1

11) 🛠️🔍💧 Leaks were found in the drain pipes or fittings. A qualified plumber should evaluate and repair as necessary.

- behind kitchen sink in utility room

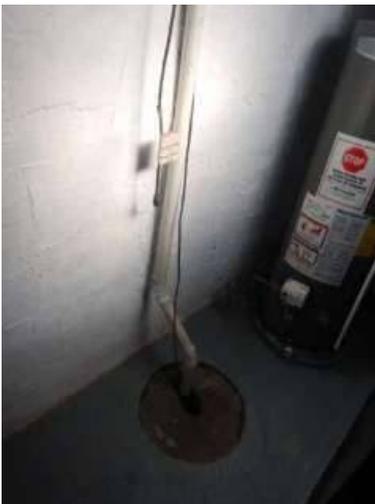
Photo 13-1

13) **i** No battery backup system was found for the sump pump. If the power goes out during heavy rains, the sump pump won't be able to eliminate accumulated water. Consider installing a battery backup system for the sump pump, especially you travel frequently. For more information on sump pumps see:

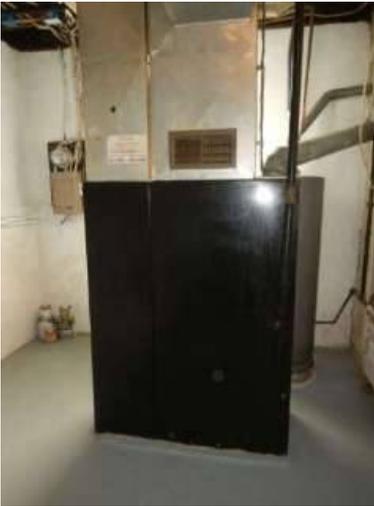
Photo 16-1

16) 🗝️🔧🔍📌 The last service date of the gas forced air furnace appeared to be more than 1 year ago, or the inspector was unable to determine the last service date. Ask the property owner when it was last serviced. If unable to determine the last service date, or if this system was serviced more than 1 year ago, recommend that a qualified HVAC contractor inspect, clean, and service this system, and make repairs if necessary. For safety reasons, and because this system is fueled by gas, this servicing should be performed every few years in the future. Any needed repairs noted in this report should be brought to the attention of the HVAC contractor when it's serviced.

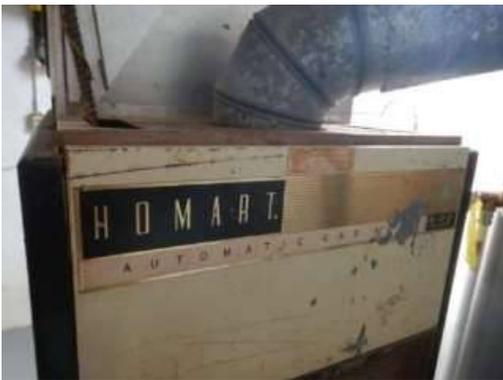
Photo 18-1

18) ⓘ The estimated useful life for most forced air furnaces is about 25 years. This furnace appeared to be beyond this age. Recommend budgeting for repairs or replacement in the next few years.

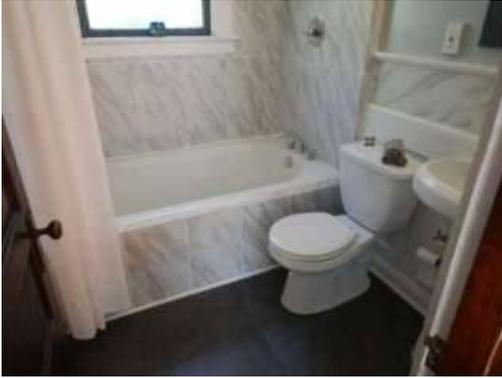
Photo 19-1

The bathroom with a shower or bathtub didn't have an exhaust fan installed. Moisture can accumulate and result in peeling paint, mold, bacteria or fungal growth. Even if the bathroom has a window that opens, it may not provide adequate ventilation, especially during cold weather when windows are closed or when wind blows air into the bathroom. Recommend that a qualified contractor install exhaust fans per standard building practices where missing in bathrooms with showers or bathtubs.

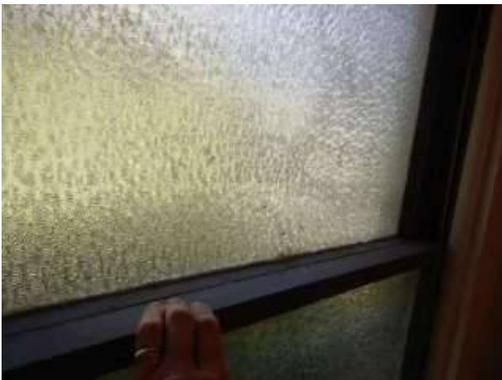
Photo 21-1

21) 🛠️ Locks on window missing in bathroom. Recommend that a qualified person repair as necessary.

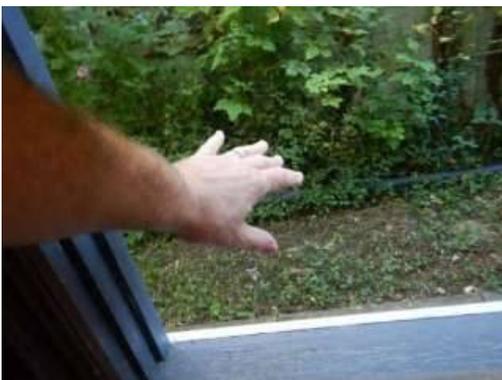
Photo 22-1

22) 🛠️ Screens were missing at all windows. Windows may not provide ventilation during months when insects are active. Recommend replacing window screens as necessary.

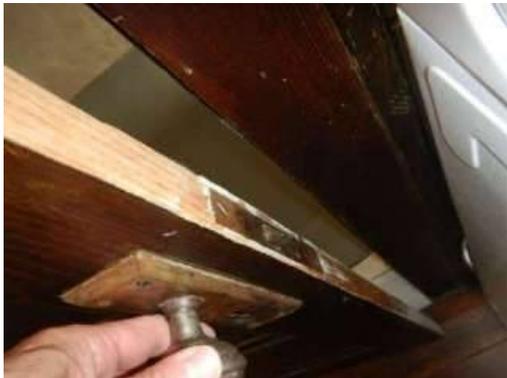
Photo 23-1

23) 🛠️ Interior door wouldn't latch or was difficult to latch. Recommend that a qualified person repair as necessary. For example, by adjusting latch plates or lock set.

- from kitchen to utility room
