Inspector: John Woodall

Residential Property Inspection Report

Property address: **10542 Thornview Dr**

Inspection date: **Saturday, July 25, 2020**

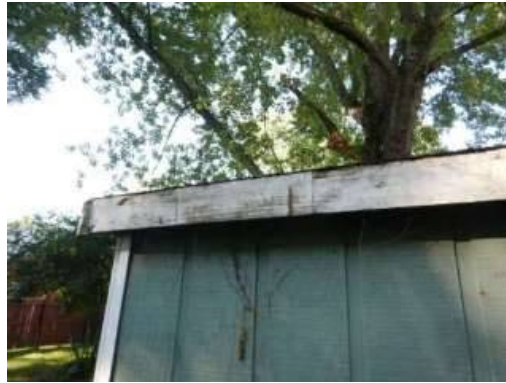
Photo 2-2

This property has a free standing shed. Shed was found with fungal rot, roof leak and earth on siding. If left unmaintained or repaired shed will decompose. Recommend repairs be made by a qualified professional.

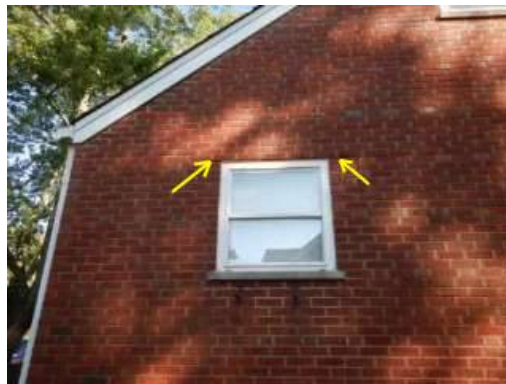
Photo 5-2

The masonry tuckpointing was damaged where the lintel over the window has rusted and expanded. Where cracks or openings are exposed, water can enter the wall structure causing further damage. Recommend that a qualified contractor repair as necessary. For example, by cleaning and painting the lintel(s) to inhibit rust and repointing as necessary.

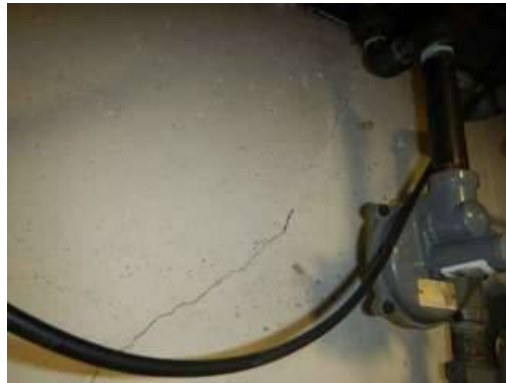
Photo 6-2

Minor cracks (1/8 inch or less) found in the foundation did not appear to be a structural concern, but recommend sealing them to prevent water infiltration and monitor them in the future. Numerous products exist to seal such cracks including hydraulic cement, non-shrinking grout, resilient caulks and epoxy sealants.

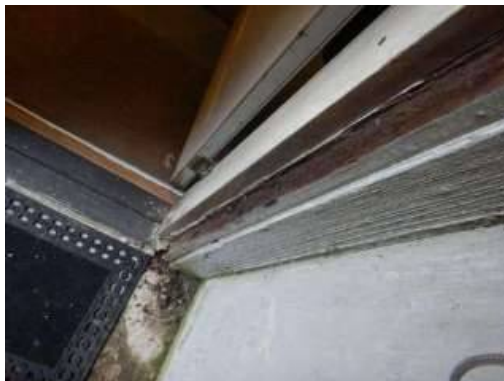
Photo 7-2

7) 🛠️💧 The paint or stain finish in some areas was failing (e.g. peeling, faded, worn, thinning). Siding and trim with a failing finish can be damaged by moisture. Recommend that a qualified contractor prep (e.g. clean, scrape, sand, prime, caulk) and repaint or restain where necessary and per standard building practices. Any repairs needed to the siding or trim should be made prior to this.

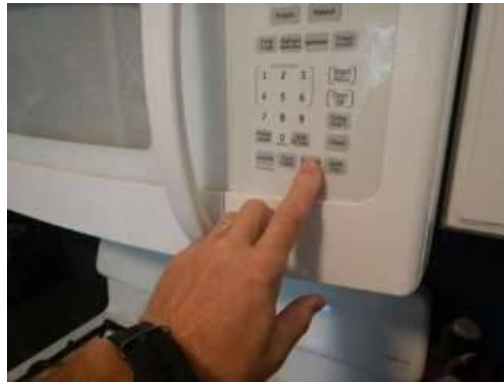
Photo 25-2

The microwave light was not working. Recommend evaluation, and replace bulb or repair fan as necessary.

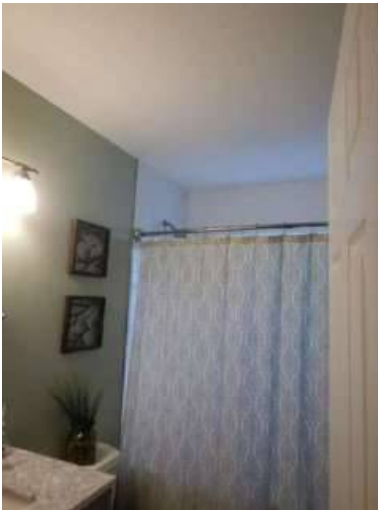
Photo 27-1

The bathroom with a shower or bathtub didn't have an exhaust fan installed. Moisture can accumulate and result in peeling paint, mold, bacteria or fungal growth. Even if the bathroom has a window that opens, it may not provide adequate ventilation, especially during cold weather when windows are closed or when wind blows air into the bathroom. Recommend that a qualified contractor install exhaust fans per standard building practices where missing in bathrooms with showers or bathtubs.

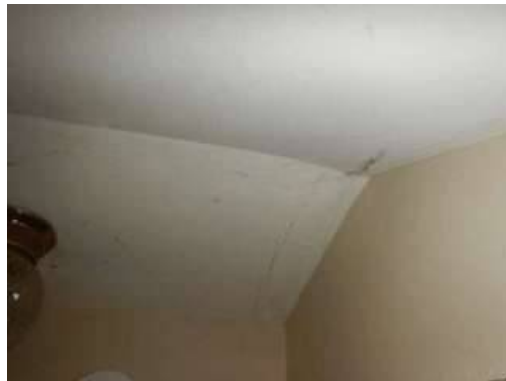
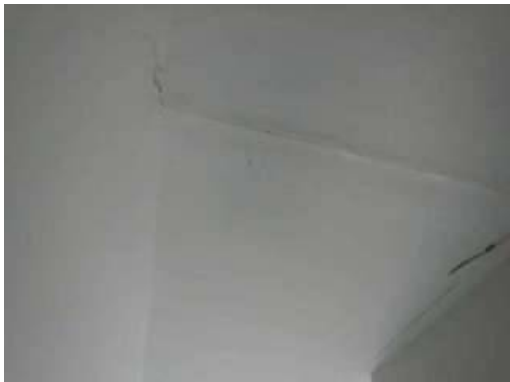
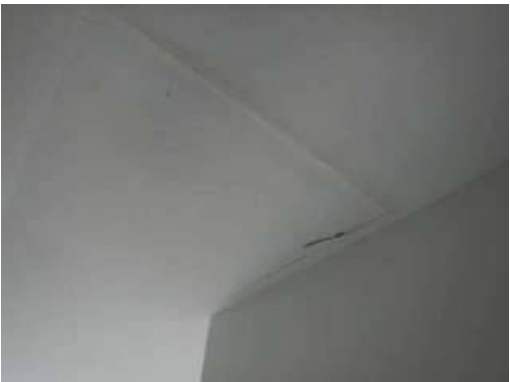
29) 🛠️ ⓘ Minor cracks, nail pops and/or blemishes were found in the walls and/or ceilings. Cracks and nail pops are common, are often caused by lumber shrinkage, seasonal expansion and contraction, or minor settlement, and can be more or less noticeable depending on changes in humidity. Blemishes may be caused by normal usage or substandard patching and painting. They did not appear to be a structural concern, but the client may wish to repair these for aesthetic reasons.

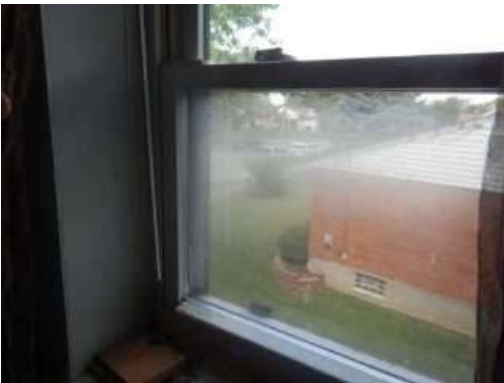
Photo 31-1

Condensation or staining was visible between the multi-pane glass in window. This indicates that the seal between the panes of glass has failed. As a result, the view through the window may be obscured and the window's R-value will be reduced. Recommend that a qualified contractor evaluate and repair windows as necessary. Usually, this means replacing the glass in window frames. Be aware that evidence of failed seals may be more or less visible depending on the temperature, humidity, sunlight, etc. Because of this windows other than those that the inspector identified may also have failed seals and need glass replaced.

1 in attic

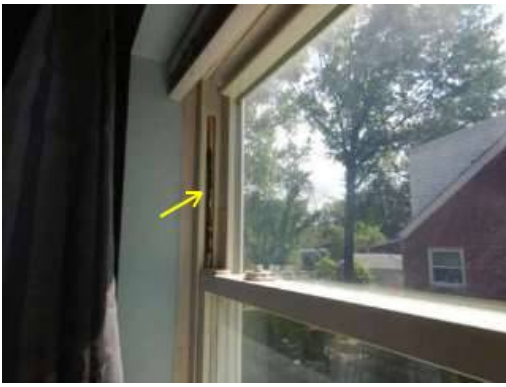
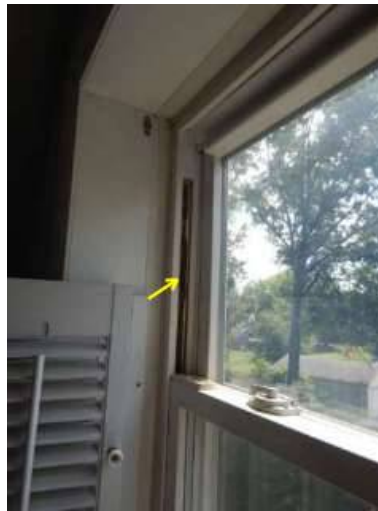
@ front bedroom

@ attic

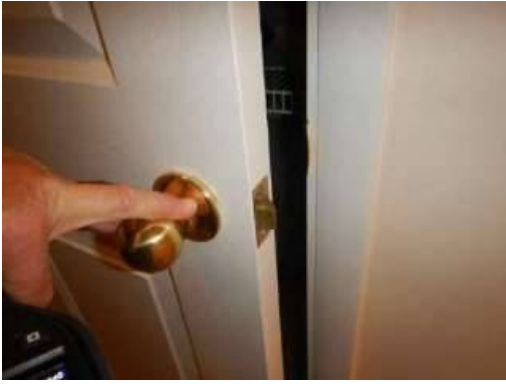
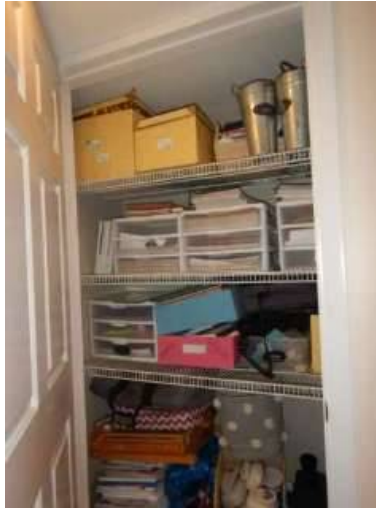
Interior door wouldn't latch or was difficult to latch. Recommend that a qualified person repair as necessary. For example, by adjusting latch plates or lock set.

@ closet at bottom of basement stairs

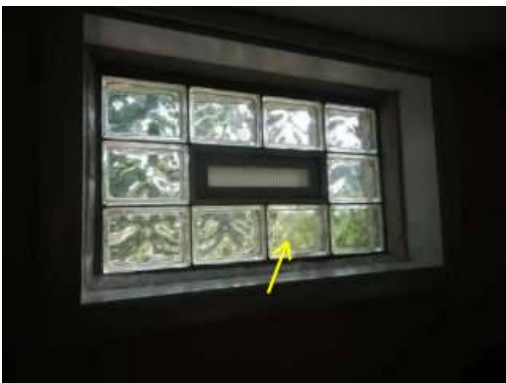
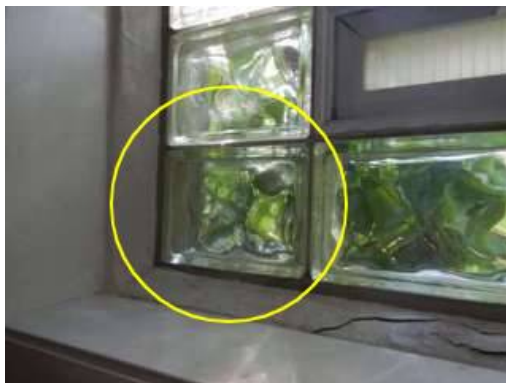
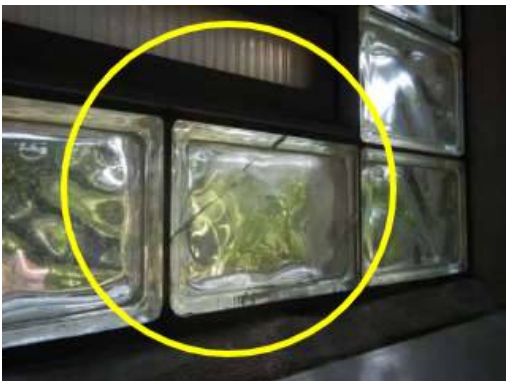
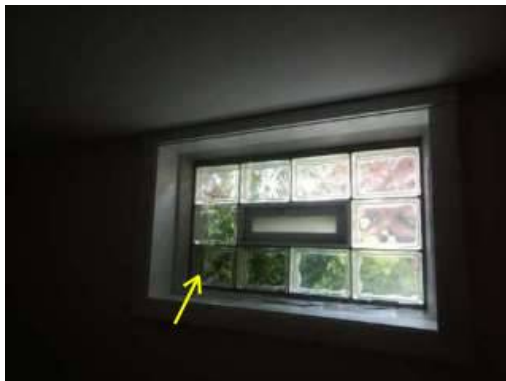
Glass in window was cracked or broken. Recommend that a qualified contractor replace glass where necessary.

- two glass block windows in basement

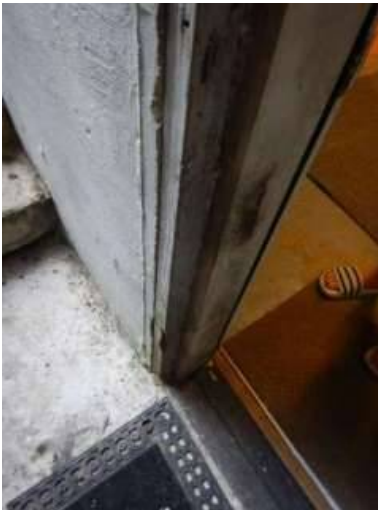
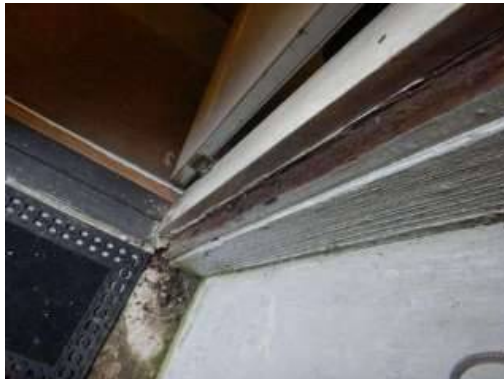
7) 🛠️💧 The paint or stain finish in some areas was failing (e.g. peeling, faded, worn, thinning). Siding and trim with a failing finish can be damaged by moisture. Recommend that a qualified contractor prep (e.g. clean, scrape, sand, prime, caulk) and repaint or restain where necessary and per standard building practices. Any repairs needed to the siding or trim should be made prior to this.

@ basement door jamb/brickmold

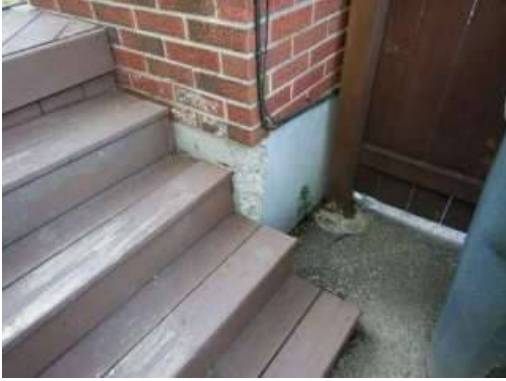
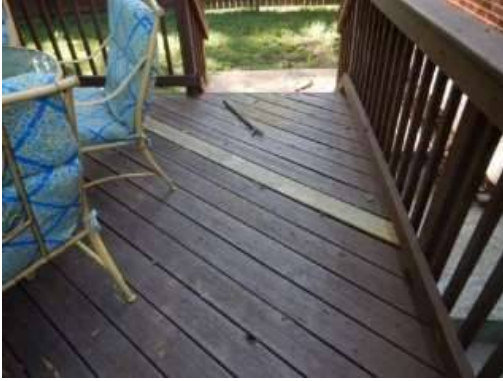
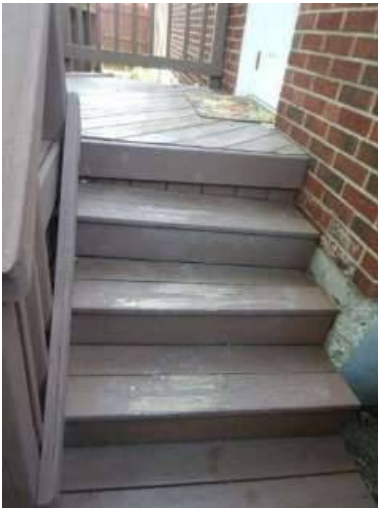
Wooden deck surfaces were overdue for normal maintenance. Recommend that a qualified person clean and preserve as necessary. Where decks have been coated with a finish such as opaque stains or paint, it may be too difficult to strip the finish and apply anything but paint or opaque stain. Where transparent stain or penetrating oil has been applied in the past, recommend that a penetrating oil be used. For more information, visit:

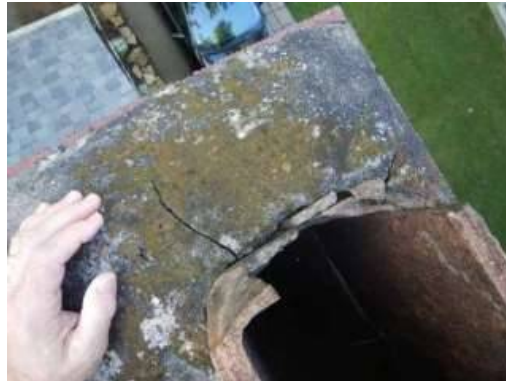
Photo 14-2

The masonry chimney crown is cracked. Crowns are meant to keep water off of the chimney structure and prevent damage from freeze-thaw cycles. Recommend that a qualified contractor repair or replace crowns as necessary, and per standard building practices.

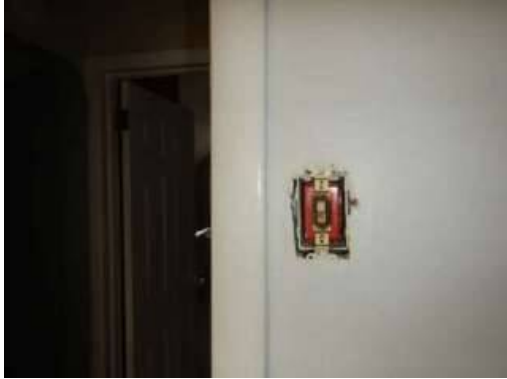
Photo 15-1

Cover plates for switches, receptacles (outlets) or junction boxes were missing or broken. These plates are intended to contain fire and prevent electric shock from occurring due to exposed wires. Recommend that a qualified person install cover plates where necessary.

@ attic

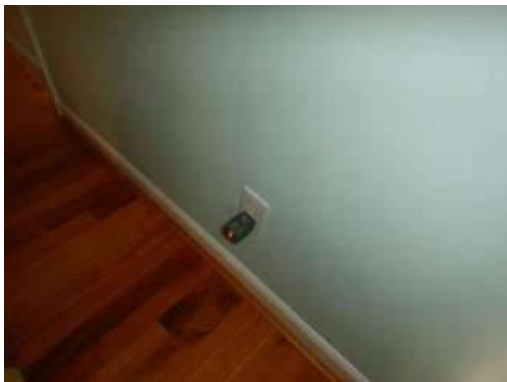
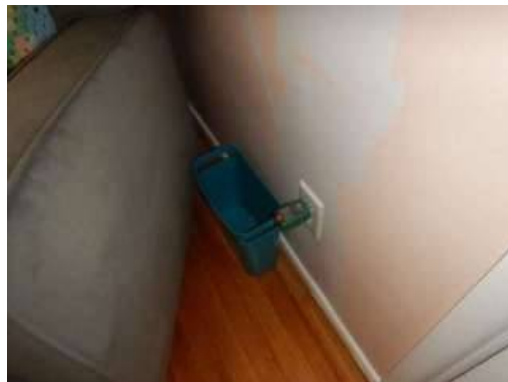
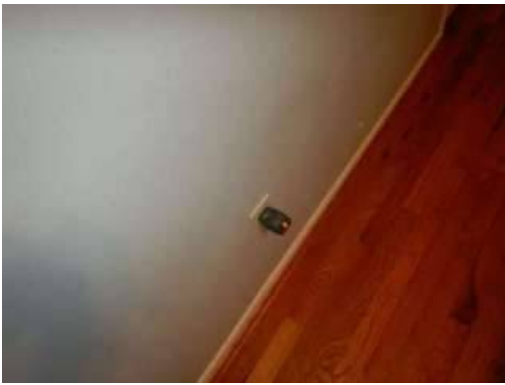
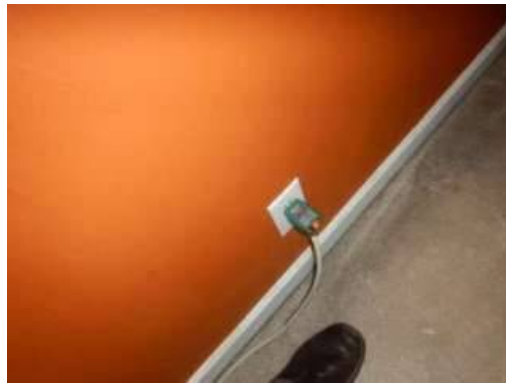
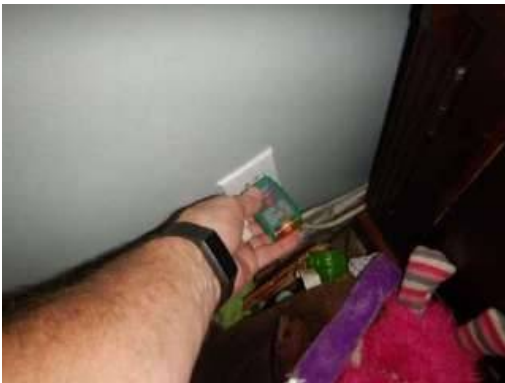
Modern, 3-slot electric receptacle (outlet) was found with an open ground. Three-slot receptacles should have a hot, a neutral and a ground wire connected. Homeowners often install new 3-slot receptacles on older, 2-wire circuits that only have hot and neutral wires. This is a shock hazard when appliances that require a ground are used with these receptacles. Examples of such appliances include computers and related hardware, refrigerators, freezers, portable air conditioners, clothes washers, aquarium pumps, and electrically operated gardening tools. Where the electric system was installed prior to when grounded circuits were required (1960's), it is permissible to replace 3-slot receptacles with 2-slot receptacles to prevent appliances that require a ground from being plugged into an ungrounded circuit. However, the client should be aware of this limitation when planning use for various rooms, such as an office. For newer electrical systems, circuits should be repaired so grounded, 3-wire cables provide power to 3-slot receptacles. Recommend that a qualified electrician repair per standard building practices.

- dining room
- 2 in back bedroom
- 2 in front bedroom
- all but front plug in living room
- all in attic

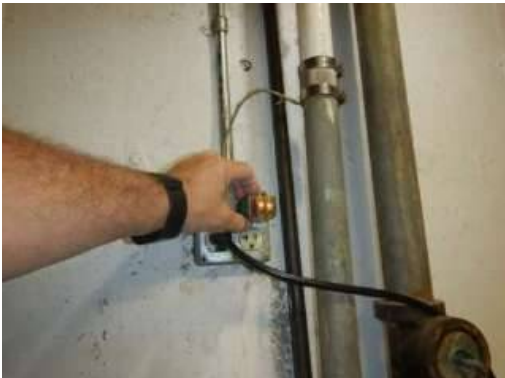
Photo 17-1

Receptacle (outlet) at the laundry wet area had no visible ground fault circuit interrupter (GFCI) protection. If not GFCI-protected, receptacles in wet areas pose a shock hazard. Recommend that a qualified electrician evaluate and install GFCI protection if necessary and per standard building practices. General guidelines for GFCI-protected receptacles include the following locations:

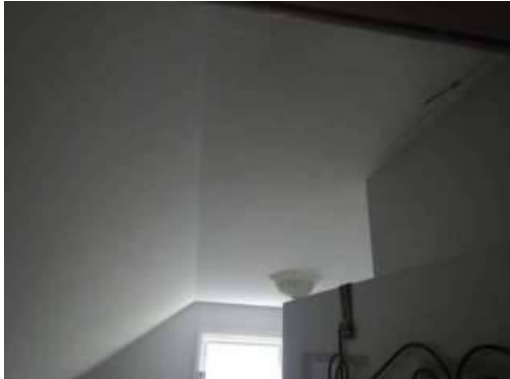
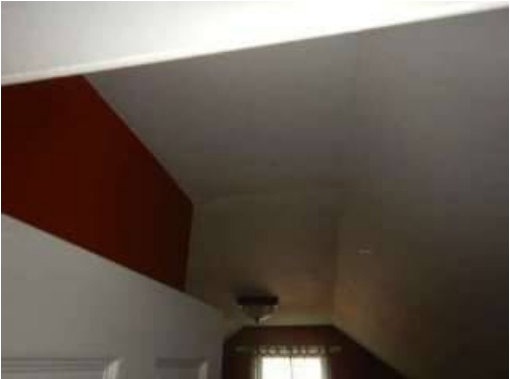
Some smoke/CO2 alarms were missing in areas where they should be. Smoke alarms should be installed in each bedroom, in hallways leading to bedrooms, on each level and in attached garages. They have a limited lifespan and should be replaced every 10 years. Batteries in smoke alarms should be changed when taking occupancy and annually in the future. Carbon monoxide alarms should be installed near sleeping areas and on each level in

homes with a fuel-burning appliance or attached garage. For more information on smoke alarms see: <https://www.bestchoicehomeinspections.com/articles/smoke-alarms/>

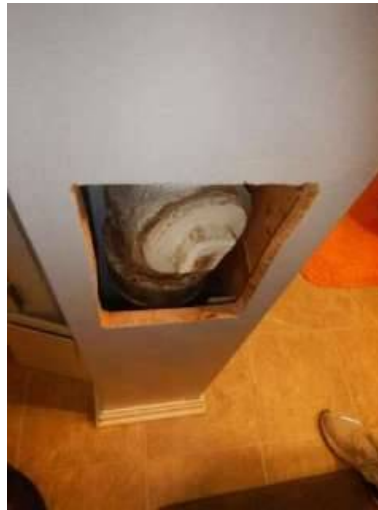
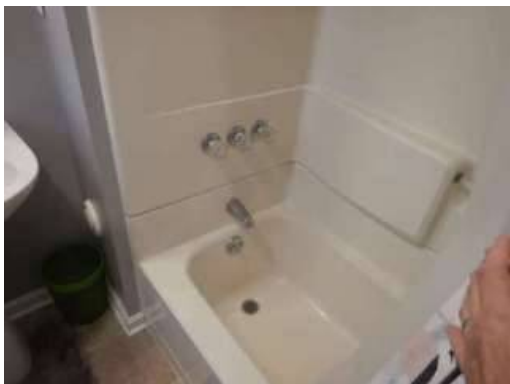
20) 🔍 Based on the disclosures, the large old growth tree in front, and the slow basement bathtub drain, I believe it is important to have the main drainage line camera scoped to the street to be sure there are no future drainage issues. If the tree roots have penetrated the sewage line they will return and keep growing and you will always have drainage issues. If the sewage line has been penetrated it will have to be lined or replaced which can be costly. Recommend evaluation and repairs be done by a qualified professional.

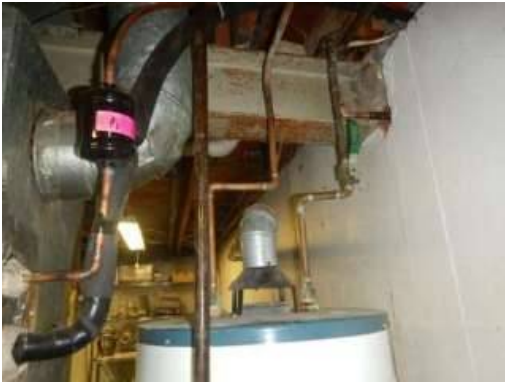
Photo 21-1

No expansion tank was installed for the water supply system. Expansion tanks are recommended when a property is on a public water supply system and the property's water system is "closed" via a pressure reducing valve (PRV), check valve, or backflow preventer. No room for expansion of water exists in this type of system. Thermal expansion occurs when water is heated during non-use periods. In a closed system with no provision for expansion, its effects can include:

Expansion tanks can eliminate these problems by giving water a place to go when thermal expansion occurs. When a water heating cycle ends, or when any fixture is opened within the system, the impact of thermal expansion is reduced, and water drains out of the expansion tank back into the system. Recommend that a qualified plumber install an expansion tank per standard building practices.

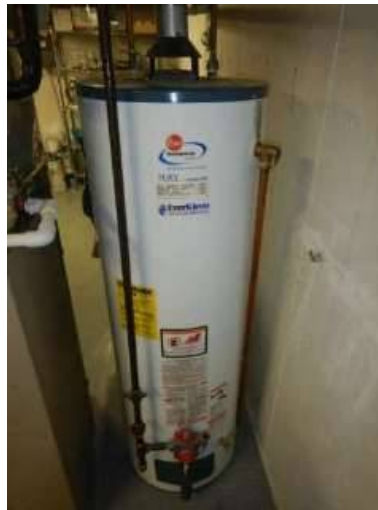
Photo 22-2

The estimated useful life for most water heaters is 8-12 years. This water heater appeared to be beyond this age. Recommend budgeting for repairs or replacement in the next few years.

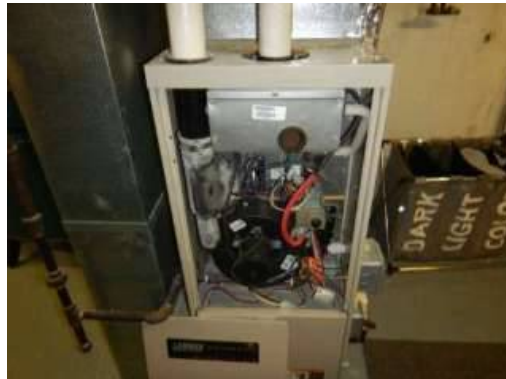
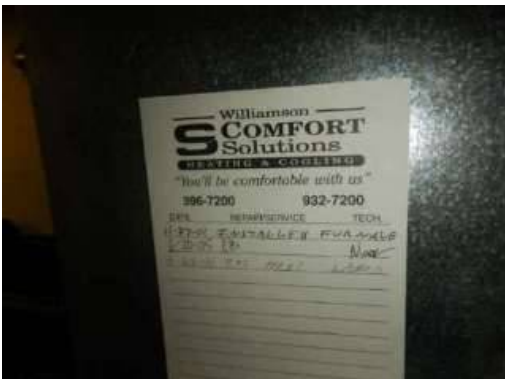
The last service date of the HVAC system appeared to be more than 2 years ago. Ask the property owner when it was last serviced. If unable to determine the last service date, or if this system was serviced more than 2 years ago, recommend that a qualified HVAC contractor service this system and make repairs if necessary. Because this system has a compressor and refrigerant system, this servicing should be performed every few years in the future.

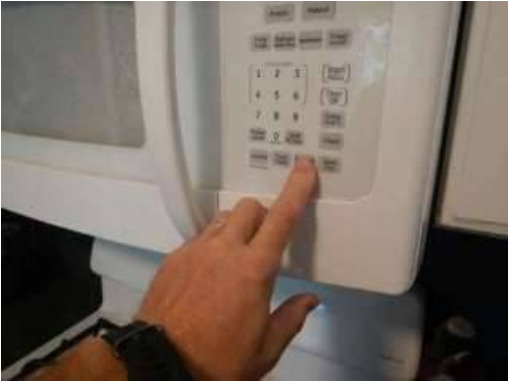
Photo 25-2

25) 🔧🔍 The microwave light was not working. Recommend evaluation, and replace bulb or repair fan as necessary.

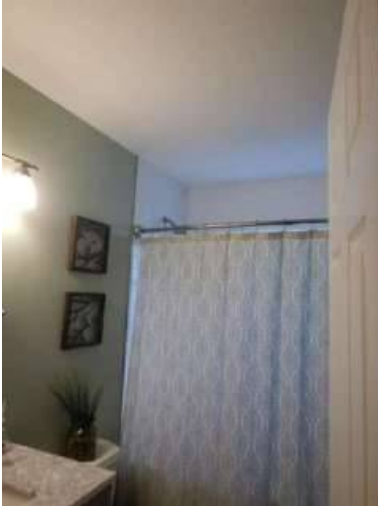
Photo 27-1

The bathroom with a shower or bathtub didn't have an exhaust fan installed. Moisture can accumulate and result in peeling paint, mold, bacteria or fungal growth. Even if the bathroom has a window that opens, it may not provide adequate ventilation, especially during cold weather when windows are closed or when wind blows air into the bathroom. Recommend that a qualified contractor install exhaust fans per standard building practices where missing in bathrooms with showers or bathtubs.

Note: In older masonry homes adding and properly venting a fan may not be practical.

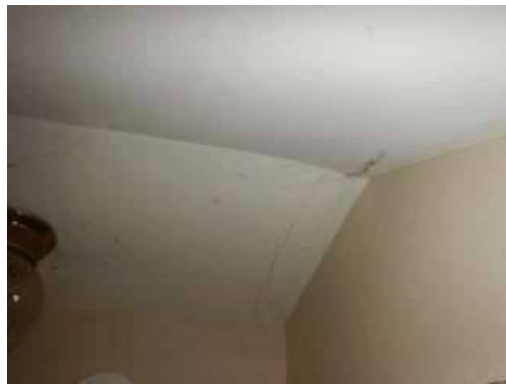
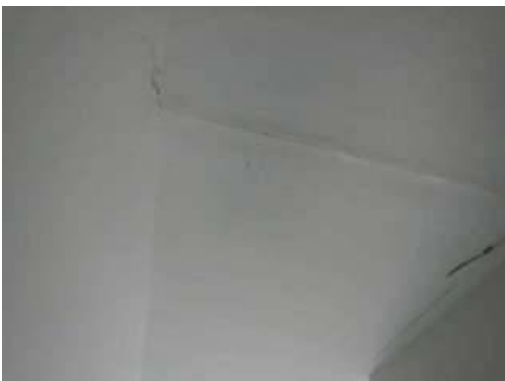
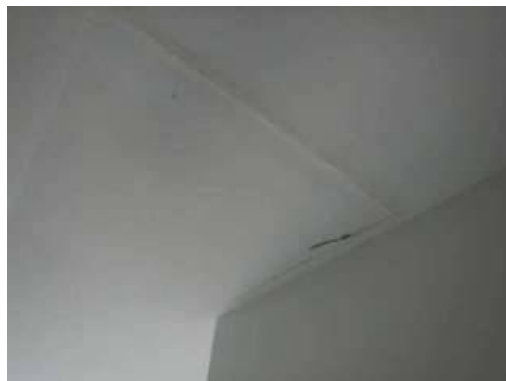
29) 🛠️ ⓘ Minor cracks, nail pops and/or blemishes were found in the walls and/or ceilings. Cracks and nail pops are common, are often caused by lumber shrinkage, seasonal expansion and contraction, or minor settlement, and can be more or less noticeable depending on changes in humidity. Blemishes may be caused by normal usage or substandard patching and painting. They did not appear to be a structural concern, but the client may wish to repair these for aesthetic reasons.

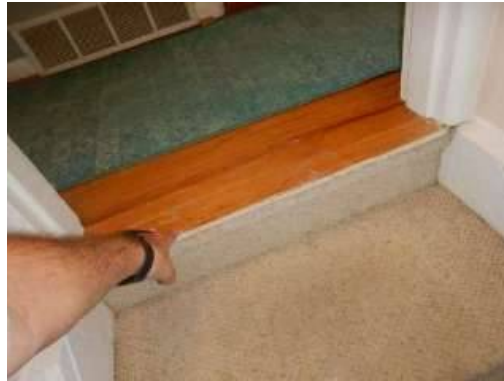
Photo 30-2

Stair nose/flooring was loose and subject to damage. This could also be a hazard. Recommend installing proper support for the stair nose as appropriate.

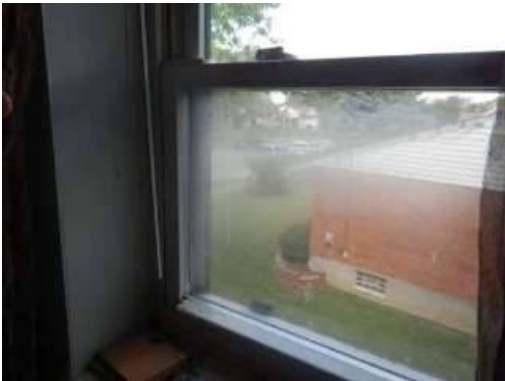
Photo 31-1

Condensation or staining was visible between the multi-pane glass in window. This indicates that the seal between the panes of glass has failed. As a result, the view through the window may be obscured and the window's R-value will be reduced. Recommend that a qualified contractor evaluate and repair windows as necessary. Usually, this means replacing the glass in window frames. Be aware that evidence of failed seals may be more or less visible depending on the temperature, humidity, sunlight, etc. Because of this windows other than those that the inspector identified may also have failed seals and need glass replaced.

1 in attic

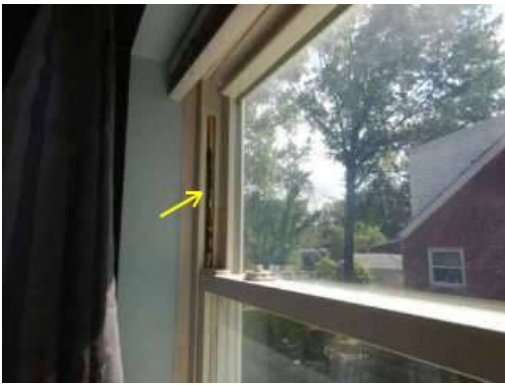
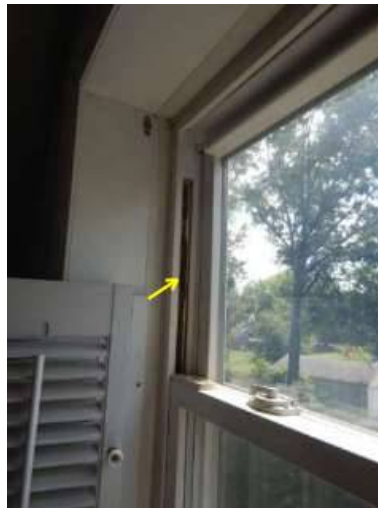
Window with cosmetic damage at spring containment. Recommend that a qualified person repair as necessary.

@ front bedroom

@ attic

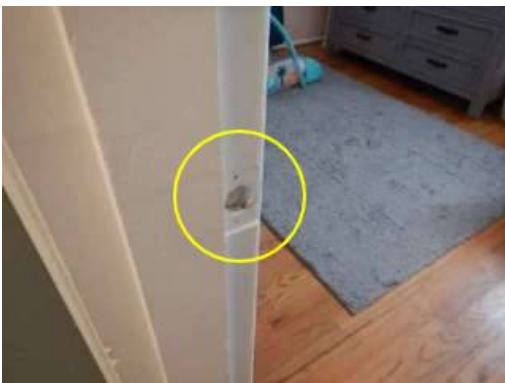
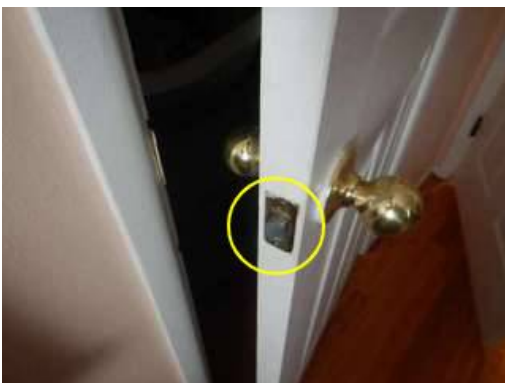
The back bedroom door strike plate was missing and the closet door latch was installed backwards. Recommend that a qualified person repair or replace as necessary.

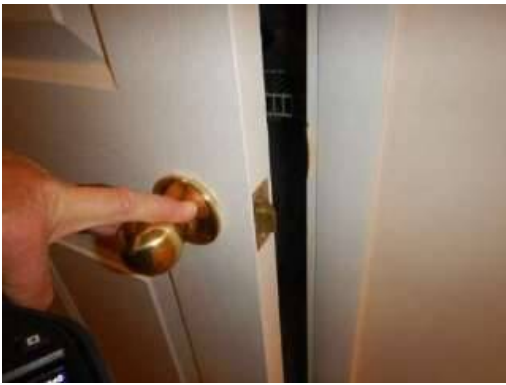
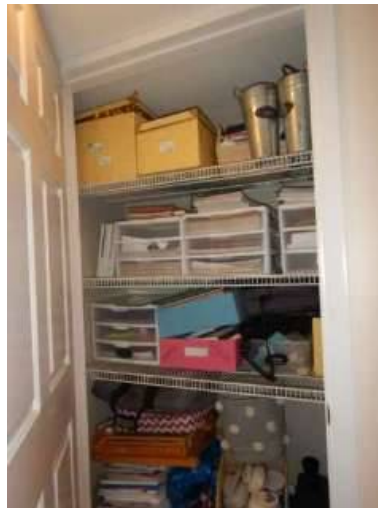
Interior door wouldn't latch or was difficult to latch. Recommend that a qualified person repair as necessary. For example, by adjusting latch plates or lock set.

@ closet at bottom of basement stairs

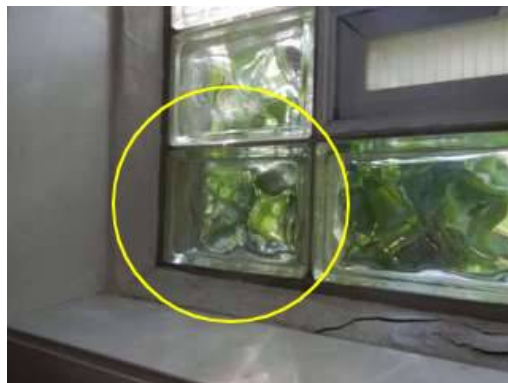
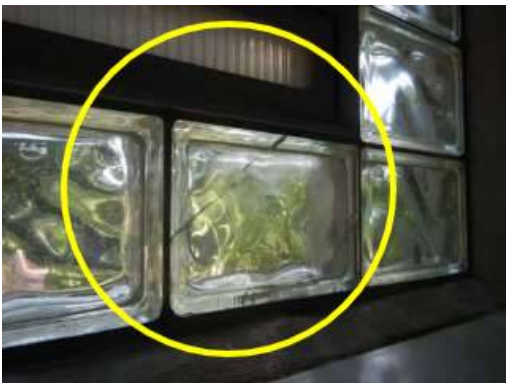
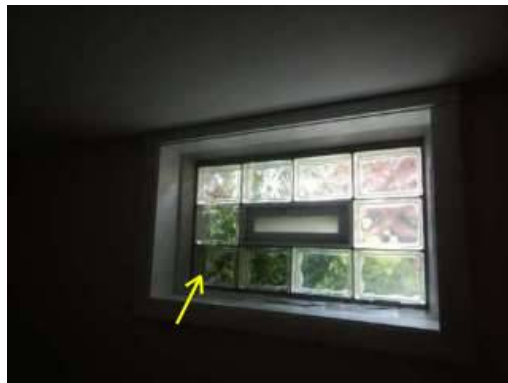
35) 🛠️ Glass in window was cracked or broken. Recommend that a qualified contractor replace glass where necessary.
