## Residential Property Inspection Report

Client(s): Reid Butler

Property address: 41 Linden

Inspection date: Saturday, August 1, 2020

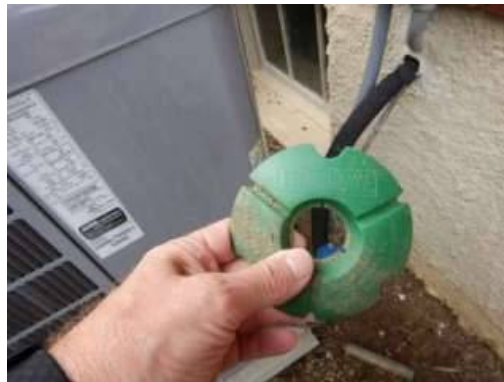
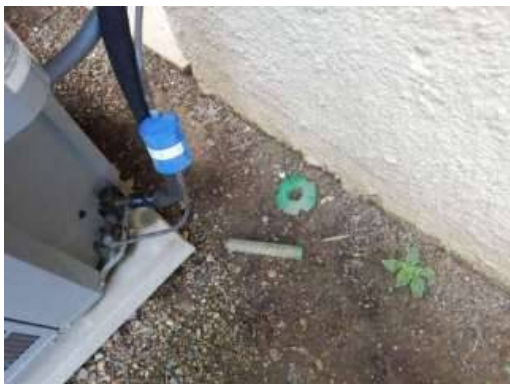
Bait traps found at perimeter. Recommend consult with property owner about history of treatment, infestation, prior or ongoing treatment plan and warranties.

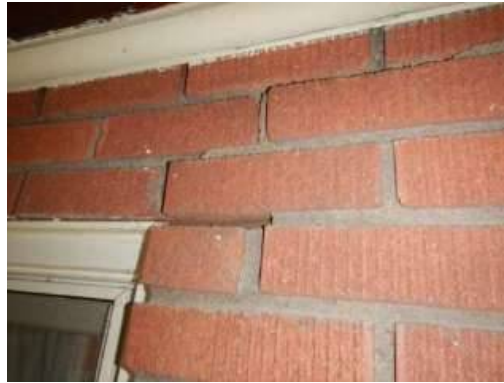
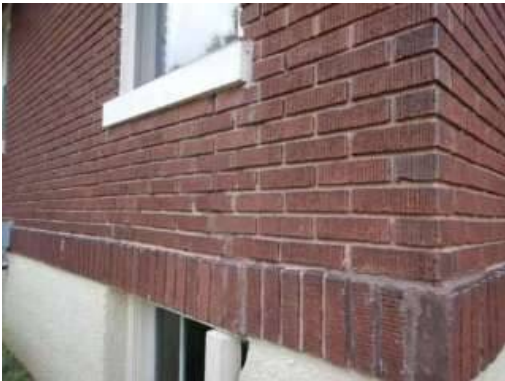
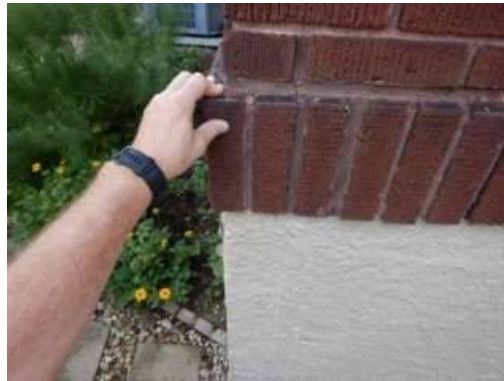
Minor cracks were found in the exterior masonry. These do not appear to be a structural concern. Where cracks or openings are exposed, water can enter causing further damage. Recommend that a qualified contractor seal cracks as necessary.

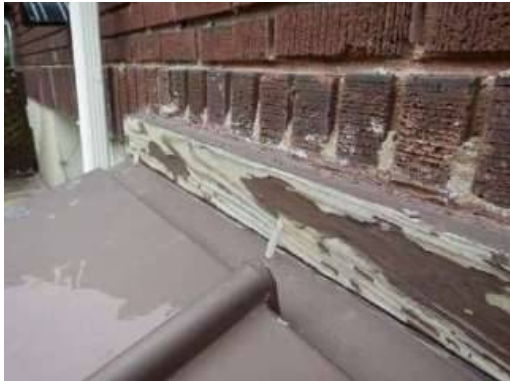
Photo 4-3 @ lintel over hatch

The paint or stain finish in some areas was failing (e.g. peeling, faded, worn, thinning). Siding and trim with a failing finish can be damaged by moisture. Recommend that a qualified contractor prep (e.g. clean, scrape, sand, prime, caulk) and repaint or restain where necessary and per standard building practices. Any repairs needed to the siding or trim should be made prior to this.

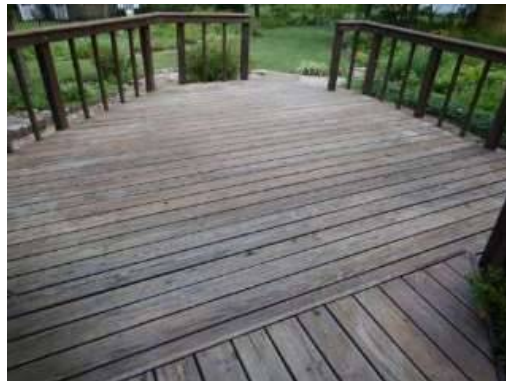
Photo 7-2

Wooden deck surfaces were overdue for normal maintenance. Recommend that a qualified person clean and preserve as necessary. Where decks have been coated with a finish such as opaque stains or paint, it may be too difficult to strip the finish and apply anything but paint or opaque stain. Where transparent stain or penetrating oil has been applied in the past, recommend that a penetrating oil be used. For more information, visit: <https://www.bestchoicehomeinspections.com/articles/deck-maintenance/>

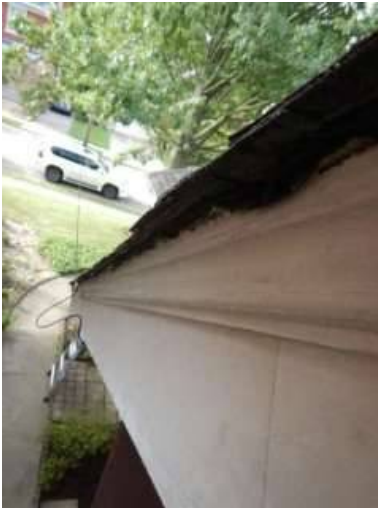
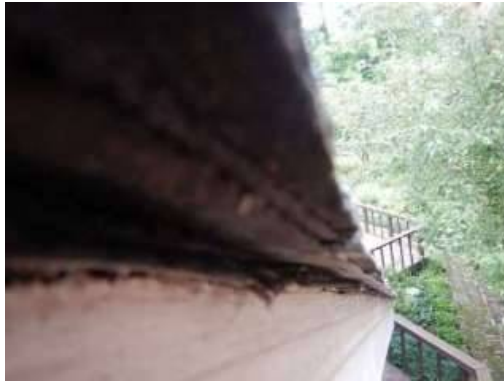
8) **i** This asphalt composition roof surface appeared to have two or more layers of shingles. Additional layers of composition shingles typically last only 80% of their rated life, and the shingle manufacturer's warranty may be voided. The client should be aware that all layers of roofing will need to be removed when this roof surface needs replacing in the future. This will add to the cost.

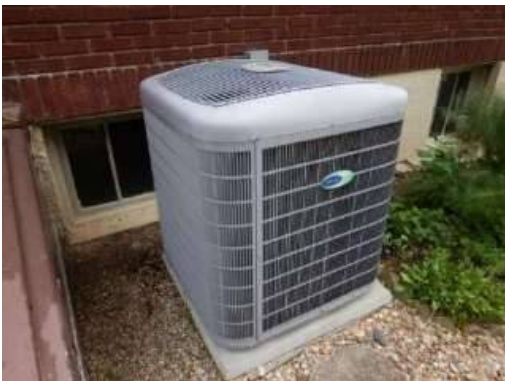
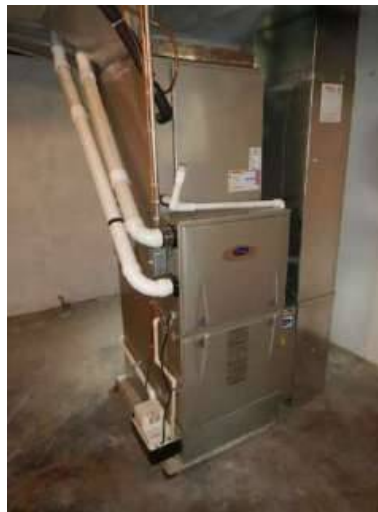
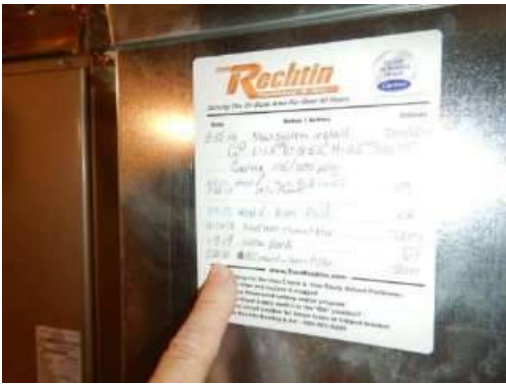
The last service date of the HVAC system appeared to be within the last 2 years based on information provided to the inspector or labeling on the equipment. Routine servicing is not needed at this point. However, because this system has a compressor and refrigerant system, service should be performed every few years in the future.

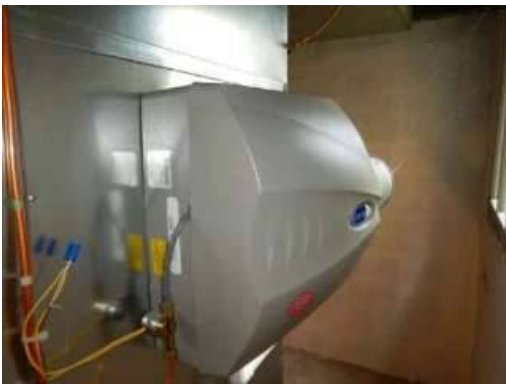
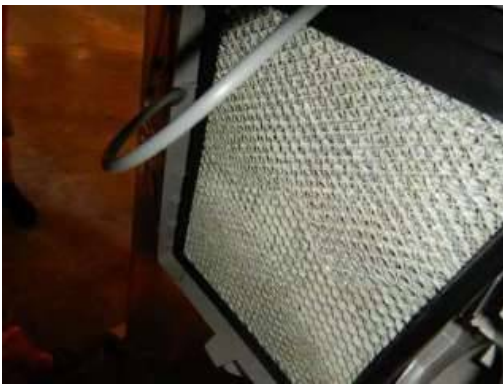
22) Humidifier appears to be working. These are seasonal systems that require some instruction and regular maintenance. Recommend that the client review all available documentation for the humidifier. Recommend the humidifier be serviced when the HVAC system is serviced.

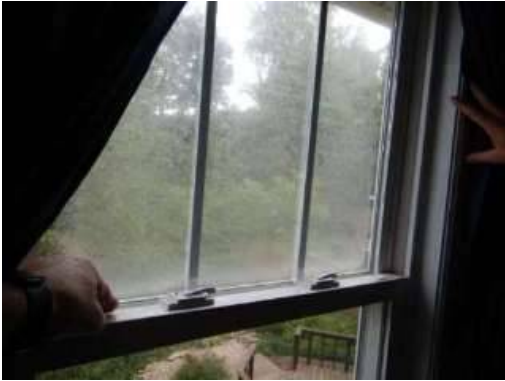
Photo 27-1

27) 🔧🔍 Condensation or staining was visible between the multi-pane glass in window. This indicates that the seal between the panes of glass has failed. As a result, the view through the window may be obscured and the window's R-value will be reduced. Recommend that a qualified contractor evaluate and repair windows as necessary. Usually, this means replacing the glass in window frames. Be aware that evidence of failed seals may be more or less visible depending on the temperature, humidity, sunlight, etc. Because of this windows other than those that the inspector identified may also have failed seals and need glass replaced.

@ upper back bedroom on left, upper sash

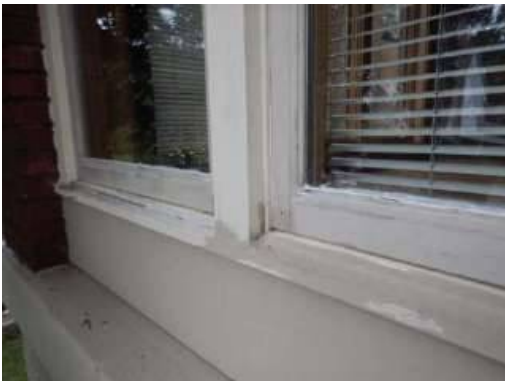
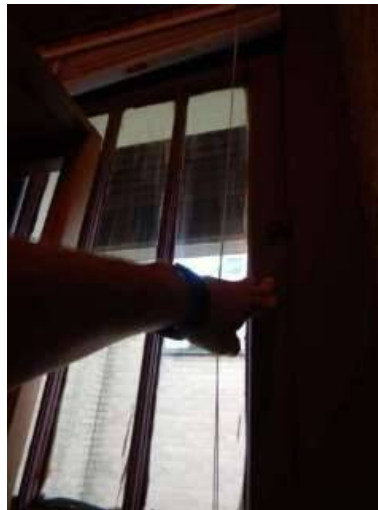
28) 🔧🔍 Window stuck or painted shut or out of adjustment. Recommend that a qualified person repair as necessary.

6 in sun room

1 in back left bedroom closet

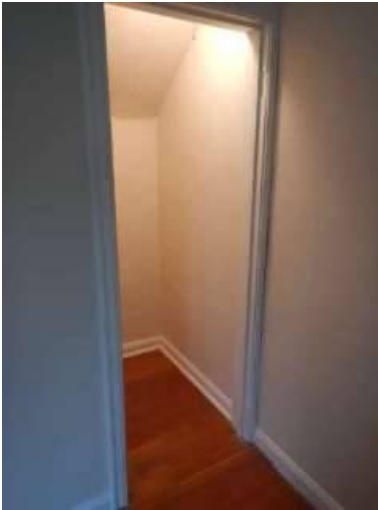
Photo 30-1

30) 🛠️ Interior door was missing. Recommend that a qualified person replace or repair doors as necessary.

@ attic bedroom closet

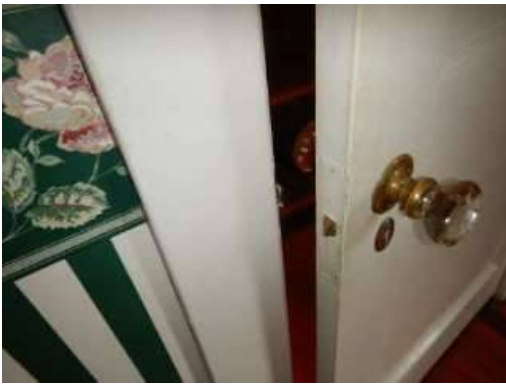
Photo 31-5 @ back left bedroom & closet

31) 🛠️ Interior door wouldn't latch or was difficult to latch. Recommend that a qualified person repair as necessary. For example, by adjusting latch plates or lock set.

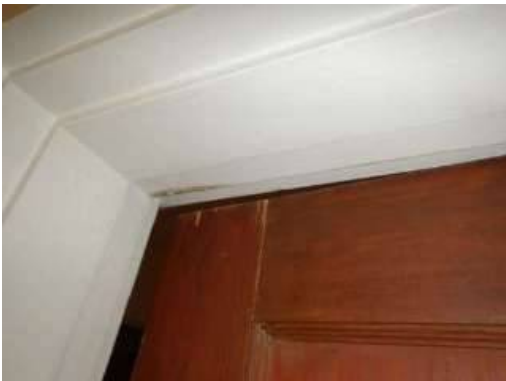
**Photo 32-1** @ living room to hall

Interior door was sticking in the door jamb and was difficult to operate. Recommend that a qualified person repair as necessary.

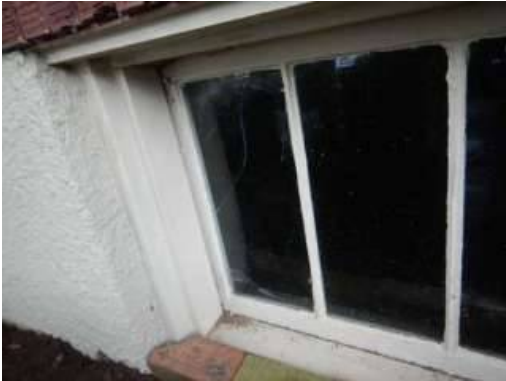
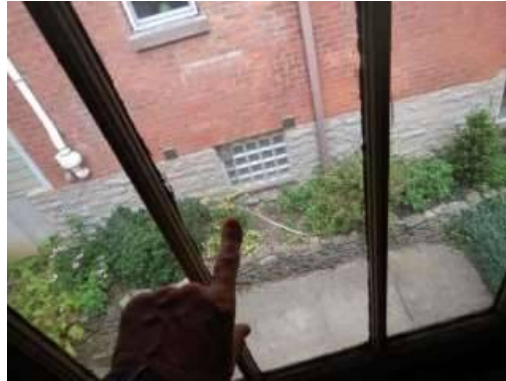
33) 🪒 Glass in window was cracked or broken. Recommend that a qualified contractor replace glass where necessary.

@ basement window under dining room

@ attic

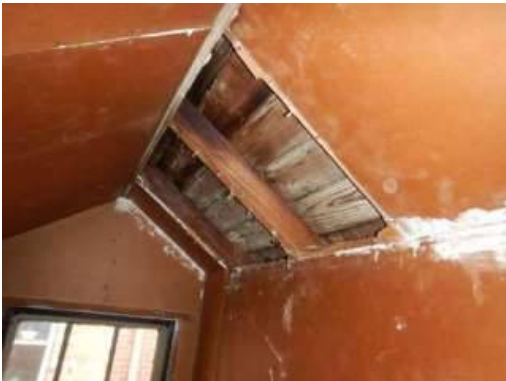
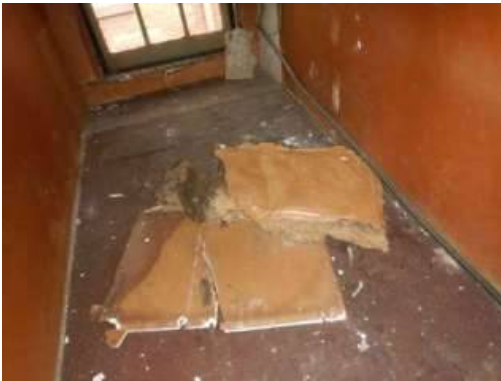
Some insulation in the attic was damaged or uneven. Heating and cooling costs may be higher due to reduced energy efficiency. Recommend that a qualified person repair, replace or install insulation as necessary and per standard building practices (typically R-38).

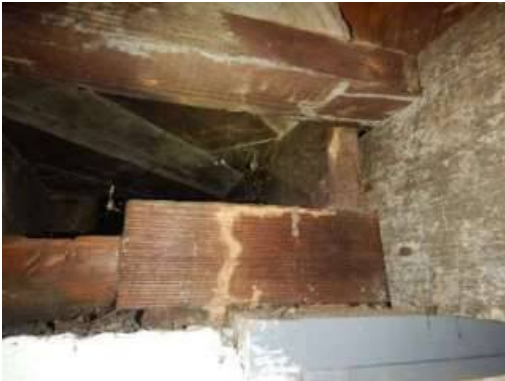
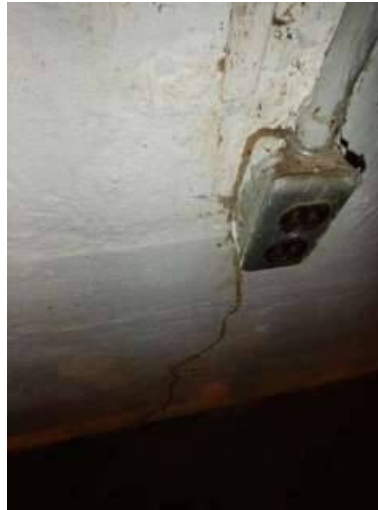
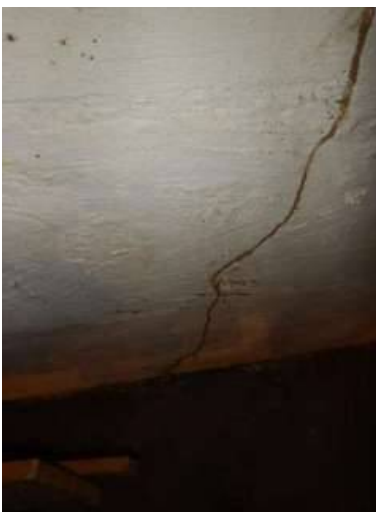
Evidence of active infestation of subterranean termites was found in the form of mud tubes with visible wood damage. Recommend the following:

- Correct any conducive conditions for wood-destroying organisms mentioned in this report.
- Consult with the property owner about any history of infestation.
- Have a state-licensed pest control operator evaluate further and treat as necessary.

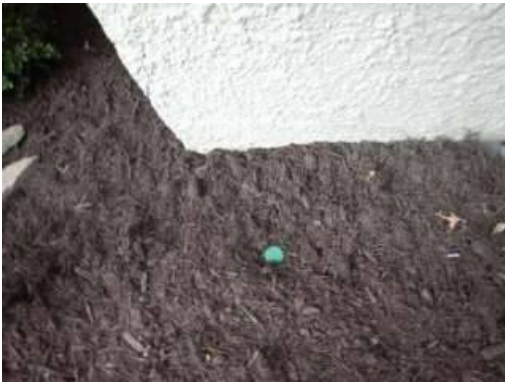
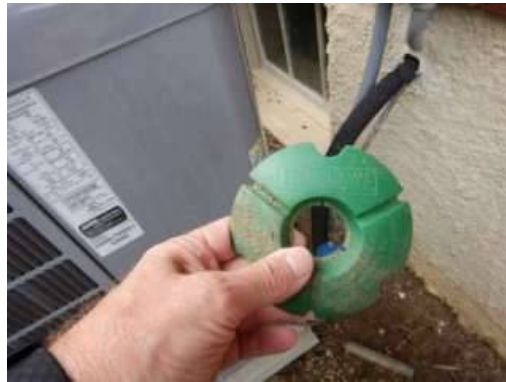
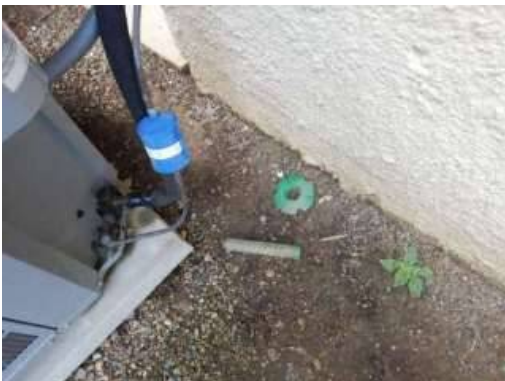
Bait traps found at perimeter. Recommend consult with property owner about history of treatment, infestation, prior or ongoing treatment plan and warranties.

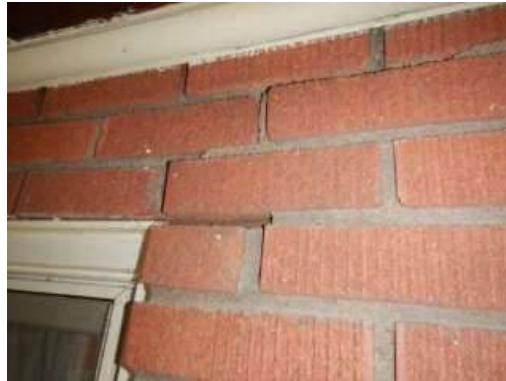
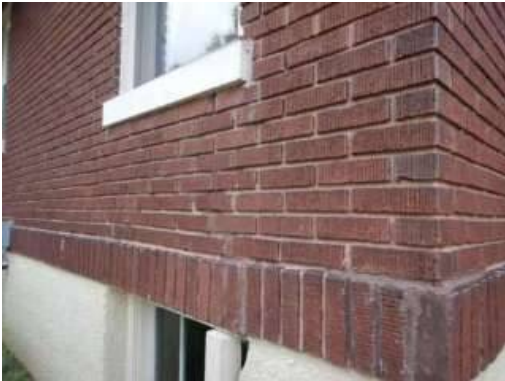
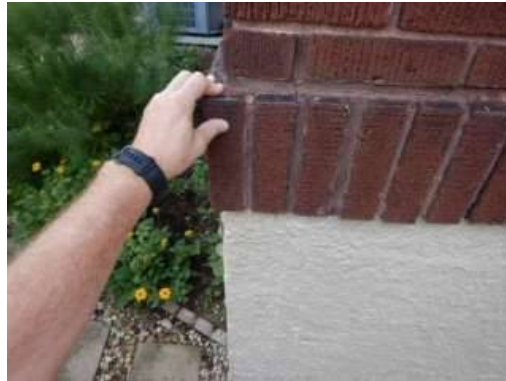
3) 🛠️ Minor cracks were found in the exterior masonry. These do not appear to be a structural concern. Where cracks or openings are exposed, water can enter causing further damage. Recommend that a qualified contractor seal cracks as necessary.

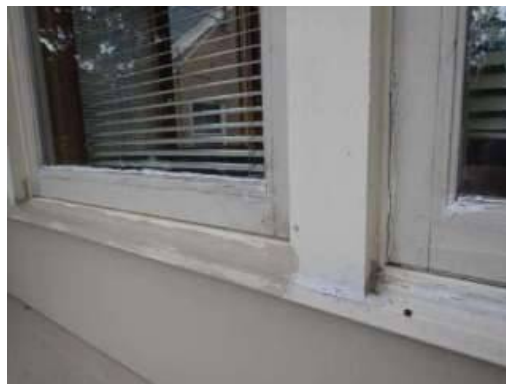
Photo 4-2 @ front door

4) 🛠️💧 The paint or stain finish in some areas was failing (e.g. peeling, faded, worn, thinning). Siding and trim with a failing finish can be damaged by moisture. Recommend that a qualified contractor prep (e.g. clean, scrape, sand, prime, caulk) and repaint or restain where necessary and per standard building practices. Any repairs needed to the siding or trim should be made prior to this.

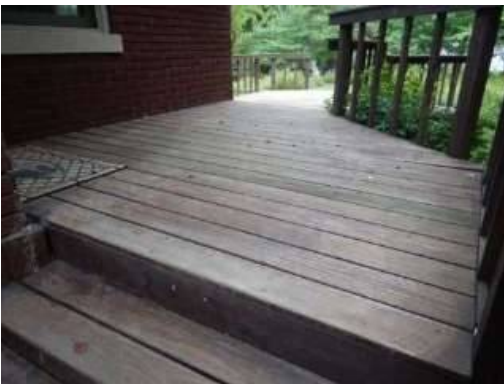
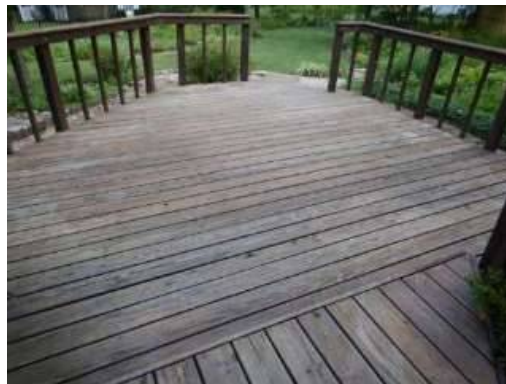
Wooden deck surfaces were overdue for normal maintenance. Recommend that a qualified person clean and preserve as necessary. Where decks have been coated with a finish such as opaque stains or paint, it may be too difficult to strip the finish and apply anything but paint or opaque stain. Where transparent stain or penetrating oil has been applied in the past, recommend that a penetrating oil be used. For more information, visit:

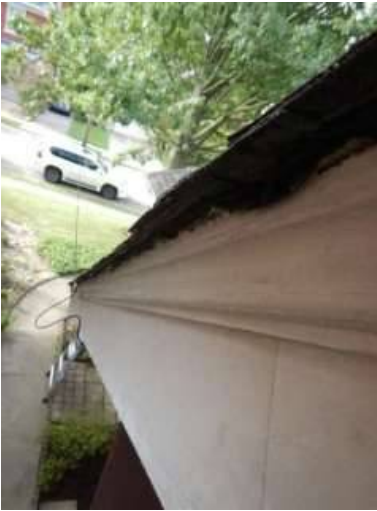
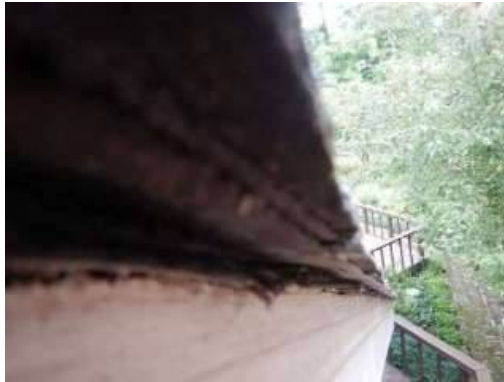
8) **i** This asphalt composition roof surface appeared to have two or more layers of shingles. Additional layers of composition shingles typically last only 80% of their rated life, and the shingle manufacturer's warranty may be voided. The client should be aware that all layers of roofing will need to be removed when this roof surface needs replacing in the future. This will add to the cost.

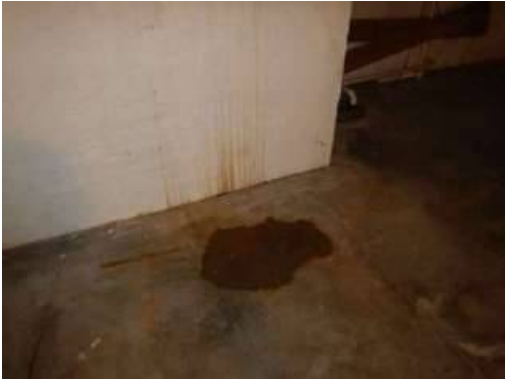
Photo 10-1

Water or signs of water were found in the basement. Source appears to be ground water penetration of the foundation. A qualified contractor who specializes in drainage issues should evaluate and repair as necessary. Typical repairs for preventing water from accumulating in basements include:

- Repairing, installing or improving rain run-off systems (gutters, downspouts, window wells and extensions or drain lines)
- Improving perimeter grading
- Repairing, installing or improving underground footing and/or curtain drains
- Epoxy injection foundation crack repairs

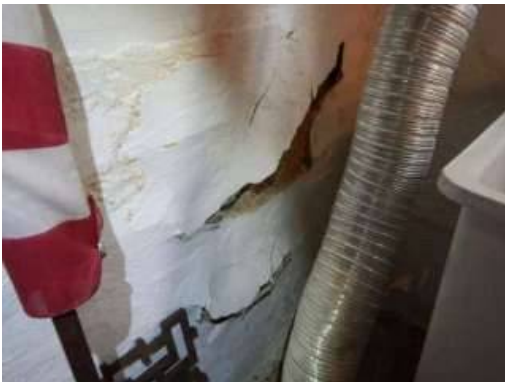
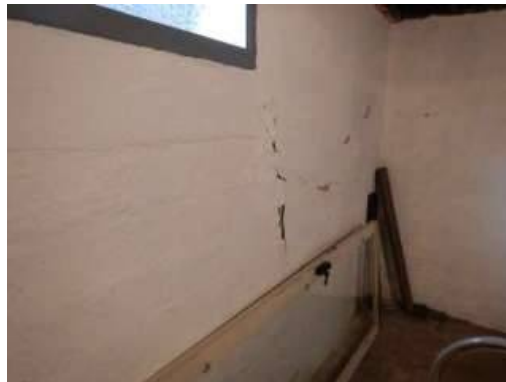
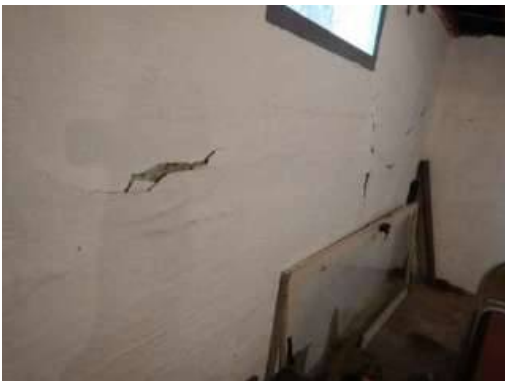
Efflorescence and/or spalling are visible on the brick and/or masonry. This can be a frustrating cosmetic issue, or it can be an indication of moisture problems including exterior wicking. Recommend evaluation and repairs be made by a qualified specialist. Recommend mitigating the moisture concerns prior to making any repairs.

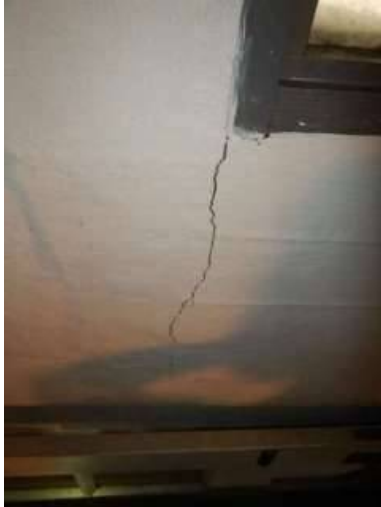
Photo 12-1

Minor cracks (1/8 inch or less) found in the foundation did not appear to be a structural concern, but recommend sealing them to prevent water infiltration and monitor them in the future. Numerous products exist to seal such cracks including hydraulic cement, non-shrinking grout, resilient caulks and

epoxy sealants.

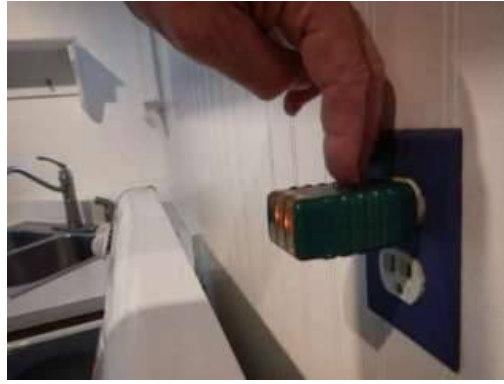
Photo 15-1

Receptacle (outlet) at the kitchen sink and laundry wet area had no visible ground fault circuit interrupter (GFCI) protection. If not GFCI-protected, receptacles in wet areas pose a shock hazard. Recommend that a qualified electrician evaluate and install GFCI protection if necessary and per standard building practices. General guidelines for GFCI-protected receptacles include the following locations:

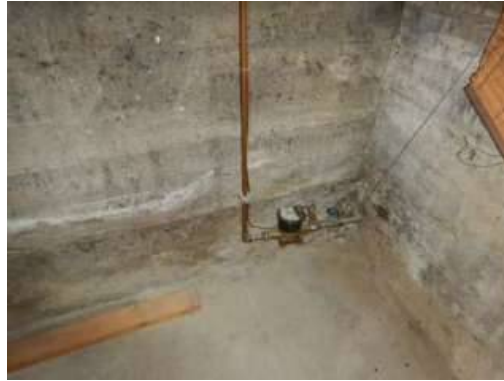
Photo 18-1

The water supply pressure was greater than 80 pounds per square inch (PSI). Pressures above 80 PSI may void warranties for some appliances such as water heaters or washing machines. Flexible supply lines to washing machines are likely to burst with higher pressures. 40-80 PSI is considered the normal range for water pressure in a home, and most plumbers recommend 50-60 PSI . Typically, the pressure cannot be regulated at the water meter. Recommend that a qualified plumber evaluate and make modifications to reduce the pressure to below 80 PSI . Installing a pressure reducing valve on the main service pipe is a common solution to this problem. If one exists, then it should be adjusted, repaired or replaced as necessary to maintain lower pressures. Note that installing a pressure reducing valve creates a "closed system," which may require installing an expansion tank at the water heater if one is not already installed.

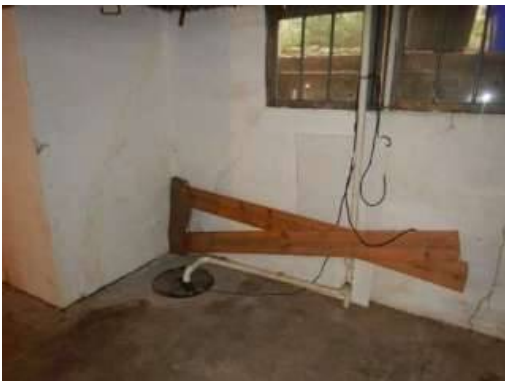
Photo 19-1

No battery backup system was found for the sump pump. If the power goes out during heavy rains, the sump pump won't be able to eliminate accumulated water. Consider installing a battery backup system for the sump pump, especially you travel frequently. For more information on sump pumps see:

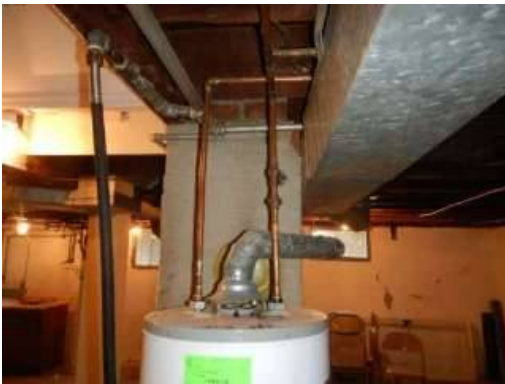
Photo 20-1

No expansion tank was installed for the water supply system. Expansion tanks are recommended when a property is on a public water supply system and the property's water system is "closed" via a pressure reducing valve (PRV), check valve, or backflow preventer. No room for expansion of water exists in this type of system. Thermal expansion occurs when water is heated during non-use periods. In a closed system with no provision for expansion, its effects can include:

- Backflow into the water main
- Damage to water heater connections, gas water heater flue tubes and pumps serving washers and dishwashers
- Leaking faucets
- "Weeping" of water through the water heater temperature-pressure relief (TPR) valve
- Noisy water hammer in the pipes

Expansion tanks can eliminate these problems by giving water a place to go when thermal expansion occurs. When a water heating cycle ends, or when any fixture is opened within the system, the impact of thermal expansion is reduced, and water drains out of the expansion tank back into the system. Recommend that a qualified plumber install an expansion tank per standard building practices.

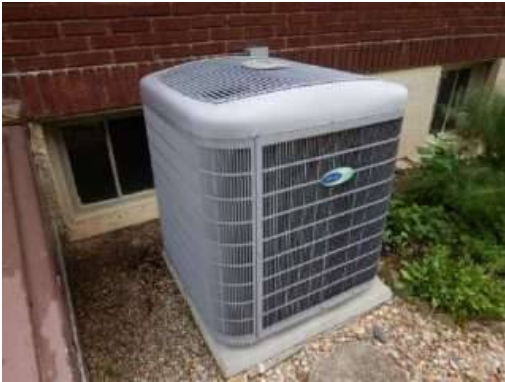
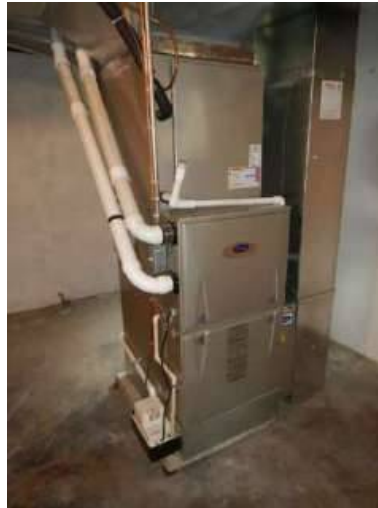
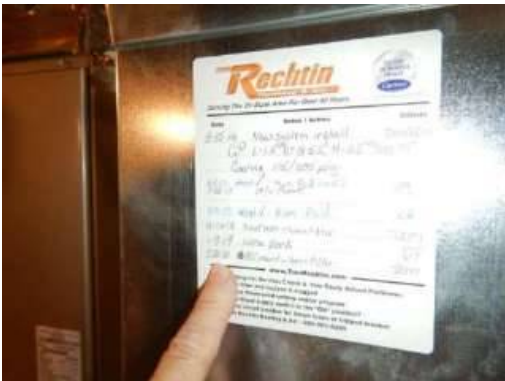
The last service date of the HVAC system appeared to be within the last 2 years based on information provided to the inspector or labeling on the equipment. Routine servicing is not needed at this point. However, because this system has a compressor and refrigerant system, service should be performed every few years in the future.

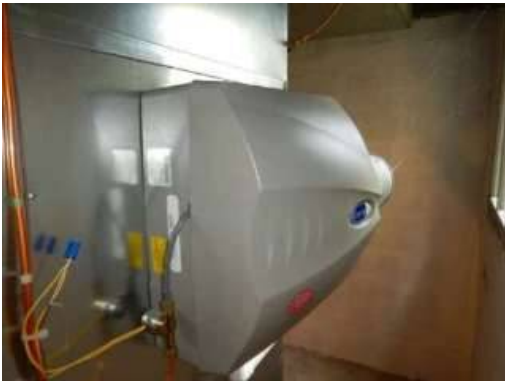
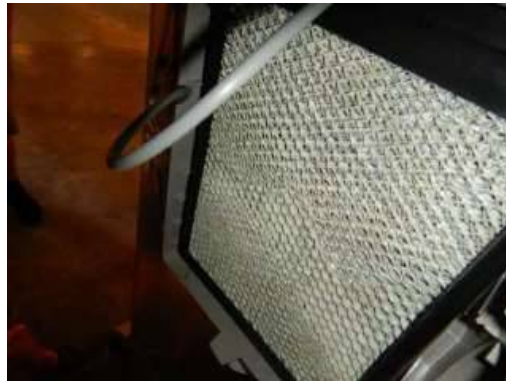
Humidifier appears to be working. These are seasonal systems that require some instruction and regular maintenance. Recommend that the client review all available documentation for the humidifier. Recommend the humidifier be serviced when the HVAC system is serviced.

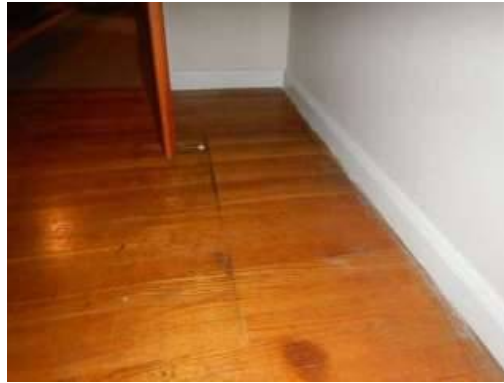
Photo 24-2

24) 🔍 Wood flooring was stained or substandard. Recommend that a qualified contractor evaluate, replace or refinish wood flooring as necessary.

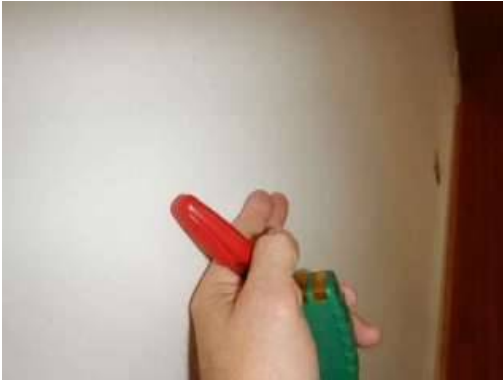
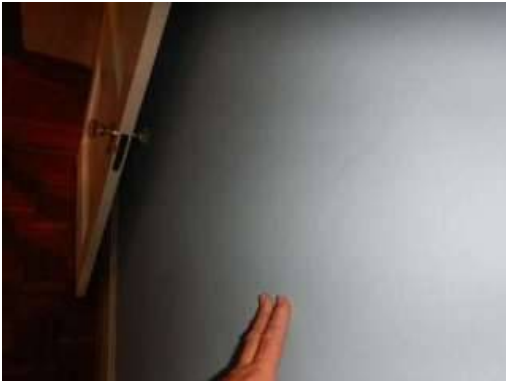
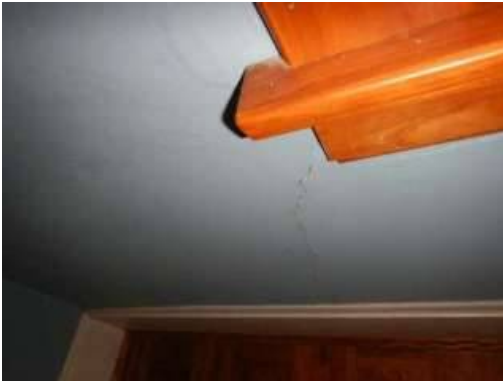
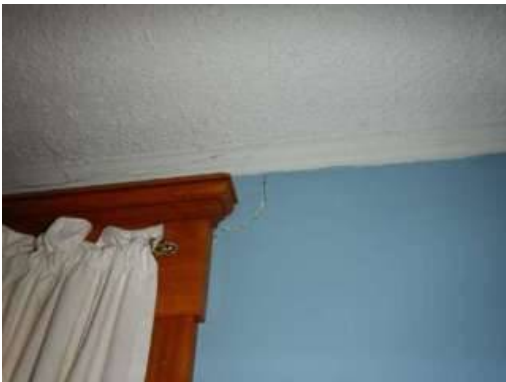
25) 🛠️ ⓘ Minor cracks, nail pops and/or blemishes were found in the walls and/or ceilings. Cracks and nail pops are common, are often caused by lumber shrinkage, seasonal expansion and contraction, or minor settlement, and can be more or less noticeable depending on changes in humidity. Blemishes may be caused by normal usage or substandard patching and painting. They did not appear to be a structural concern, but the client may wish to repair these for aesthetic reasons.

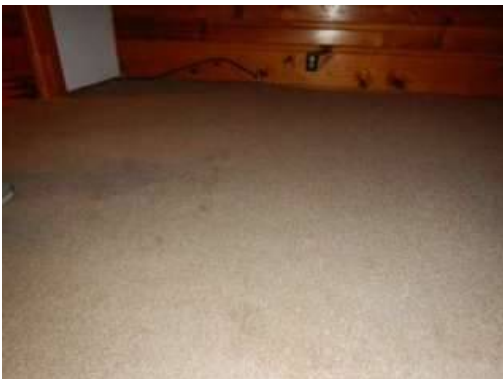
Photo 26-2

26) 🛠️ ⓘ Carpet flooring was stained. Recommend having flooring evaluated and/or cleaned or replaced as necessary.

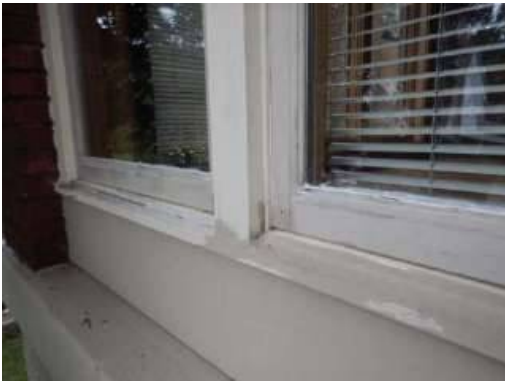
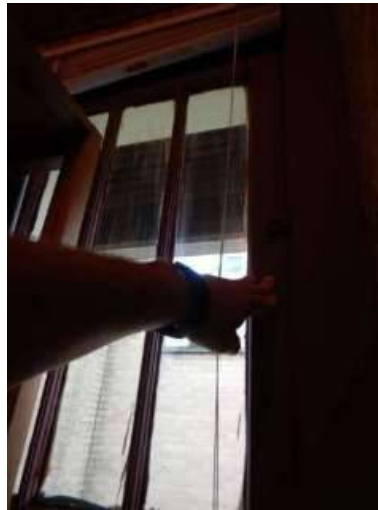
6 in sun room  
1 in back left bedroom closet

Window stuck or painted shut or out of adjustment. Recommend that a qualified person repair as necessary.

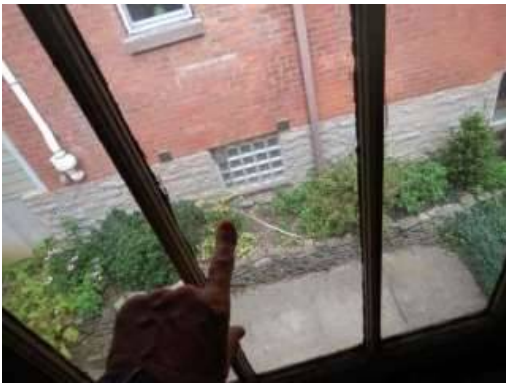
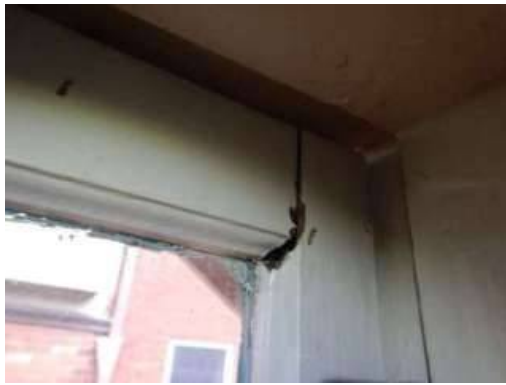
@ attic

Window damaged or out of adjustment and one panel is cracked. Recommend that a qualified person repair as necessary.

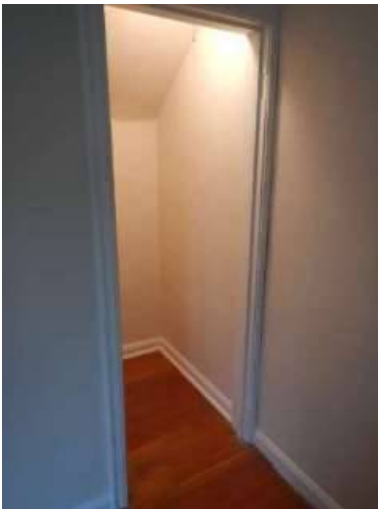
Photo 30-1

Interior door was missing. Recommend that a qualified person replace or repair doors as necessary.

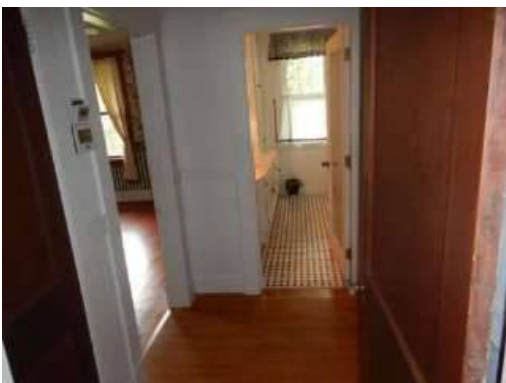
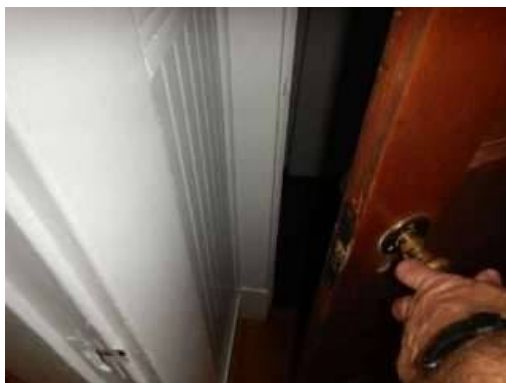
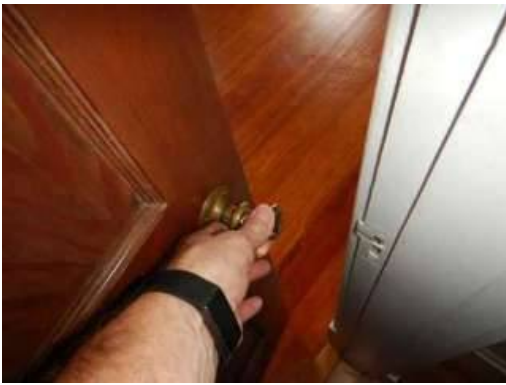
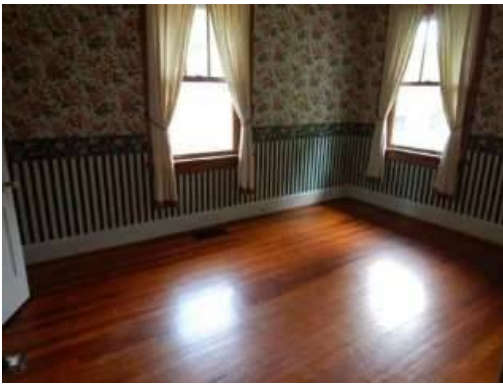
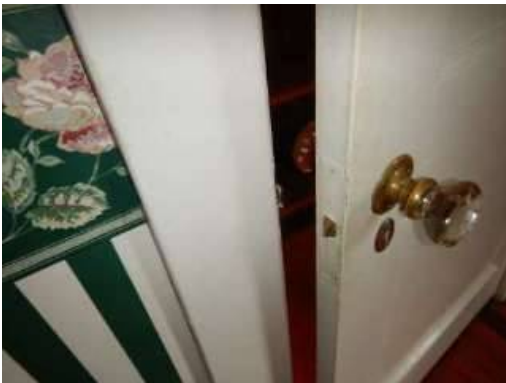
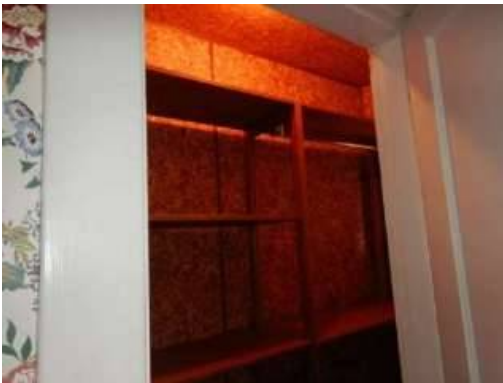
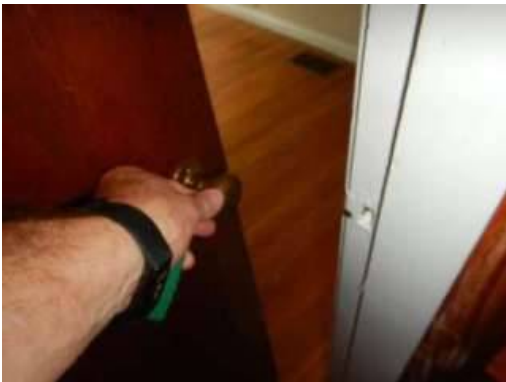
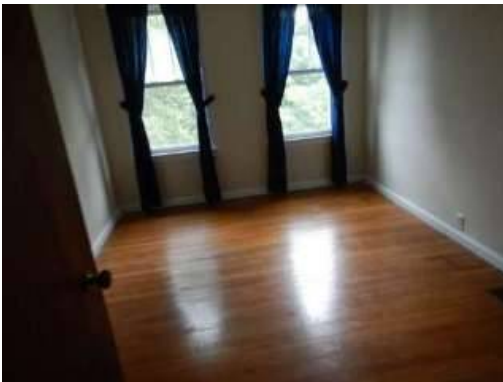
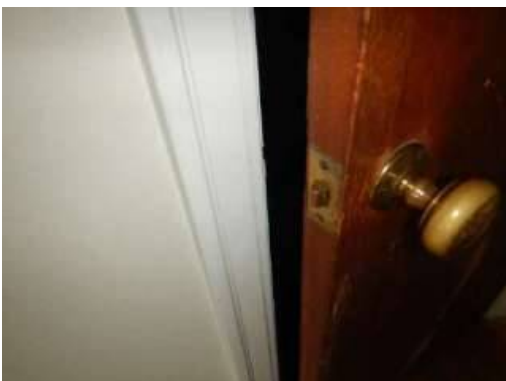
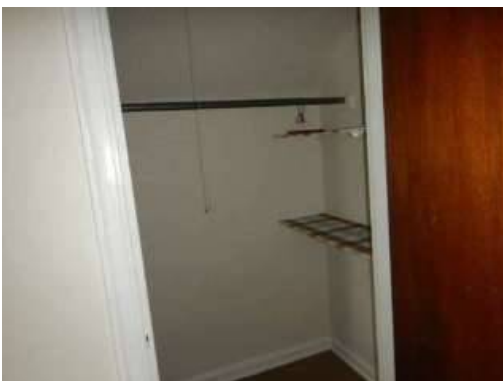
@ hall  
@ back left bedroom & closet  
@ attic back bedroom & closet

Interior door wouldn't latch or was difficult to latch. Recommend that a qualified person repair as necessary. For example, by adjusting latch plates or lock set.

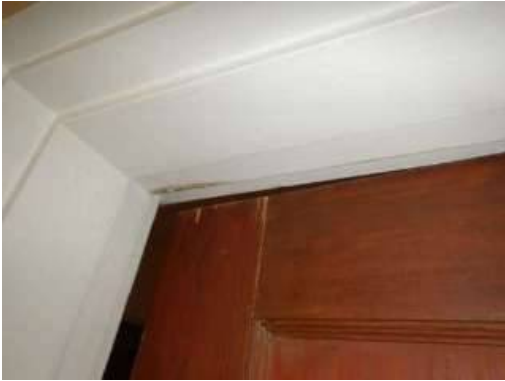
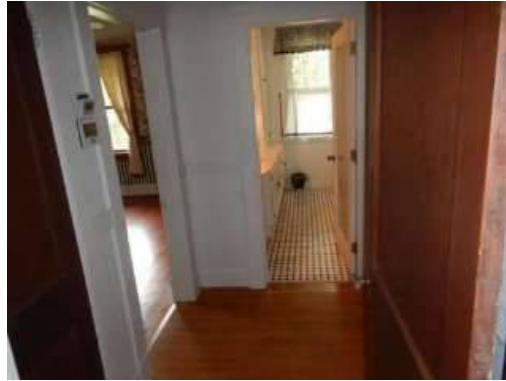
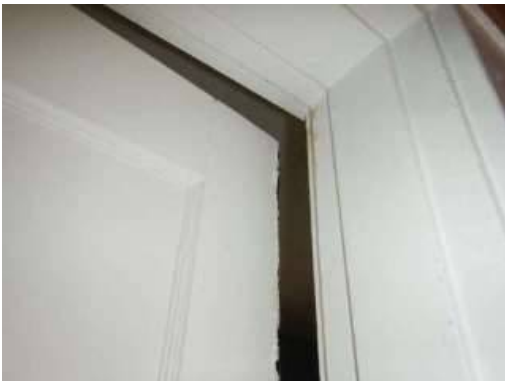
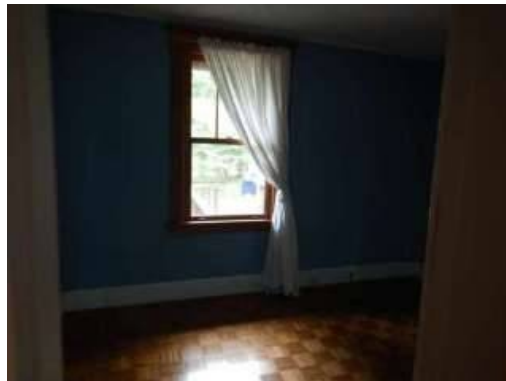
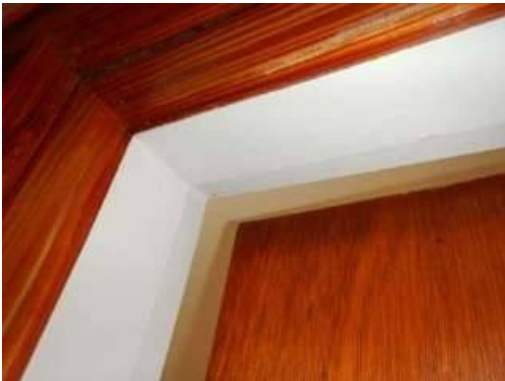
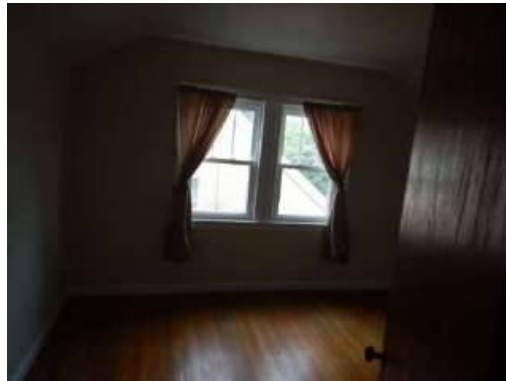
- @ living room to hall
- @ back bedroom at right
- @ attic bedroom

32) 🛠 Interior door was sticking in the door jamb and was difficult to operate. Recommend that a qualified person repair as necessary.

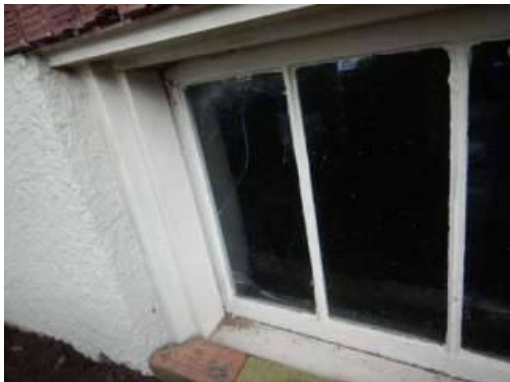
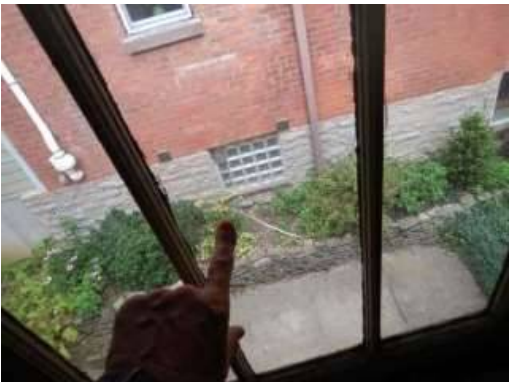
- @ basement window under dining room
- @ attic

33) 🪒 Glass in window was cracked or broken. Recommend that a qualified contractor replace glass where necessary.

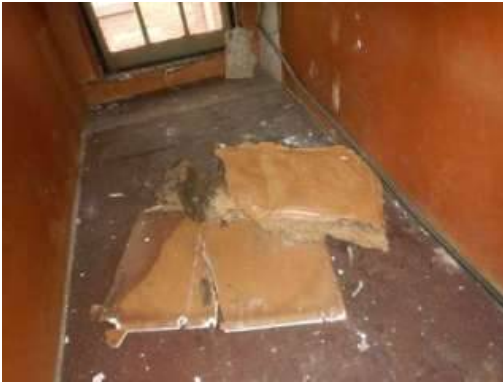
Photo 34-2

Some insulation in the attic was damaged or uneven. Heating and cooling costs may be higher due to reduced energy efficiency. Recommend that a qualified person repair, replace or install insulation as necessary and per standard building practices (typically R-38). For more information see: <https://www.bestchoicehomeinspections.com/articles/insulation/>

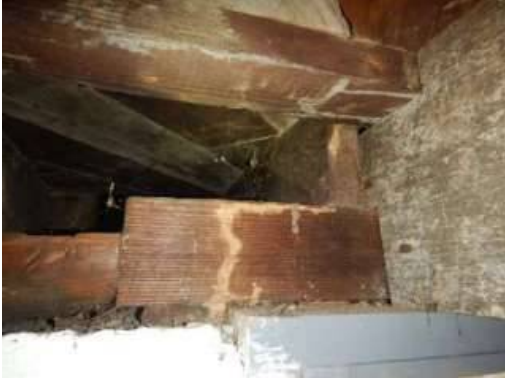
Photo 35-1

Evidence of active infestation of subterranean termites was found in the form of mud tubes with visible wood damage. Recommend the following:

- Correct any conducive conditions for wood-destroying organisms mentioned in this report.
- Consult with the property owner about any history of infestation.
- Have a state-licensed pest control operator evaluate further and treat as necessary.
